INDEPENDENT REVIEW

REPORT SRT LINE 3 INCIDENT

SYSTRA Canada Reference: 23038-GART-0001_D

Toronto Transit Commission (TTC)

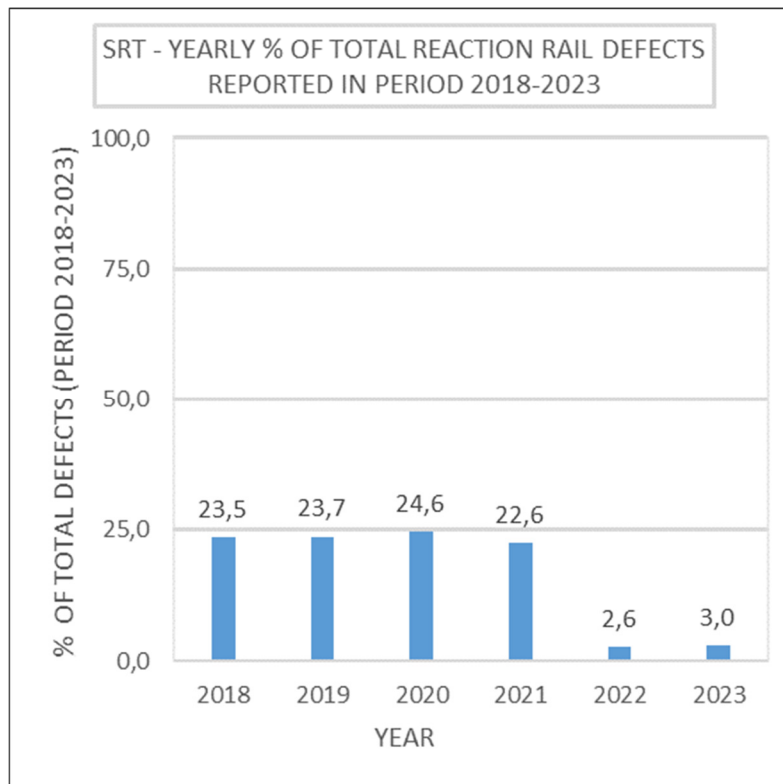
Figure 1: Defect distribution on the Reaction Rail over the last 5 years

Regarding the reaction rail defects, during the migration from MOWIS to MAXIMO, the defects listed dropped off very significantly. Apparently only new defects and defects to be repaired before closing the line to revenue service remained listed. Another possibility was the removal of duplicated defects already present in MOWIS which may have artificially increased the number of defects prior to 2022. Overall, the migration process is not clear and should be reviewed and better documented. A detailed forensic investigation of this data migration was not possible as we did not witness this process.

The drop in the number of defects may also be explained by the difficulty for track patrollers to see a fractured new anchor bolt design, see Section 13. In fact, the inspection is carried out during revenue service hours, with a third rail supplied with electricity, which does not allow the track patroller to lie down on the track to see the condition of the bolts. In addition, the Track and Structure team confirmed that they were no longer repainting the top cap during their maintenance operations, even after addressing areas that have been reported to have a “Polished Top Cap”. This has contributed to trivializing this phenomenon and could have been overlooked by track patrollers.

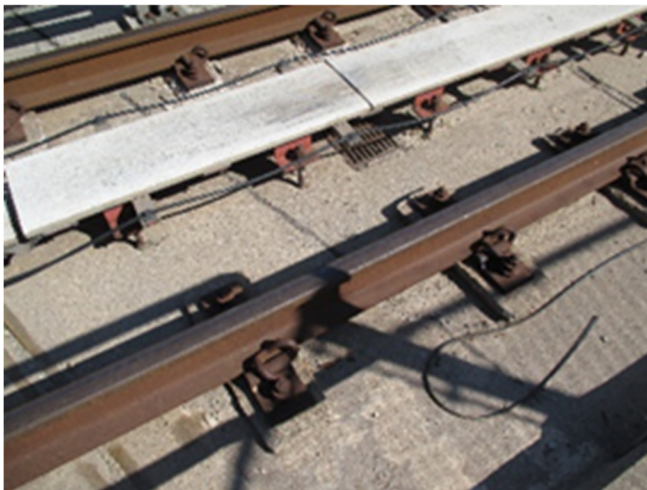
Figure 2: Wear marks on reaction rail

Normally, by design, the train must not have any contact with the reaction rail, but on site, there are many areas where the train rubs on the reaction rail, see Figure 2 and a few areas where the nuts are not tightened or missing, see Figure 3.

Wear marks on the reaction rail or “polished top cap” as reported by track patroller could be explained by:

Therefore, these “polished top cap” are not only caused by the top cap contacting the LIM which could explain why they were only classified as priority level 5 or brown. Previously, whenever the maintenance team was inspecting a “polished top cap” area, the top cap was repainted white, unfortunately, this practice was stopped a few years ago.

Consequently, it is currently difficult for track patrollers, who perform visual inspection, to know what causes these “polished top caps” without proper tools and the ability to thoroughly inspect reaction rail anchors during revenue service with power supply on.

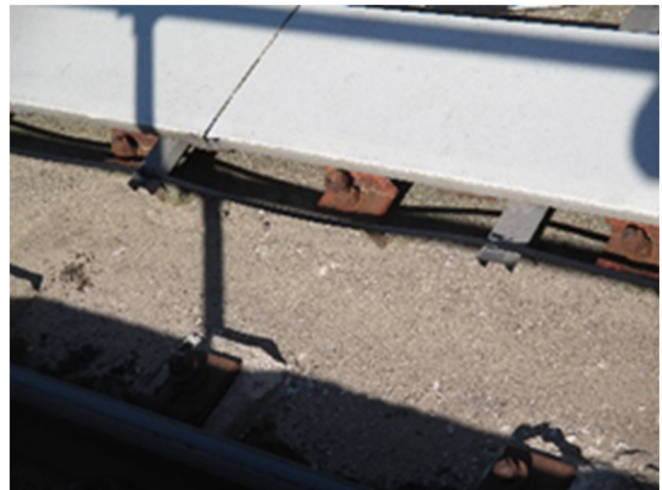
Figure 3: Broken anchor bolt

The report mentions several types of failure for the anchor bolts; fractured threaded rod and loose anchor, all of which were found on the system at different locations. A failure analysis of the fractured anchor bolts revealed that they failed due to cyclic loading, implying that they were already fractured prior to the accident. It seems that this failure mode was only found on newly replaced anchor bolt made from a combination of Hilti HSL-GR and a threaded stainless-steel rod. These bolts are used whenever a replacement of the anchor bolt is needed. The appendix E of the Gannett Fleming report details the analysis performed on a set of broken anchor bolt from the accident, original Hilti HSL-GR anchor bolt and a reference stainless-steel threaded rod. Although the mechanical properties of the stainless steel used for the threaded portion appeared to be similar to one another, the profile of the threads is different. The root of the thread is square on the threaded rod used by TTC whereas the Hilti is round. Such difference could have had an impact on the fatigue performance of the part and partly explains why the bolt fractured.

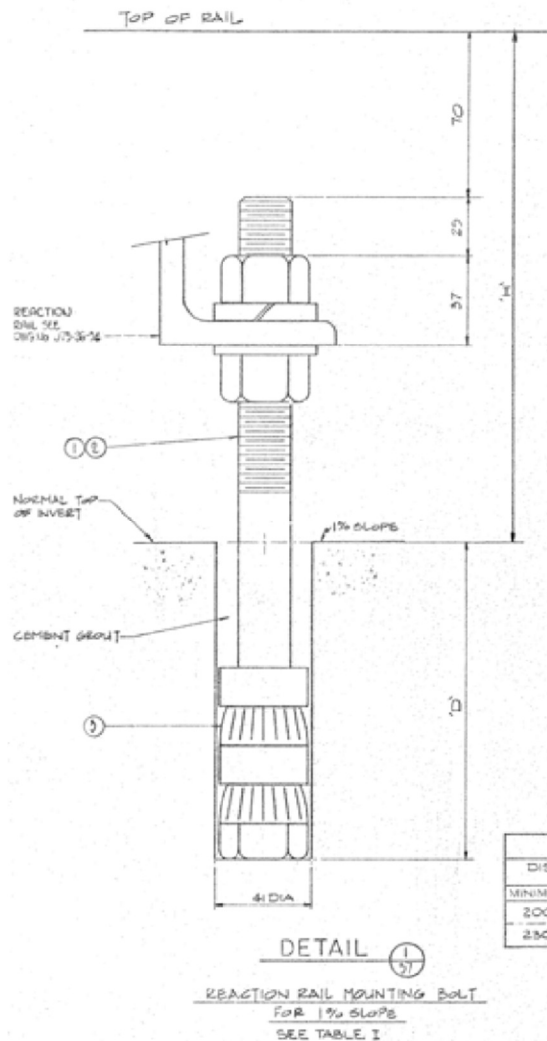
Figure 7: Original Anchors from Drawing J75-26-37

In 2016, TTC started using a new anchor design to replace the original anchor used to attach the reaction rail to the inverted concrete slab. This new solution was progressively deployed as a replacement for broken or damaged original design anchor. Not much detail was made available to SYSTRA on the design of the original anchor other than the information from the original infrastructure drawing showing an inverted 7/8-9 UNC bolt installed inside a hole with some sort of anchor sleeve with cement grout pored over.

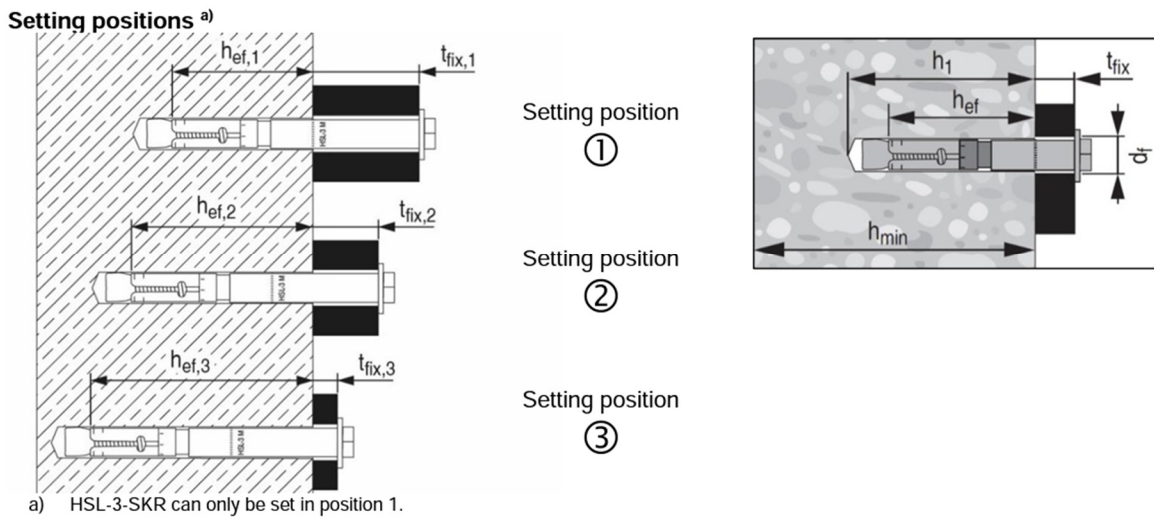
Figure 9: Setting information from Hilti technical documentation.

Using the Hilti HSL-GR with a long threaded stainless-steel rod to support the reaction rail of the SRT Line 3 can explain why several were found by Gannett Fleming to be fractured, see section 7.3. These anchors are not intended to be used in bending load as it is the case on the SRT Line 3. The metallurgical analysis confirmed that this fracture was due to cyclic loading, hence failed in fatigue probably over a long period. Combining this with the inspection process of the track patroller of walking over the reaction rail during revenue service hours suggest that this failure was not systematically reported due to its difficulty to detect. It is possible that the condition of these new anchor bolts became worse over the last few years and was not detected by the track patroller given their inspection method. It is important to note that this new anchor design was progressively replacing the original anchor design over the last 7 years.

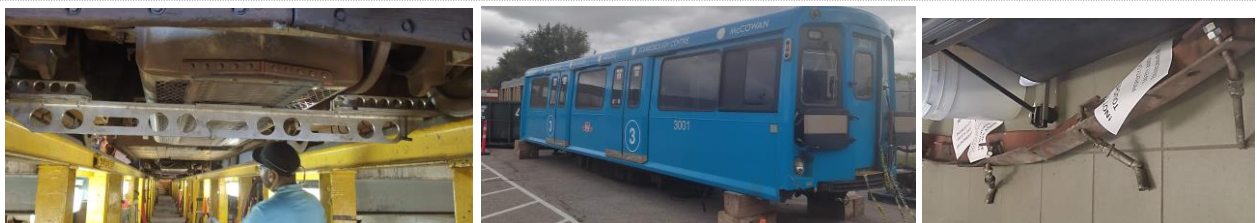
- Brief contact with the derailed car (including some damaged components and damaged reaction rail)
- Demonstration of the measurement gap car lime/reaction rail

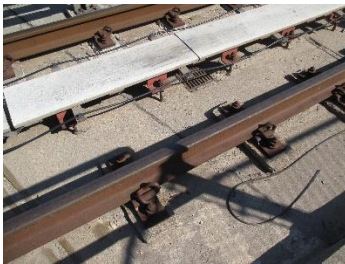
Photo n°1

- There are many areas where the train rubs on the reaction rail (photo n°1) and a few areas where the nuts are not tightened or missing (Photo n°2)
