Line 2 (Bloor-Danforth) Wheel Flats Update

Date: July 10, 2019

To: TTC Board

From: Chief Vehicle Officer (Acting)

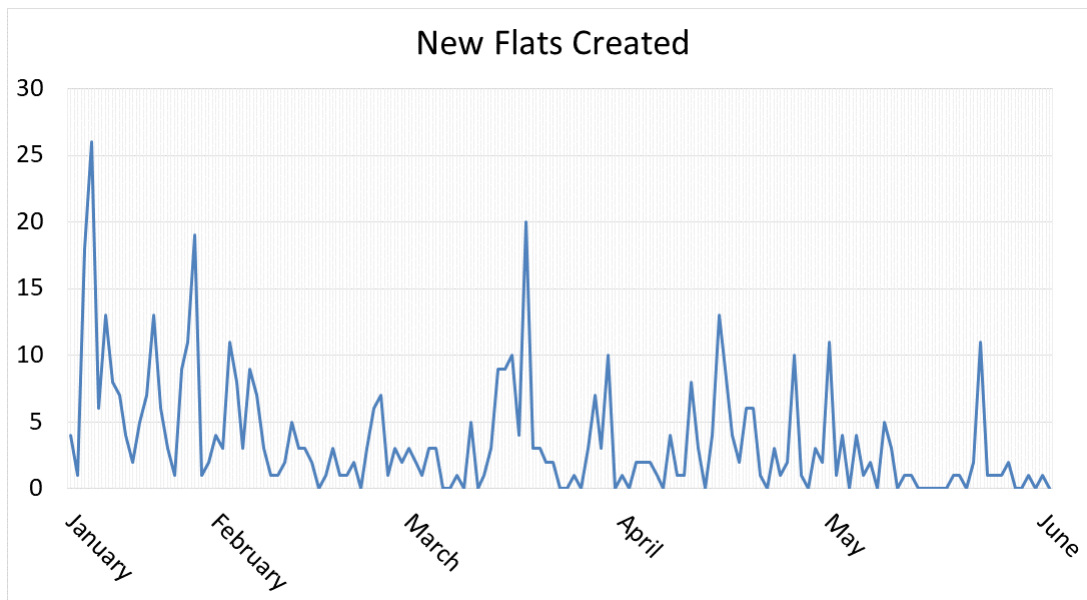
Chart A – Wheel Flats Generated by Month

In October 2018, the T1 subway vehicles on Line 2 experienced a higher than normal number of wheel flats. A normal spike in wheel flats is expected during autumn weather due to foliage falling on the tracks and seeping natural oils that reduces the friction between the vehicle steel wheels and the rail. The result is increased sliding between wheel and rail during braking, which is a major contributor to the experienced autumn wheel flats. The number and duration of wheel flats this autumn exceeded the previously experienced seasonal wheel flat trend. The vibration generated from the wheel flats raised concerns from residents along Line 2.

Historically, TTC has been able to cope with seasonal wheel flat spikes and prevent vehicles with significant wheel flats from entering service. In October 2018, however, the number of wheel flats generated was unusually high. A second and unexpected spike in the number of wheel flats occurred again in late December 2018. These two incidents overwhelmed the maintenance facility and corrective maintenance activities were no longer able to keep pace with the high volume of new wheel flats being generated each day.

The number of new wheel flats continued to remain high throughout January and February 2019. Given the large backlog of flats experienced, to ensure subway service requirements were met, trains had to be placed into service with this defect. As a result,

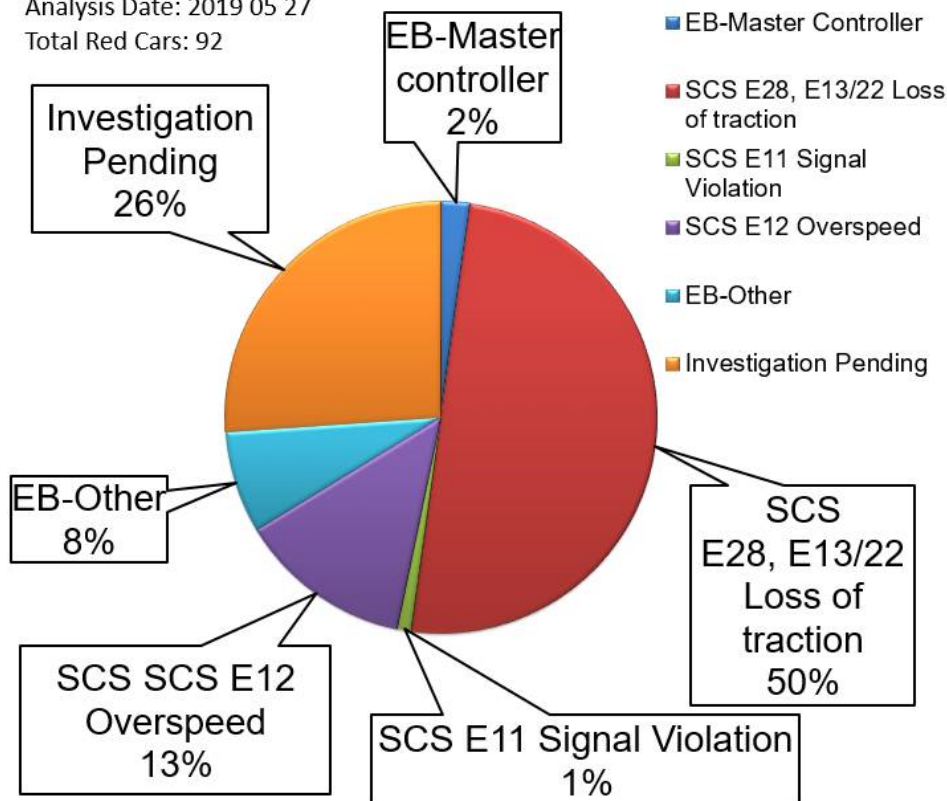
RED FLAT CARS BY EB EVENTS, APRIL 2019

Data from the Speed Control System was also analysed. This data highlighted instances of EB application and potential reasons for the application. The graph below is an example of the data analysed weekly. From this data, the investigation team would determine tests and investigations to perform in attempts to reduce the number of wheel flats generated. For example, operator information campaigns were implemented when it was identified that the number of EB applications due to over speed and signal violations increased. In addition, speed restriction zones were implemented in the open cut sections during inclement weather to minimize wheel slip.

Analysis Date: 2019 05 27
Total Red Cars: 92

To further reduce the number of emergency brake application when slippery conditions are experienced, additional tags were installed in the outdoor sections and a software upgrade has been requested from Thales to take advantage of the new tags. The software update is due to be in service before Fall 2019.
