Subway Platform Gap Retrofit Program

Date: September 24, 2019

To: TTC Board

From: Chief Infrastructure and Engineering Officer

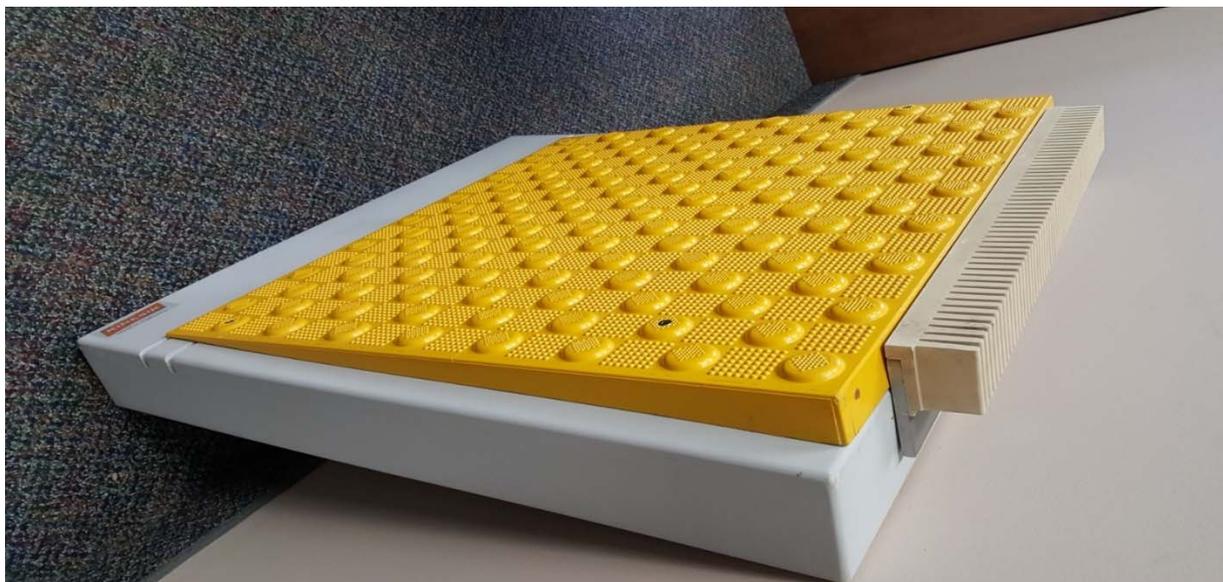
Photo 1 – Sloped precast tactile edge tile with horizontal gap filler for maximum 32 mm vertical gaps.

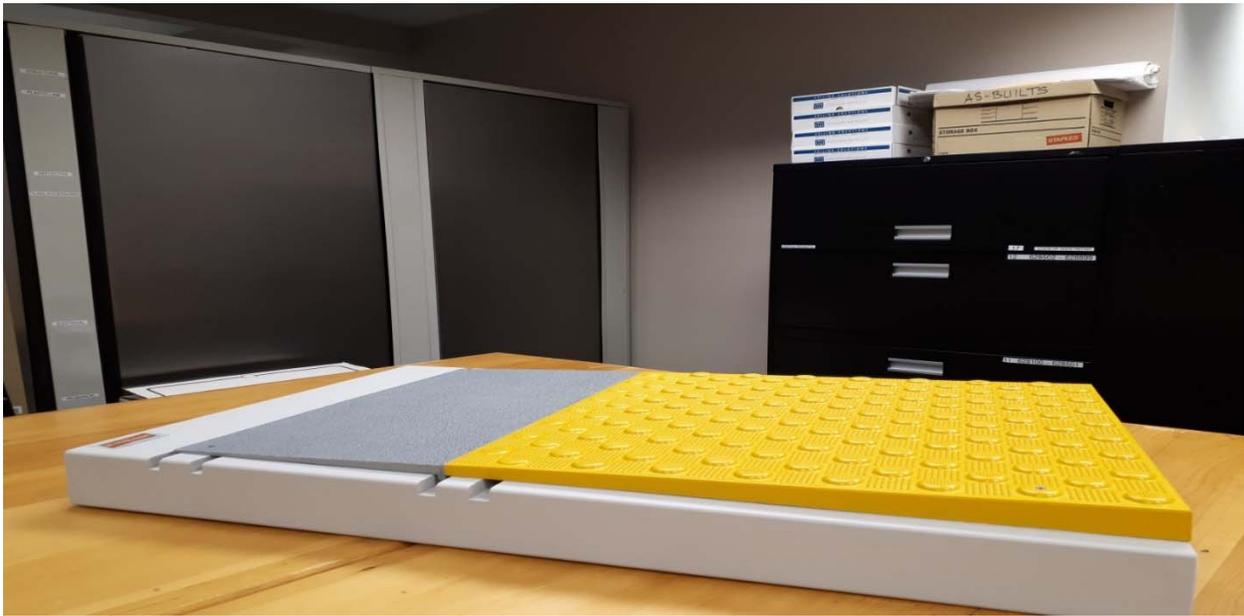
Photo 2 – Sloped precast tactile edge tile for vertical gap corrections in excess of 32 mm.

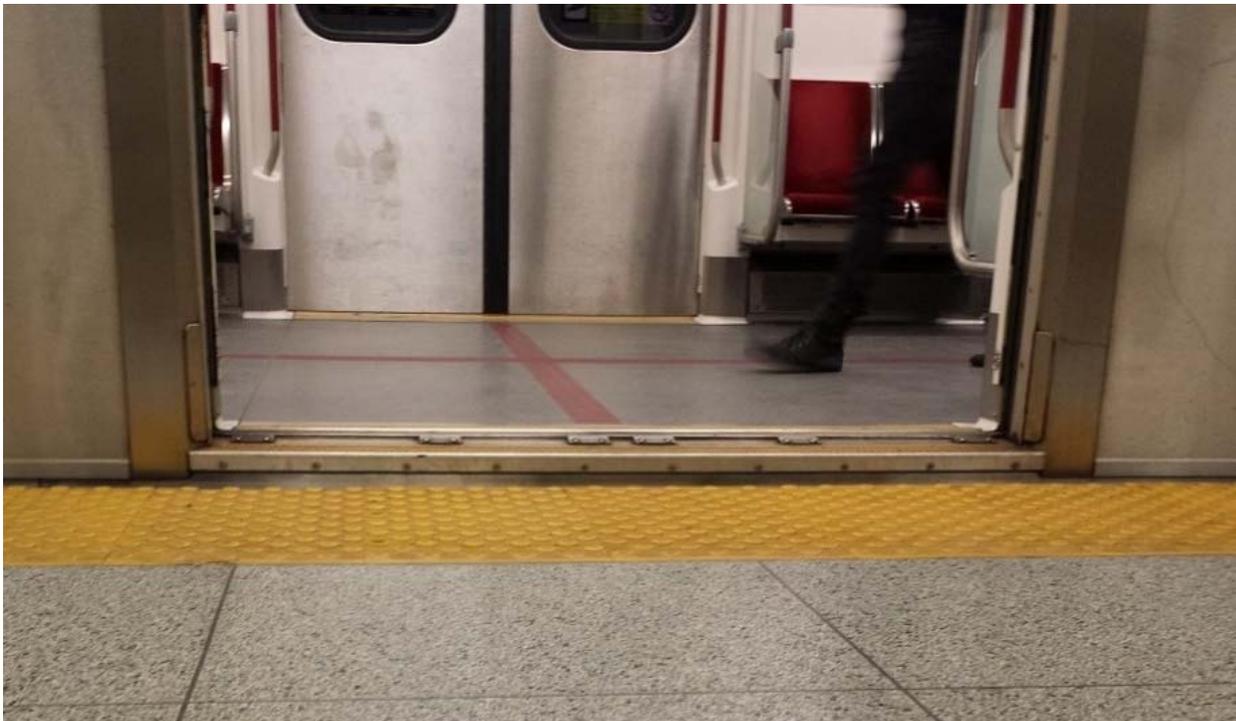
Photo 3a – Pre-existing vertical gap at Eglinton Station.

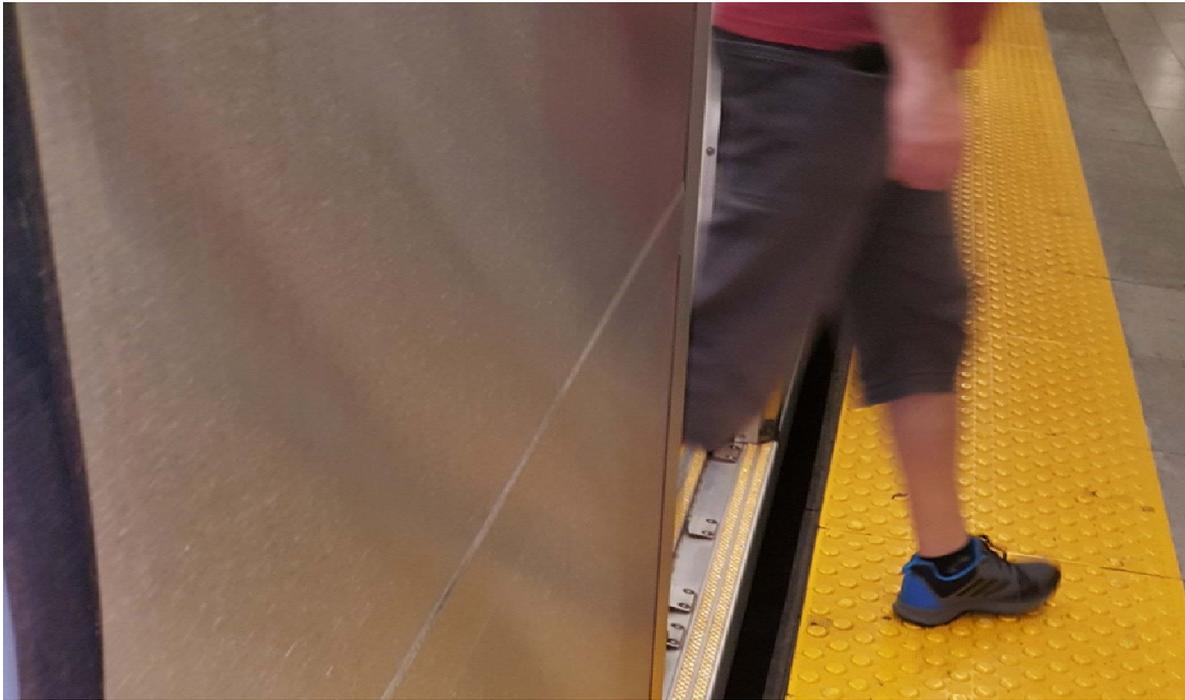
Photo 3b – Post repair platform condition.

Staff determined that the best interim solution was to remove the existing tactile tiles and replace them with sloped prefabricated pavers that incorporate the tactile tile pattern in 610 mm segments. The pavers are sloped at 1:20 (5%) to transition between the existing terrazzo platform finish and the train doors. Due to design and scheduling constraints, not all of the locations referenced in the November 2017 report were chosen for the 2018-2019 modifications. The following five locations were chosen for the 2018-2019 modifications:
