# **TSE Team Report**

## **Osgoode Interlocking Incident Report**

**February 3, 2021**

TRANSIT SYSTEMS ENGINEERING

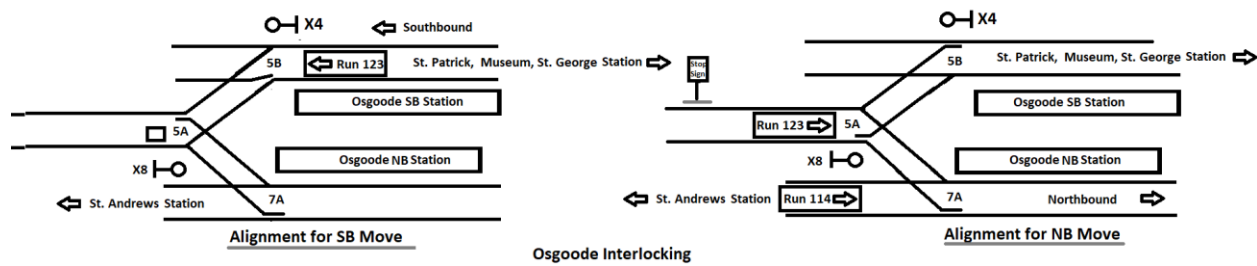
The events leading up to this incident started on June 11<sup>th</sup>, 11.53 p.m. and continued to 12:10 a.m. June 12<sup>th</sup>, 2020, and are summarized as follows:
