Work Car Hydraulic Leak Incidents Update

Date: December 3, 2024

Subway Work Car Hydraulic Fluid Leak Investigation Report

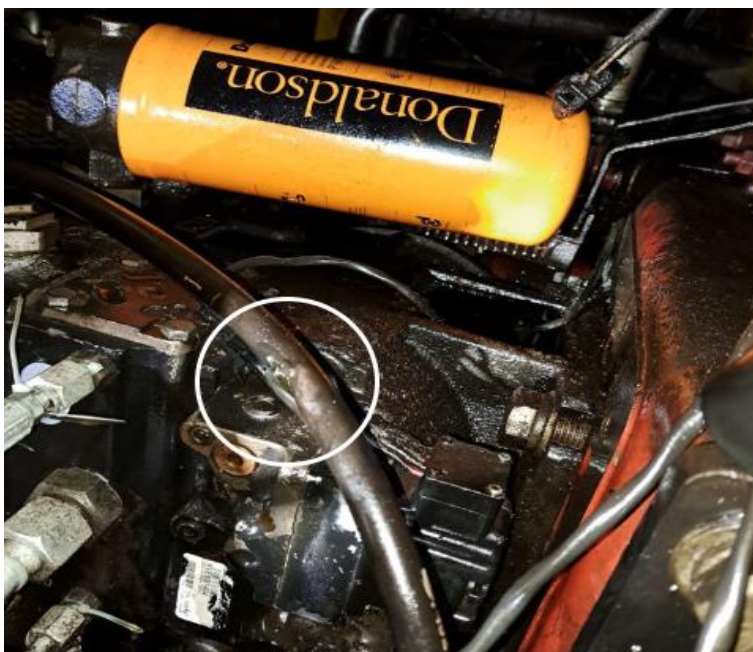
Figure 1 - Ruptured hose on RT56 on Jan. 14

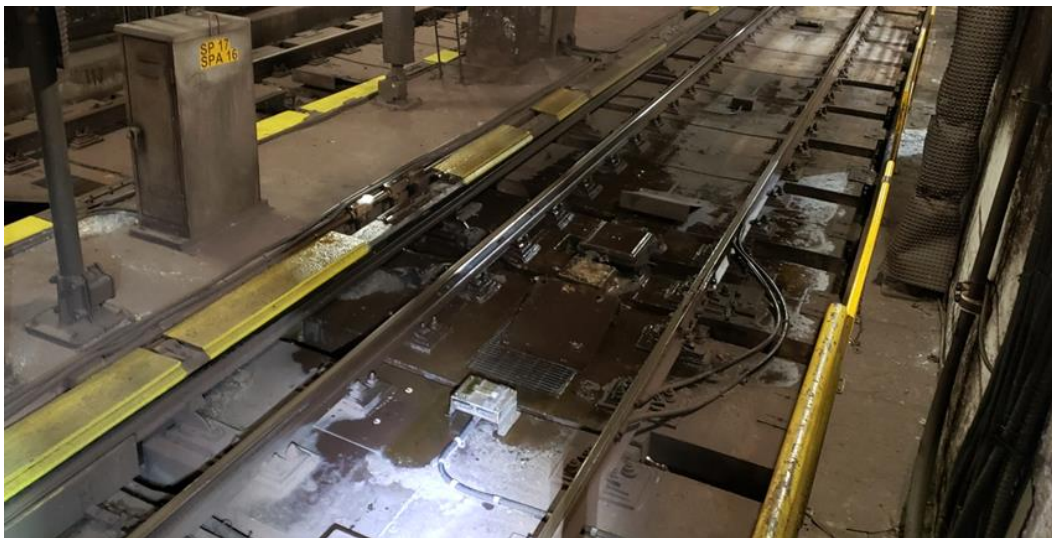
Figure 8 - Hydraulic fluid spill at Spadina station work site

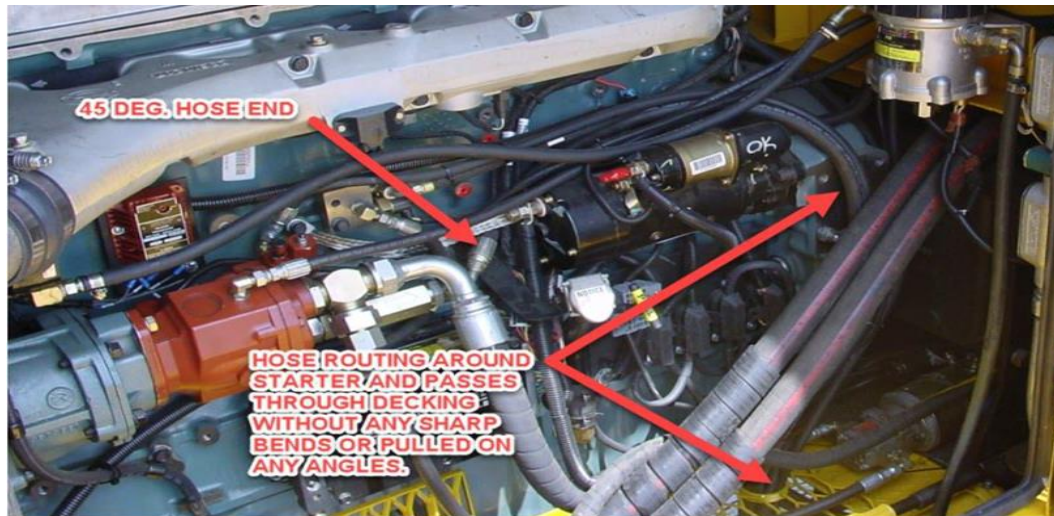
Figure 14 - RT56 original work car OEM routing

Over the years, TTC millwrights adapted the routing to address issues with the workcar OEM's hose arrangement. The TTC routing scheme pictured in Figure 15 below used a 90-degree fitting instead of the work car OEM's 45-degree fitting, is shorter in length, and avoids the engine. However, TTC's routing scheme created a sharp hose angle at the exit point of the circular steel floor ring, which led to the abrasion discussed in Section 2.5.5.1 that eventually wore through the hose.

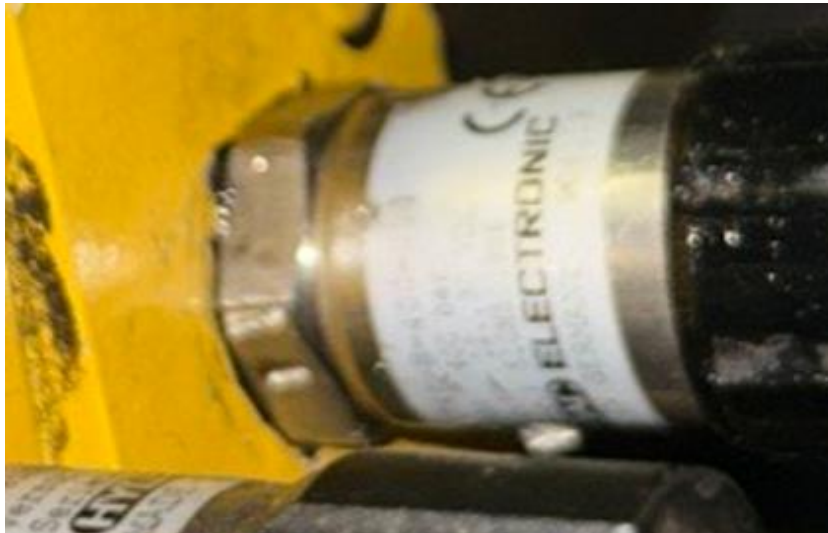
over torqued during the attempted fix of the initial leak. TTC has now received information on the Hydac sensor, which recommends a tightening torque of 20 Nm.

Figure 25 - Marks on RT41 pressure sensor

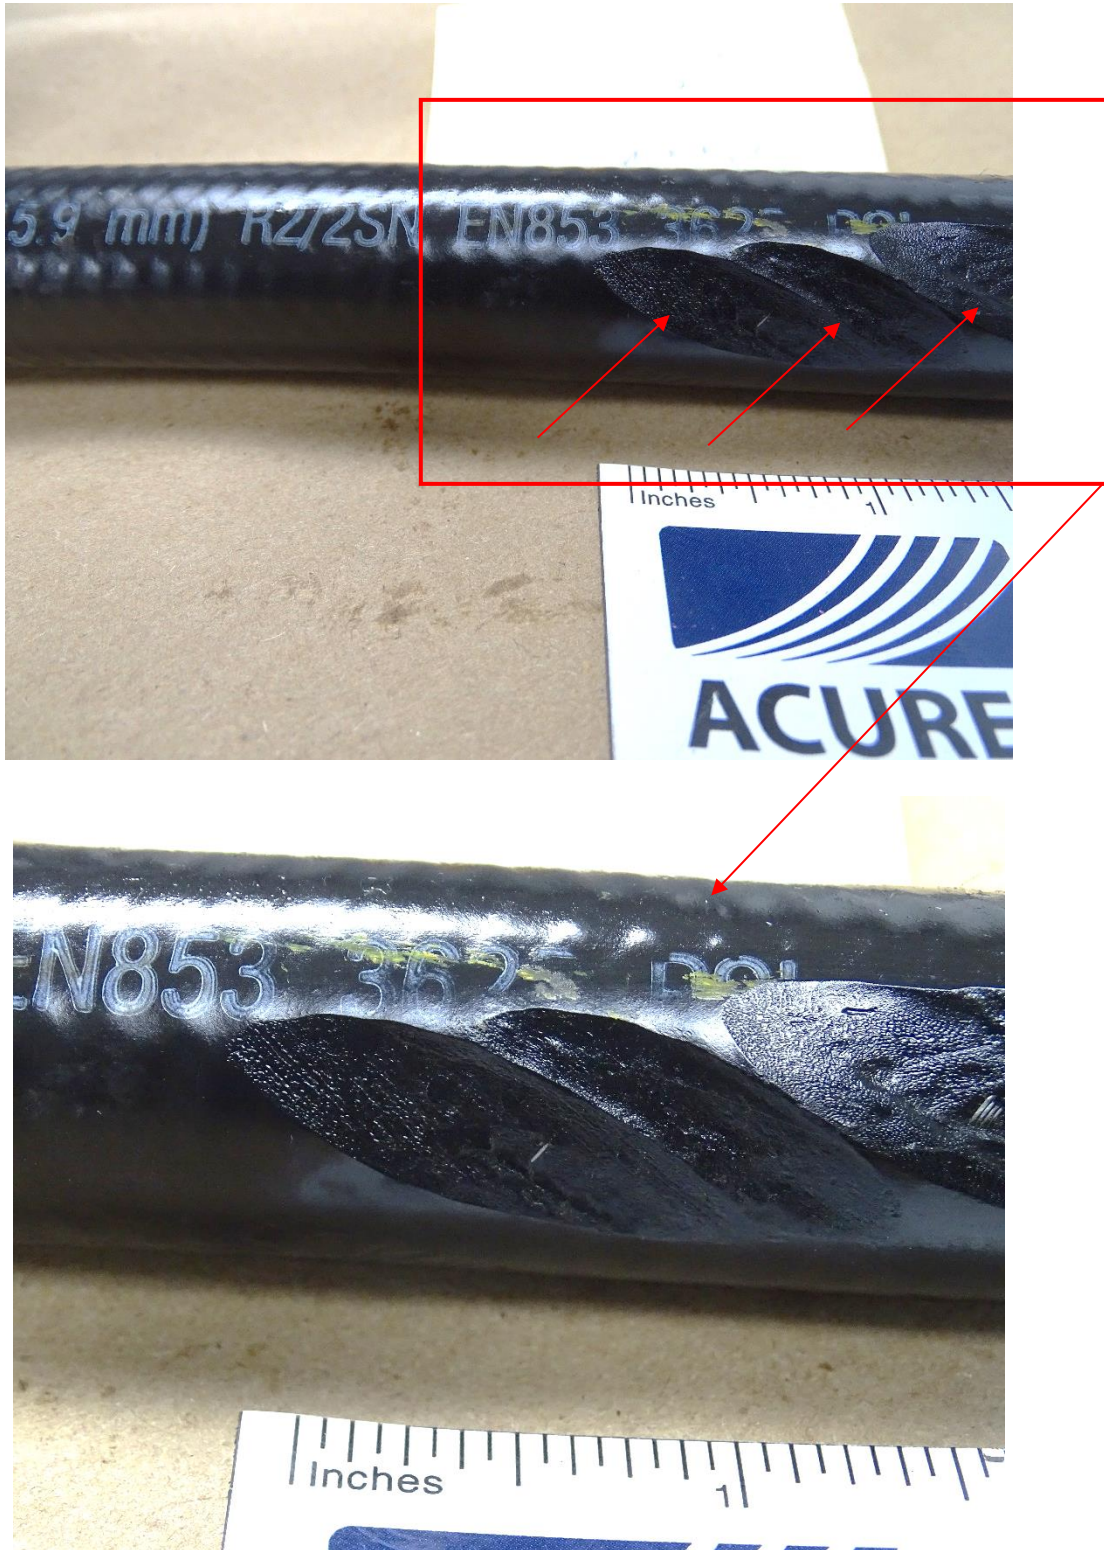
FIGURE 6. AREA #1 – SHOWING DAMAGED COVER

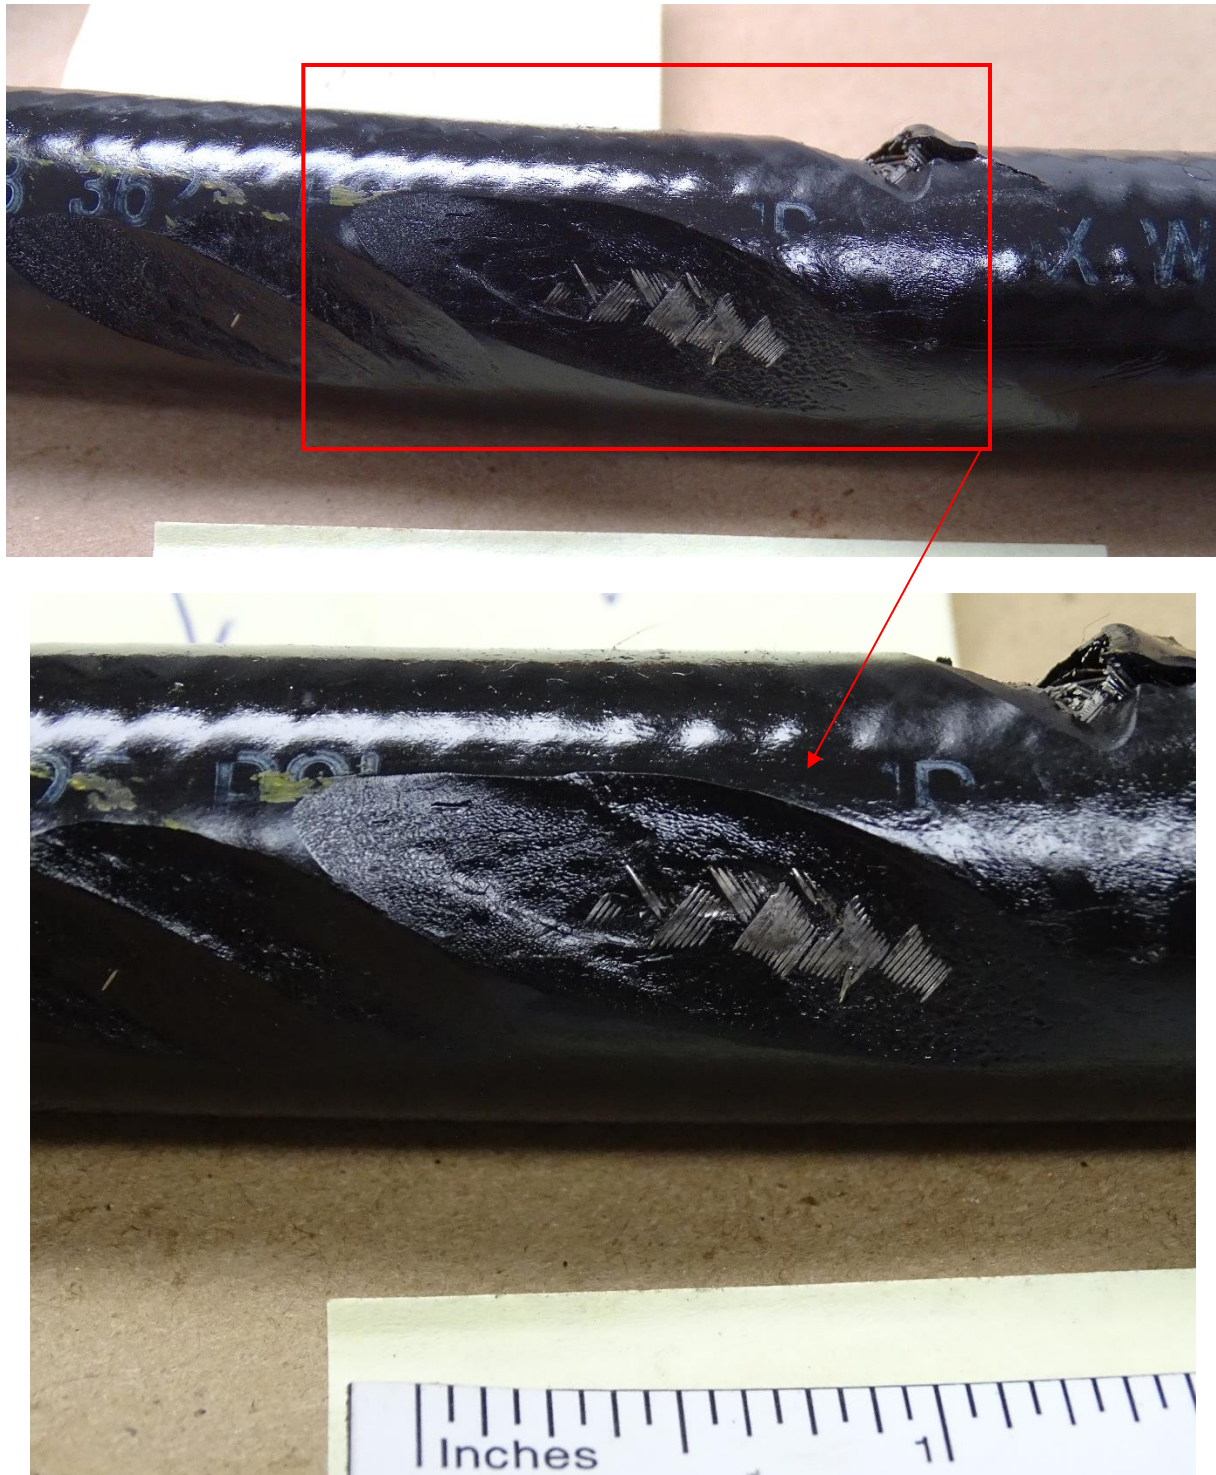
FIGURE 7. AREA #2 – SHOWING DAMAGE ON THE COVER, THE REINFORCEMENT WAS EXPOSED

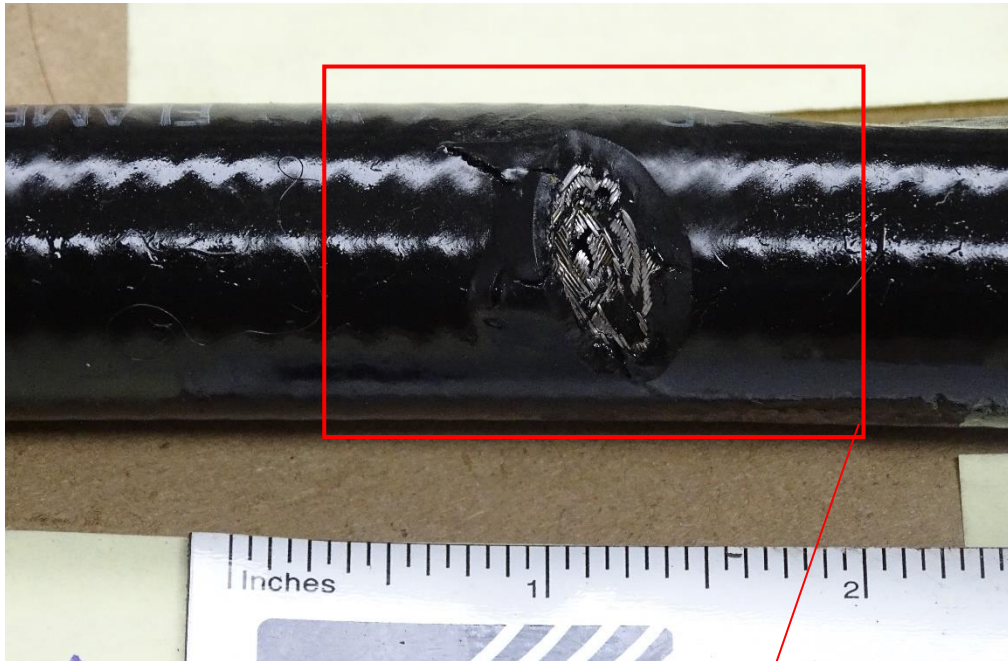
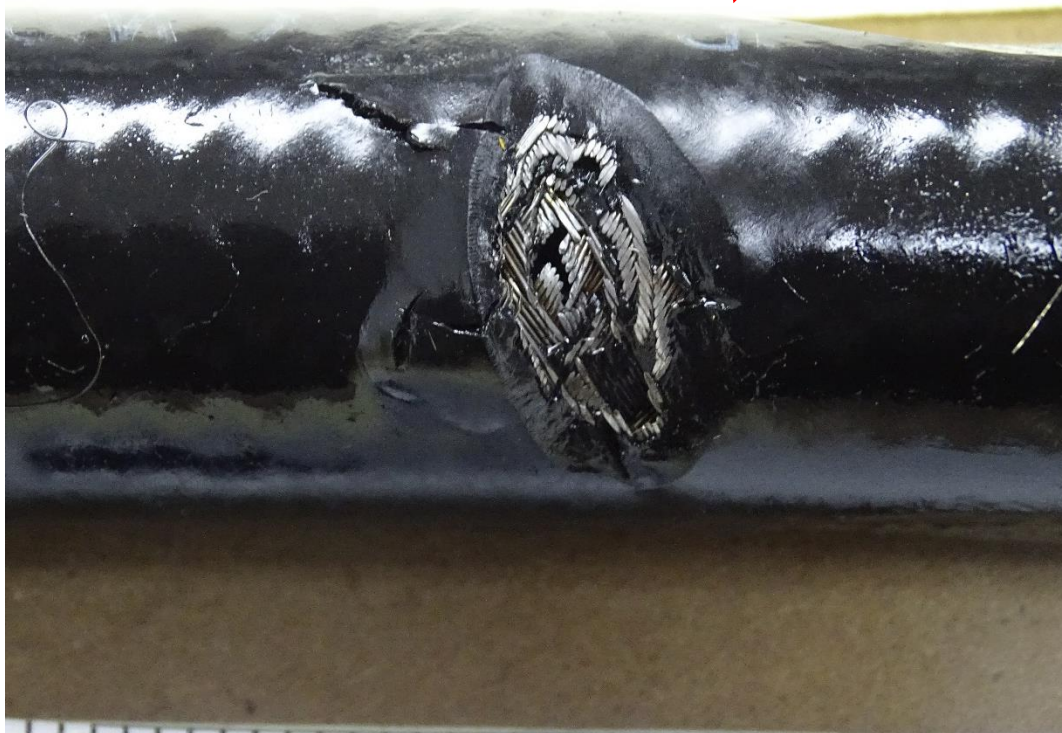
FIGURE 8. AREA 3 – SHOWING TEARING/CRACKS IN THE COVER, WIRES ARE EVIDENT AND A HOLE IS OBSERVED

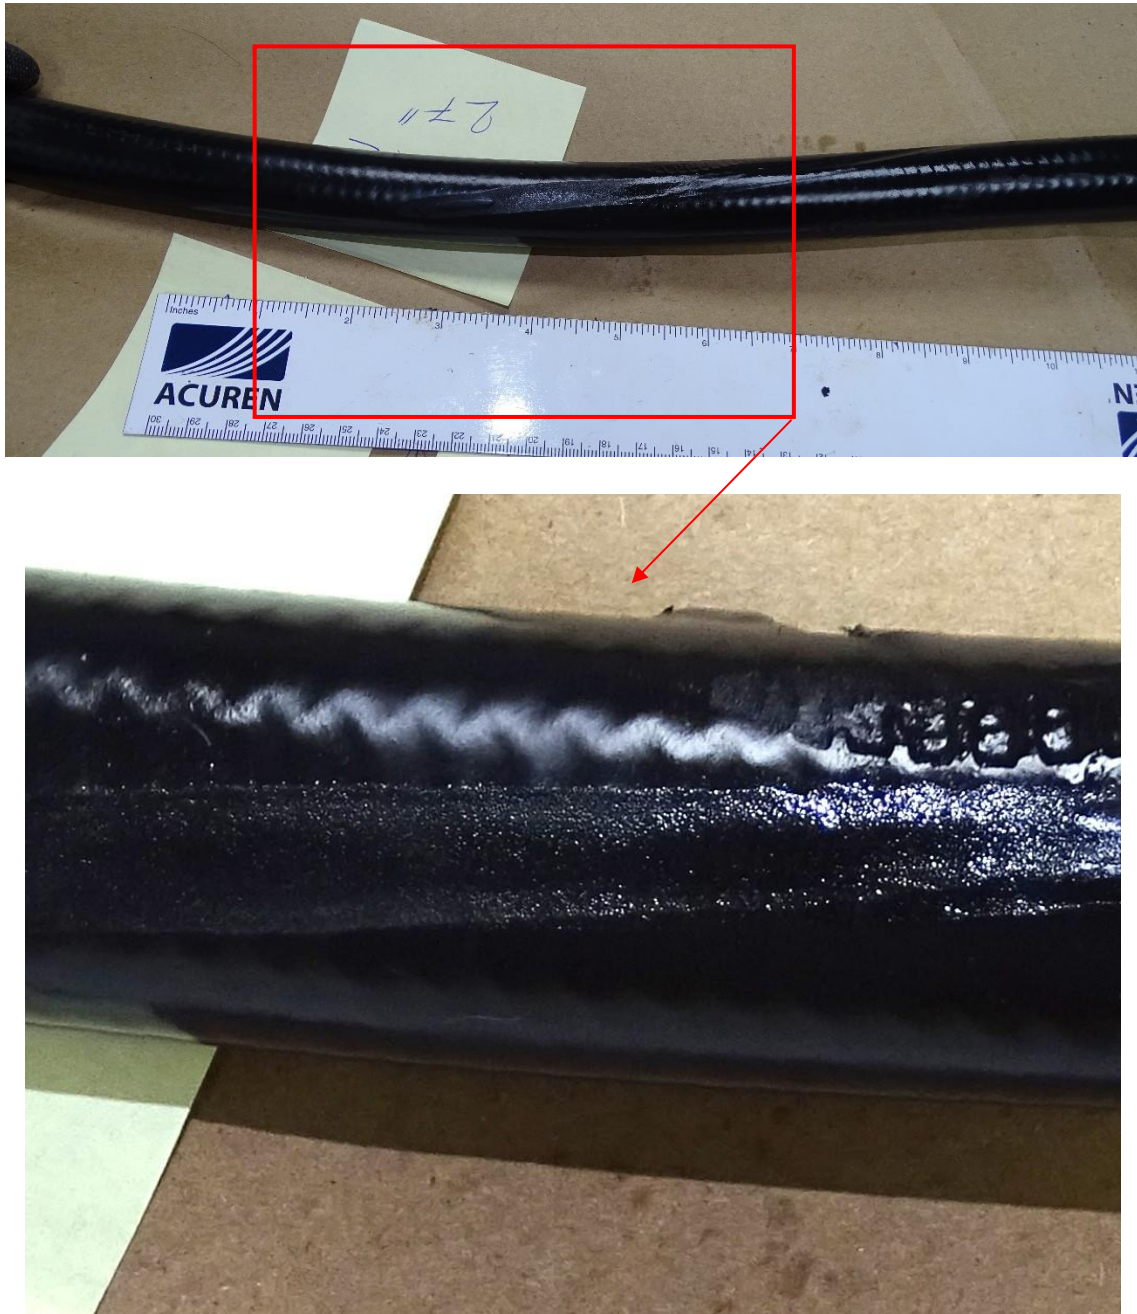
FIGURE 9. AREA #4 – SHOWING RUBBING/DAMAGE ON COVER

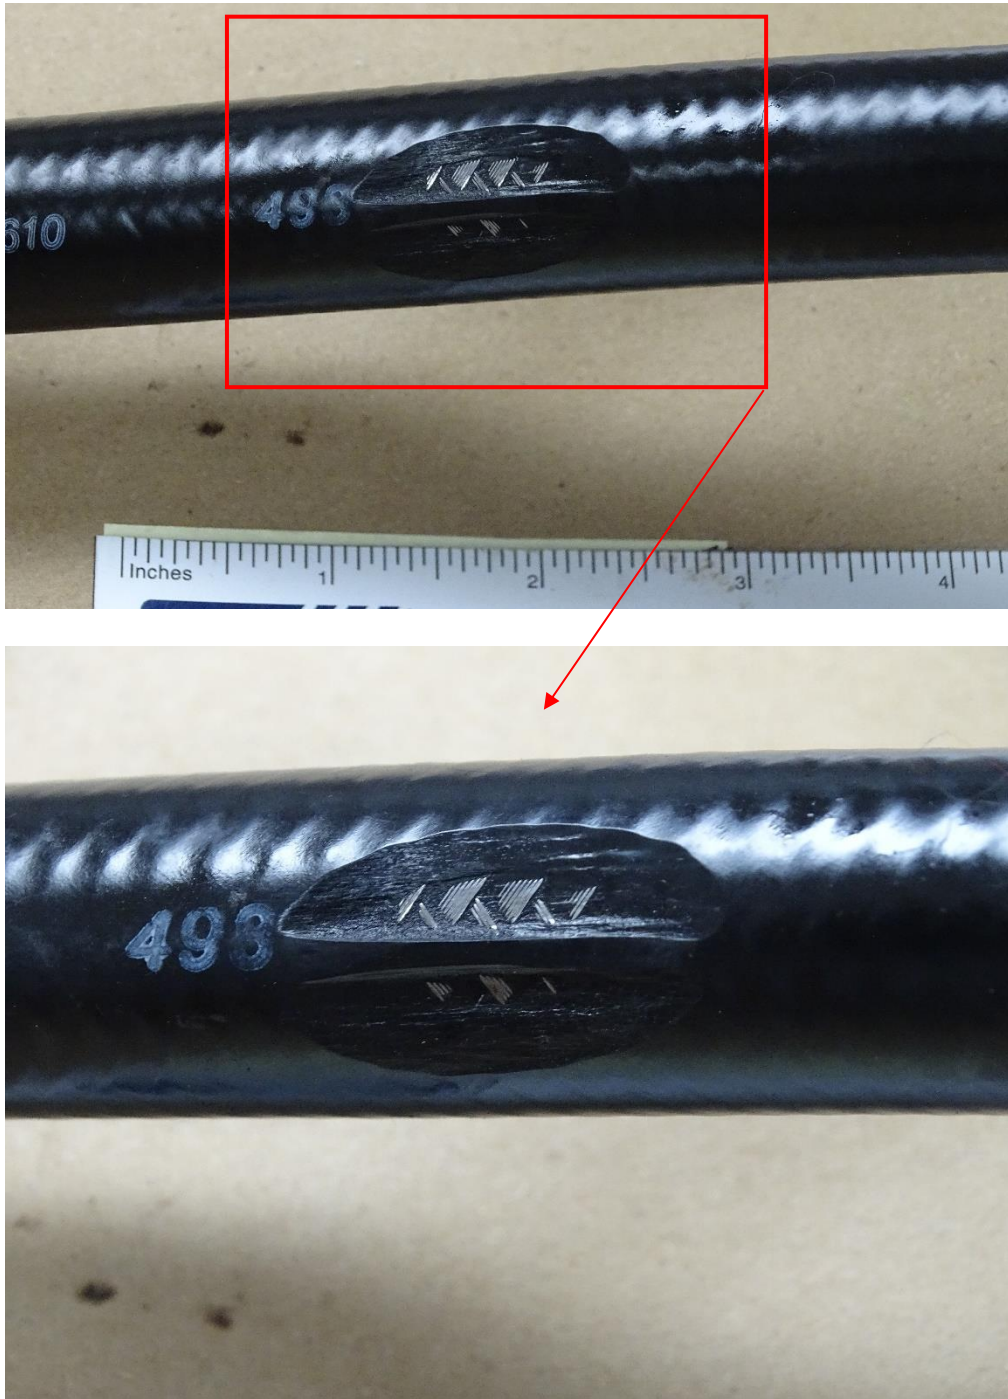
FIGURE 10. AREA #5 – SHOWING RUBBING/DAMAGE ON THE COVER AND THE REINFORCEMENT LAYER IS EVIDENT

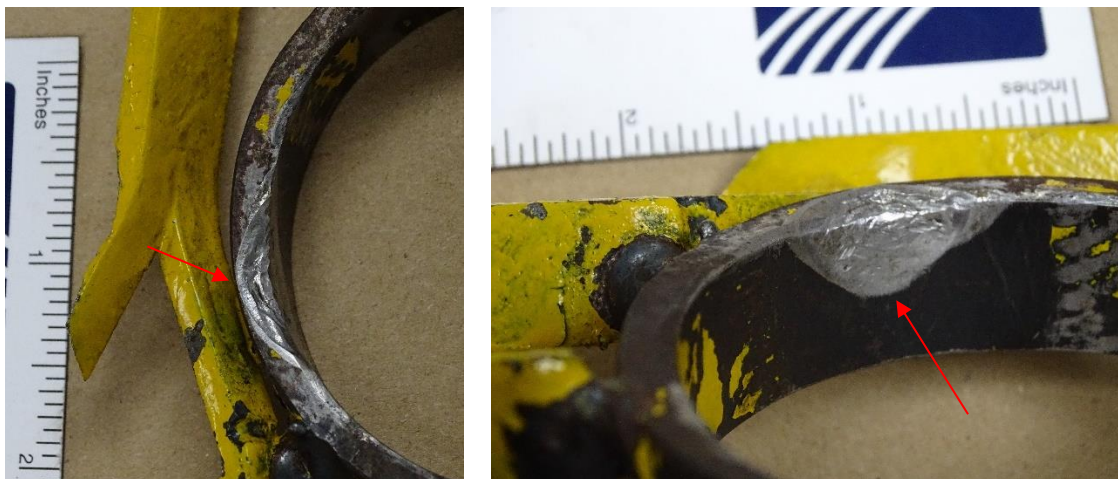
- i) To facilitate communication, the clock position was used to describe the ring as shown in Figure 11.
- ii) Deformation was observed at the edge of the ring at about 8 o'clock. In addition, evidence of rubbing was evident on the inner surface of the ring at the same position, Figure 12.
- iii) Similar shiny rubbed areas were observed on the edge and inner surface of the ring at 10 and 11 o'clock positions, Figure 13.
- iv) The metal ring exhibited rubbing at the edge and inner surface at about 4 and 5 o'clock,

FIGURE 12. DEFORMATION OBSERVED ON THE RING AT AROUND 8 O'CLOCK LOCATION

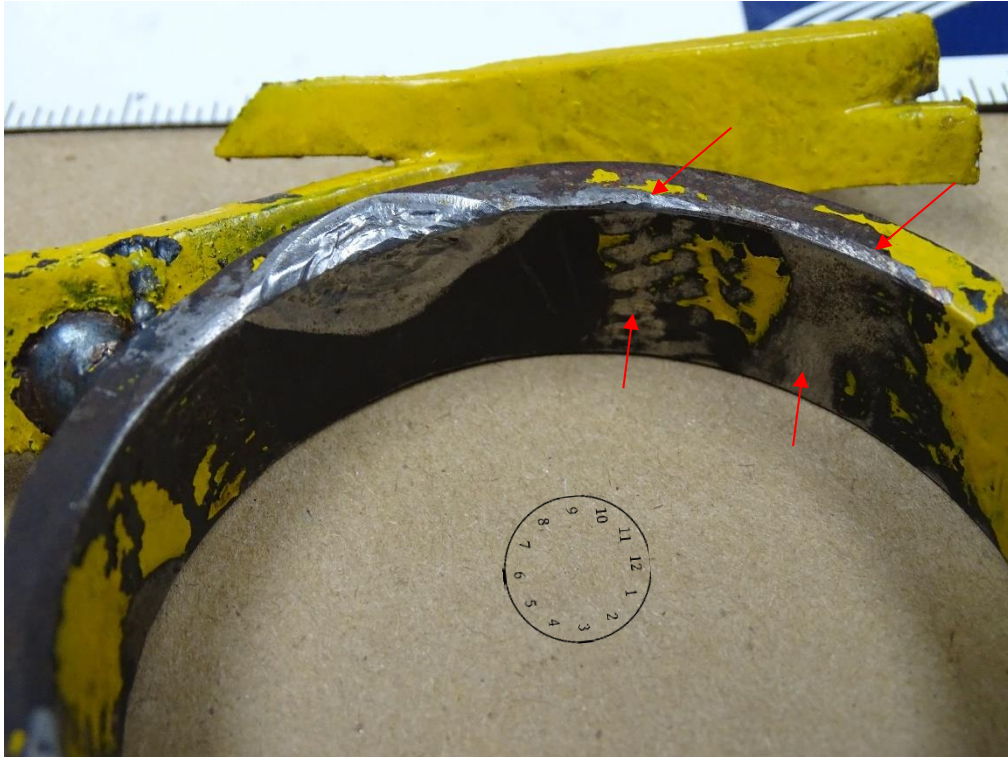
FIGURE 13. EVIDENCE OF RUBBING AT 10 AND 11 O'CLOCK

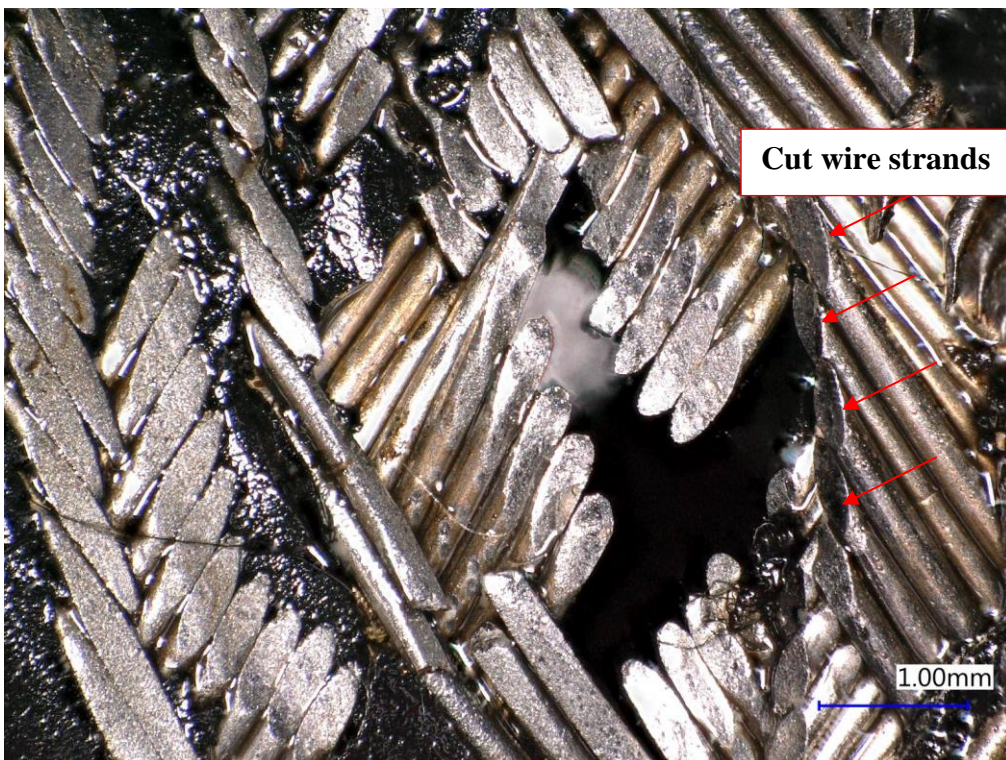
FIGURE 20. THE WIRE STRANDS IN THE DAMAGED AREA, AREA 3

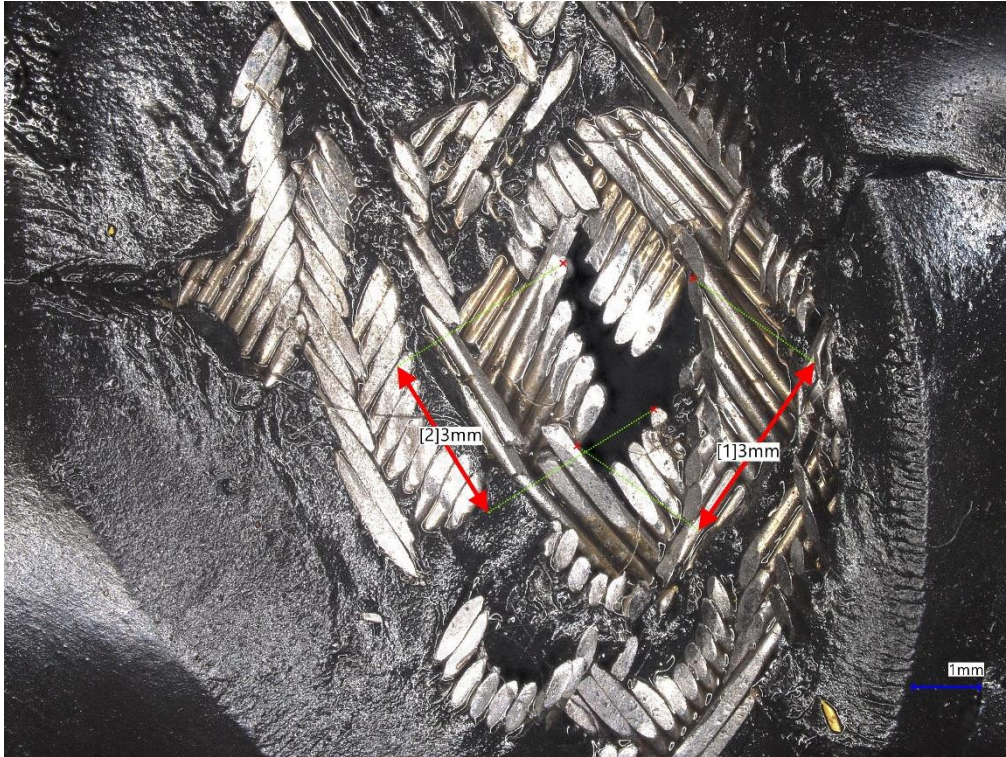
FIGURE 21. THE SIZE OF THE HOLE/LEAK AT THE CENTER OF THE DAMAGED AREA, AREA 3

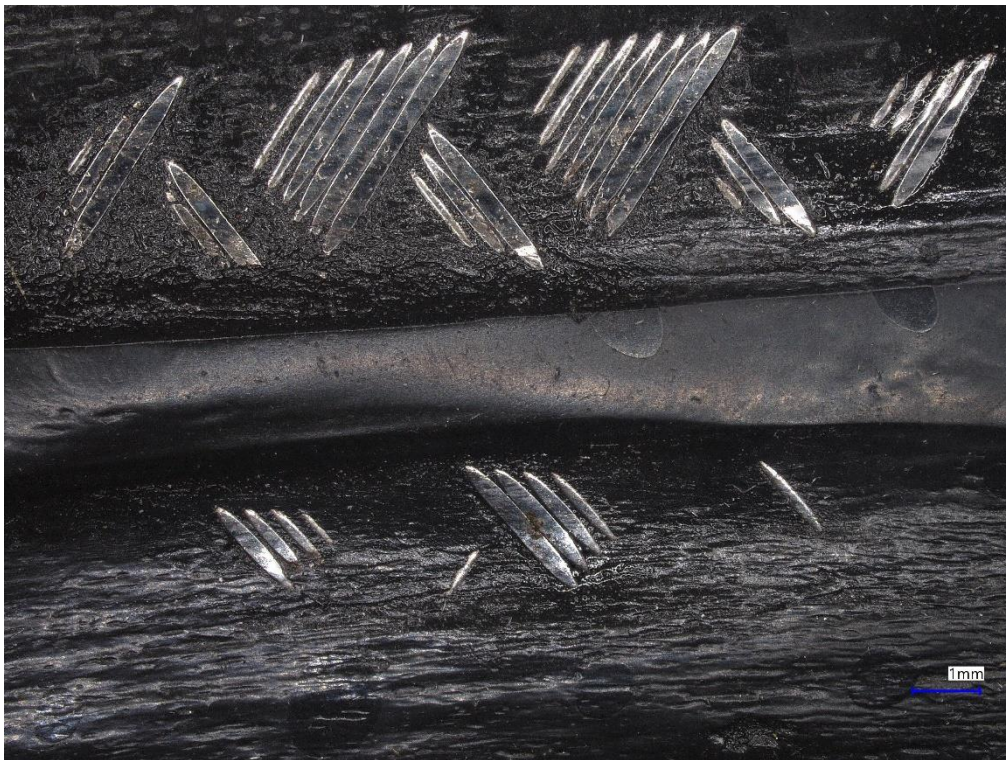
- v) Figure 22 shows a general image of the damaged area 5. The wear marks were observed on the black cover within the damaged area. The first layer of the braided wires was exposed and showed a shiny flat surface, Figure 23.

FIGURE 22. A GENERAL IMAGE OF AREA 5

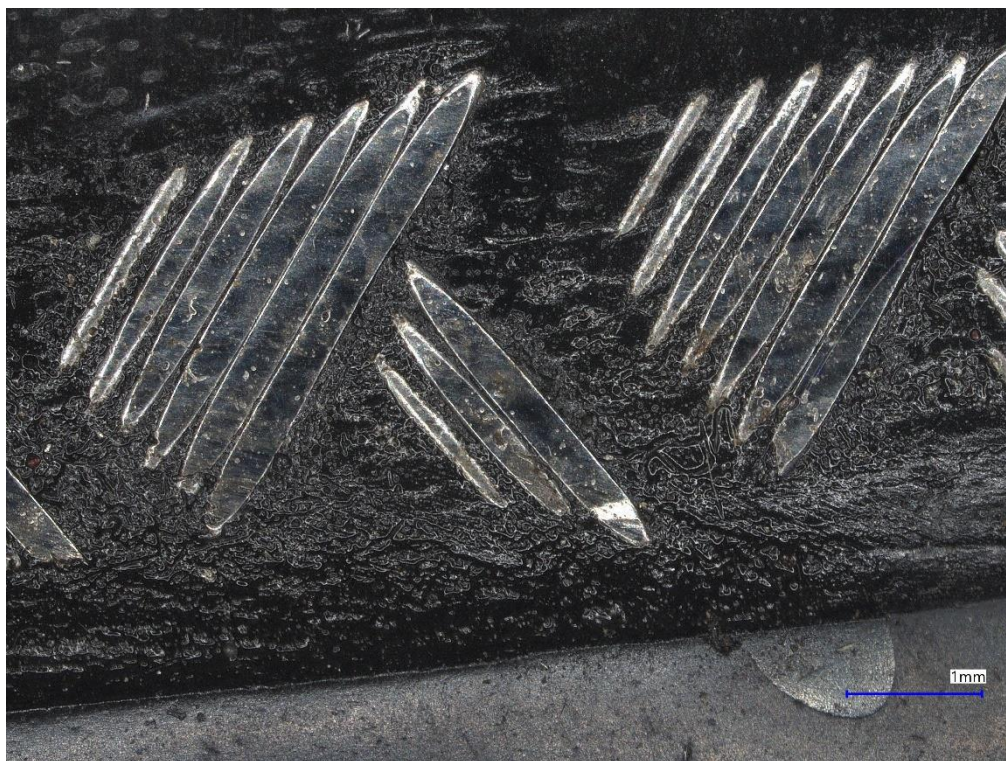
FIGURE 23. THE WIRE STRANDS IN THE DAMAGED AREA, AREA 5

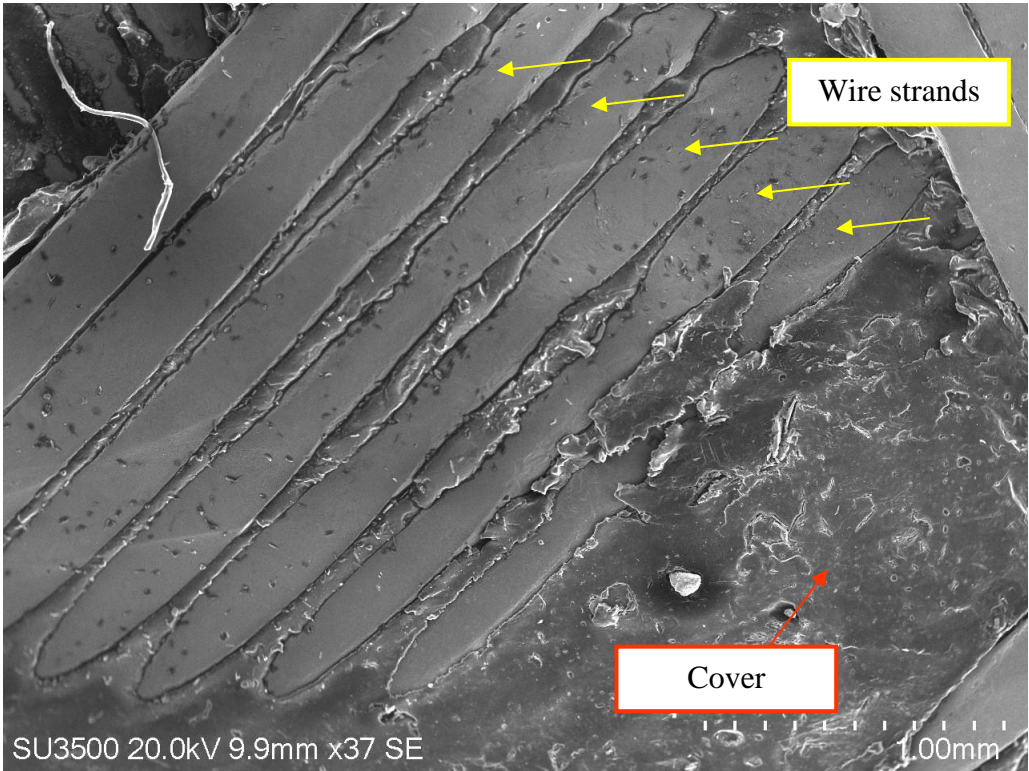
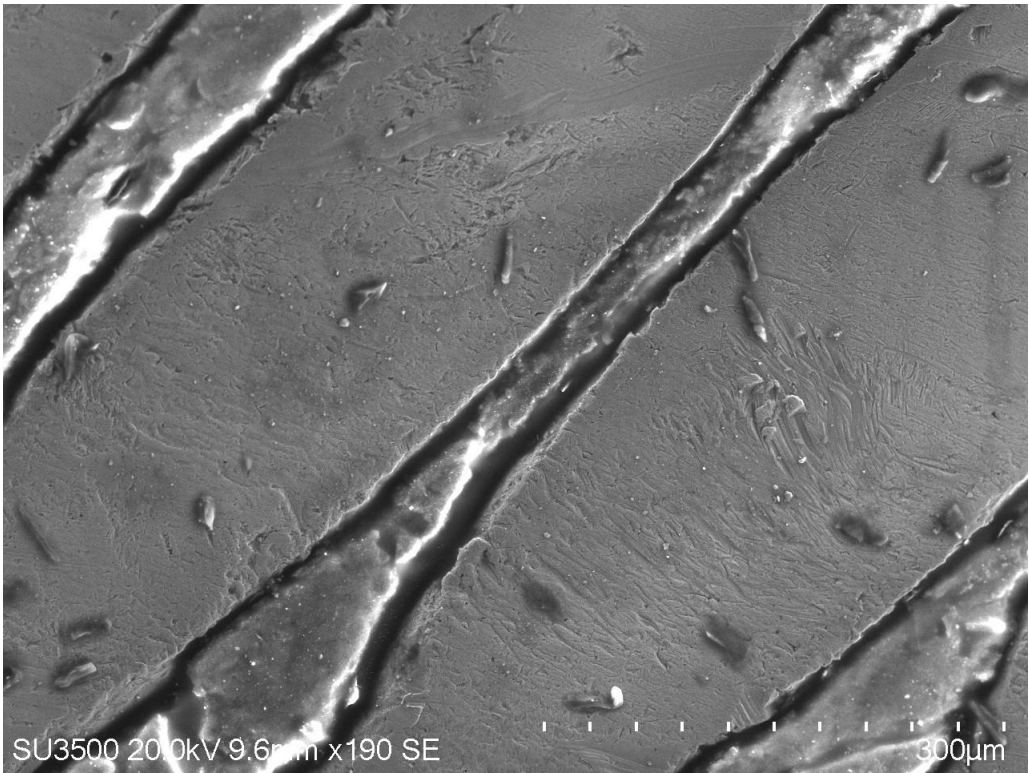
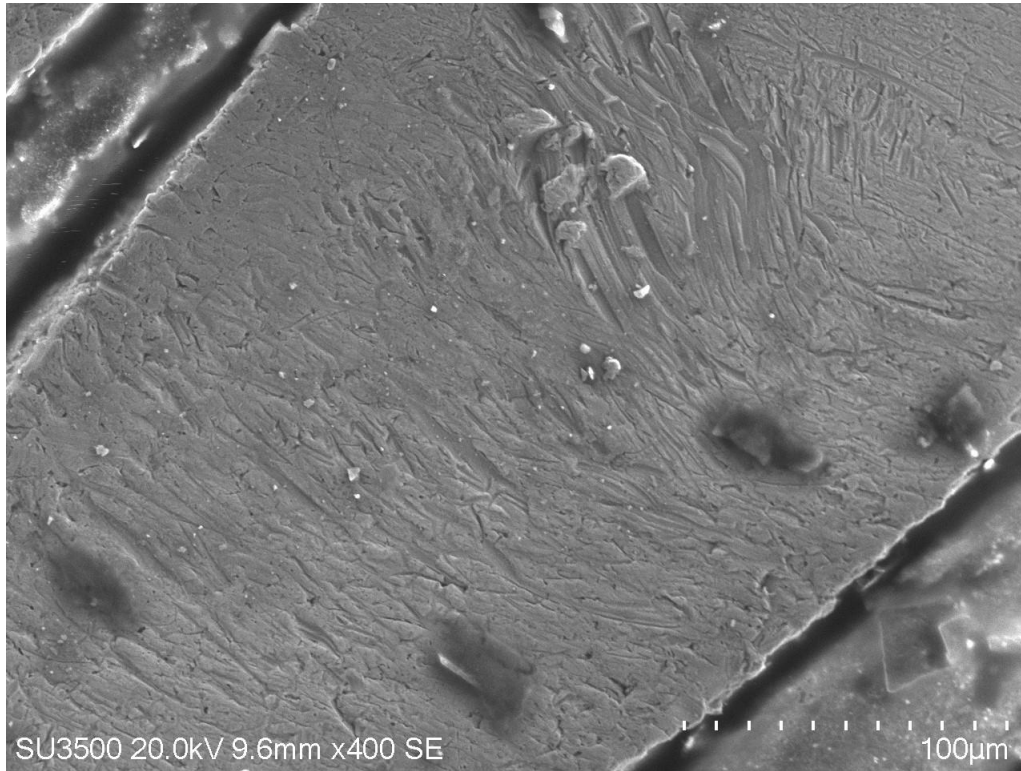
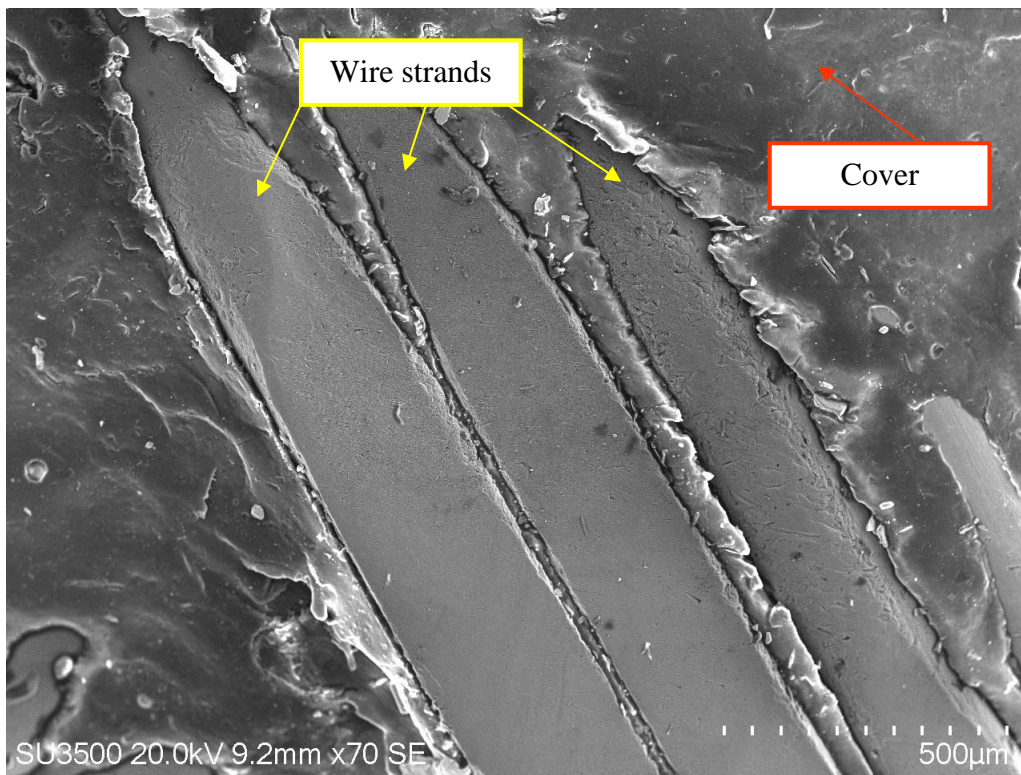
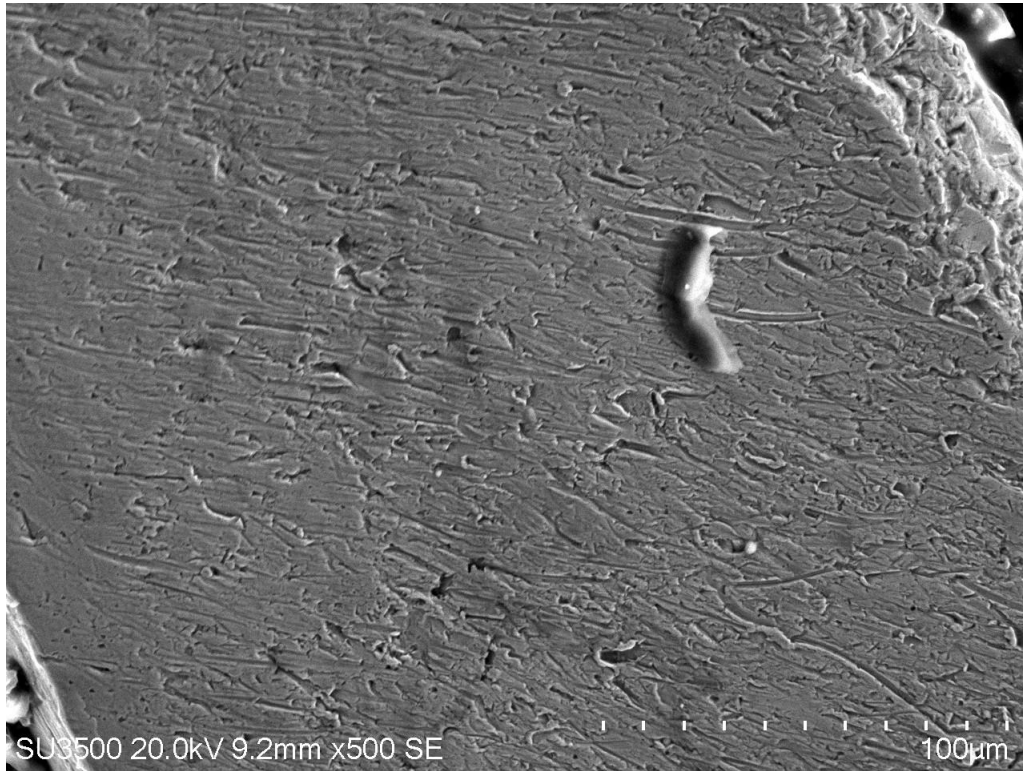
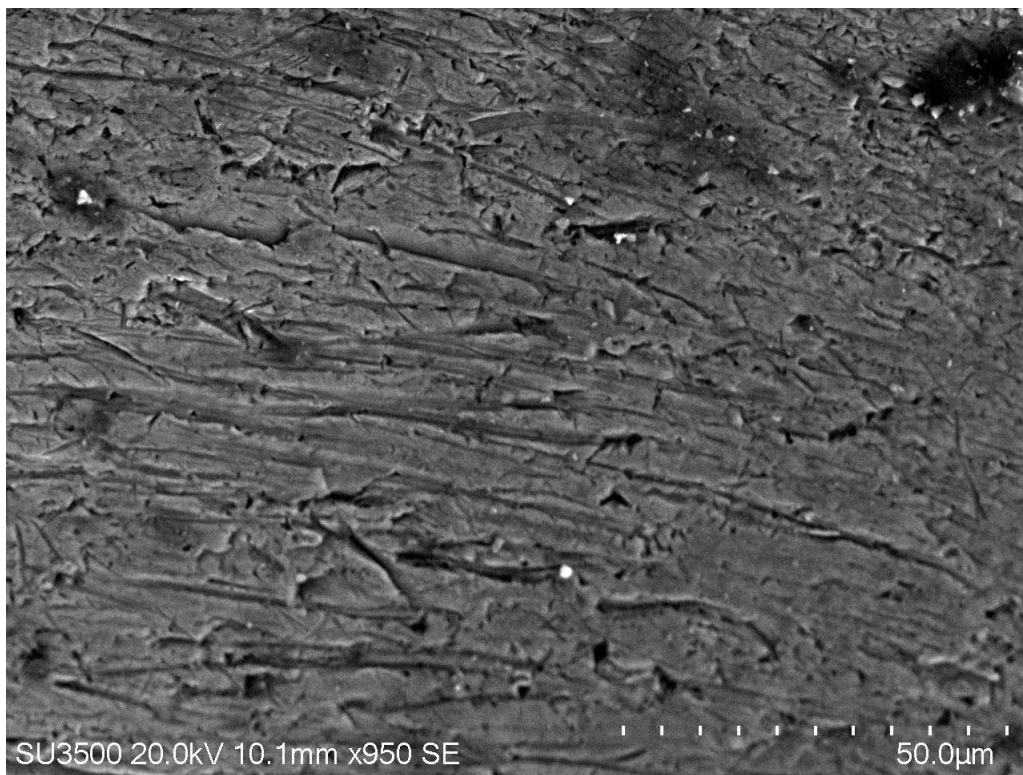
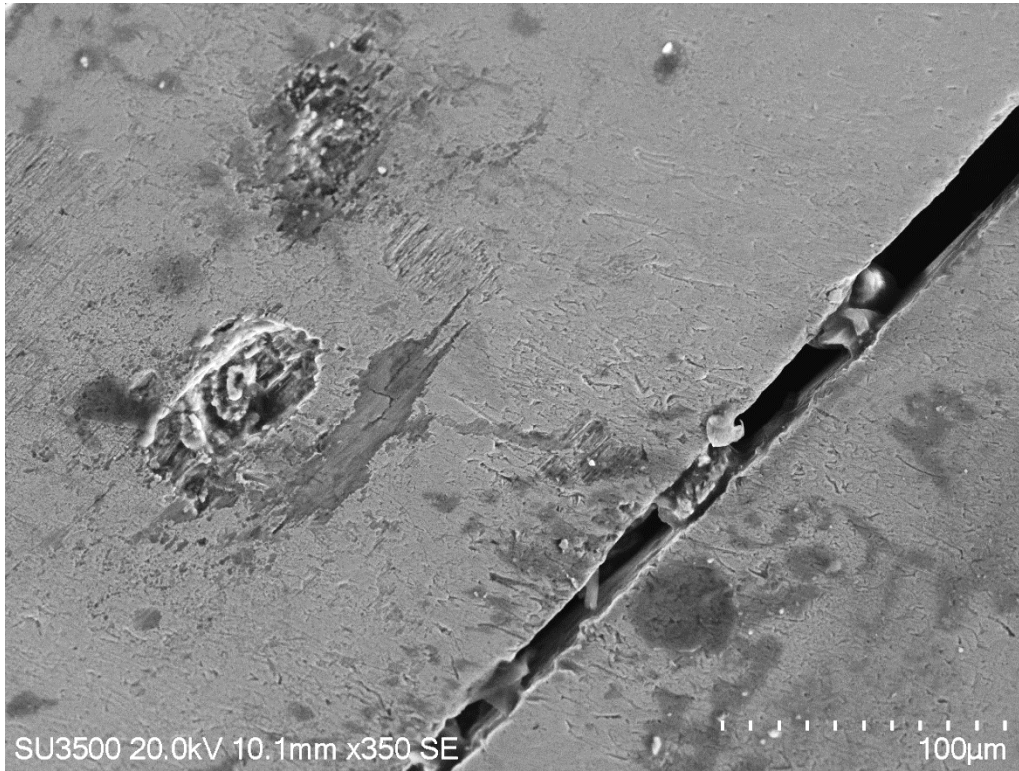
FIGURE 24. WORN WIRE STRANDS IN THE DAMAGED AREA 2

FIGURE 25. WEAR MARKS ON THE WIRE STRANDS IN THE DAMAGED AREA 2

FIGURE 26. WEAR MARKS ON THE WIRE STRANDS IN THE DAMAGED AREA 2

FIGURE 27. WORN WIRE STRANDS IN THE DAMAGED AREA 2

FIGURE 28. WEAR MARKS ON THE WIRE STRANDS IN THE DAMAGED AREA 2

FIGURE 29. WEAR MARKS ON THE WIRE STRANDS IN THE DAMAGED AREA 2

FIGURE 30. WEAR MARKS ON THE WIRE STRANDS IN THE DAMAGED AREA 2
