Work Car Hydraulic Leak Incidents Update

Date: December 3, 2024

Subway Work Car Hydraulic Fluid Leak Investigation Report

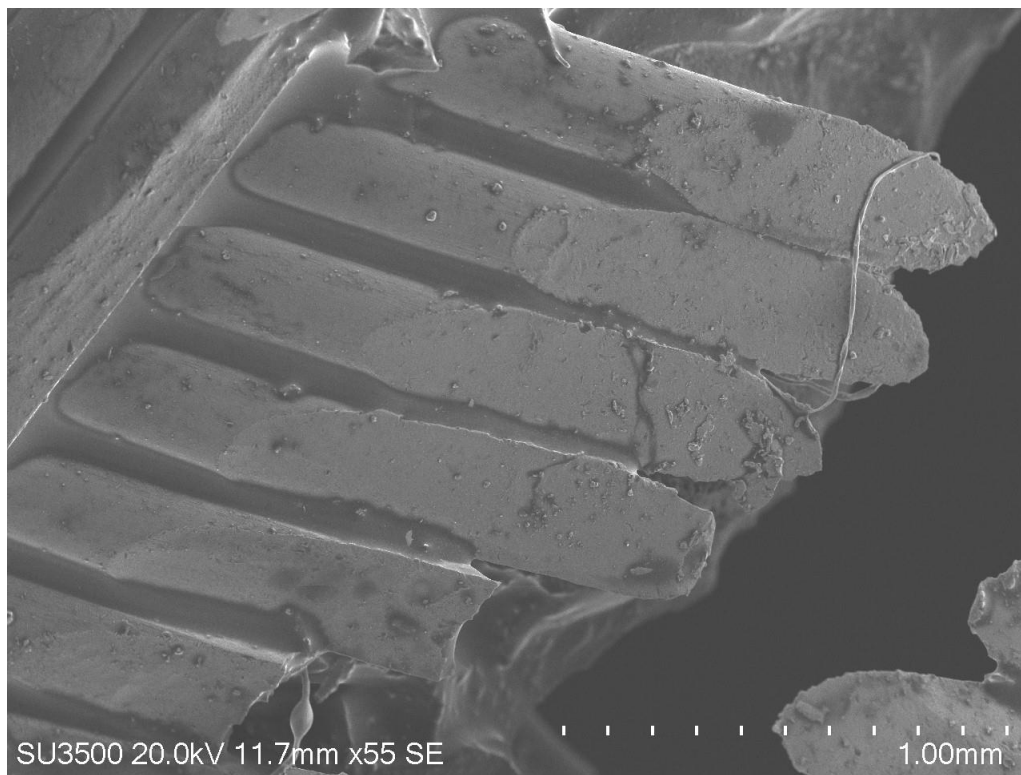
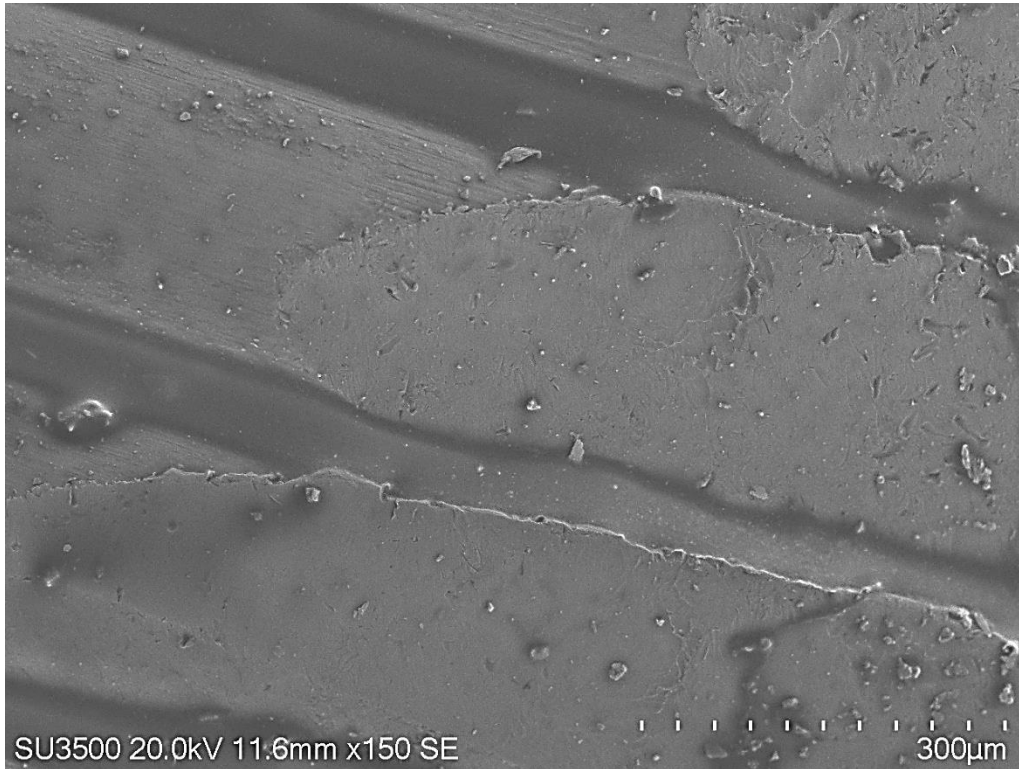
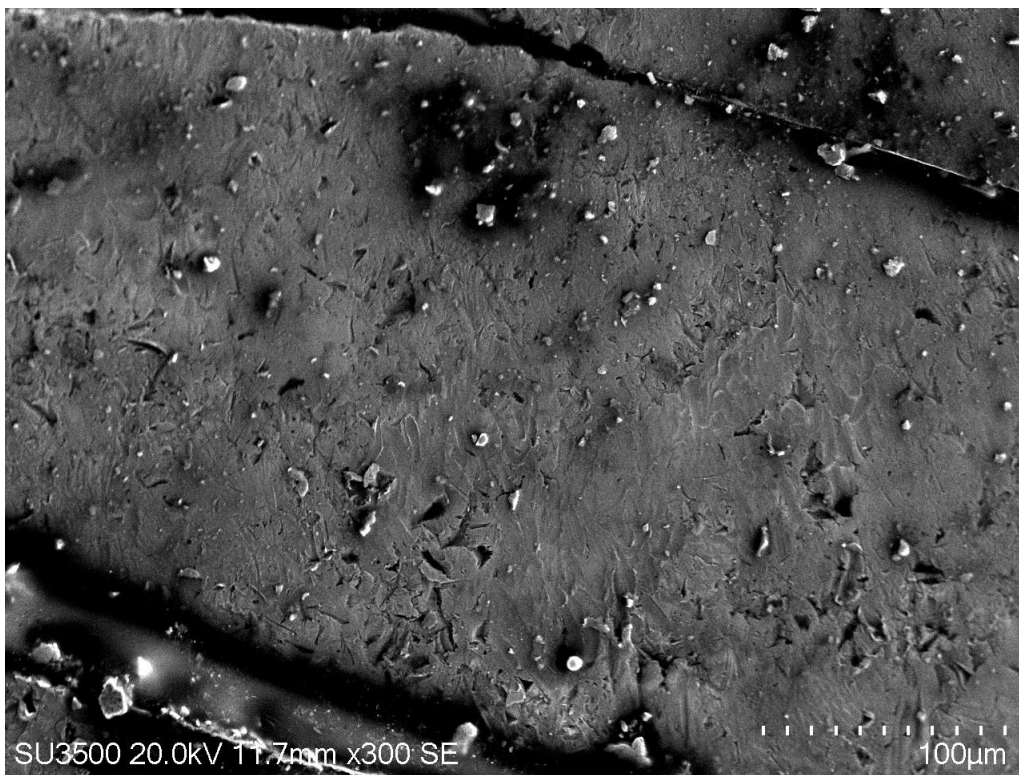
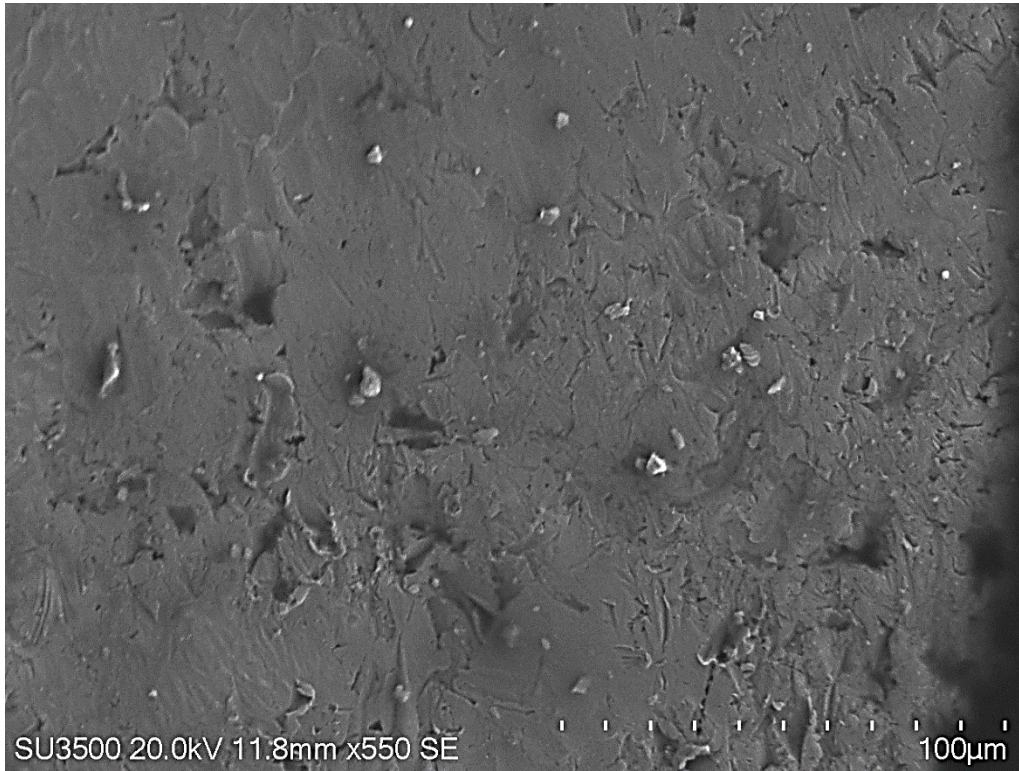
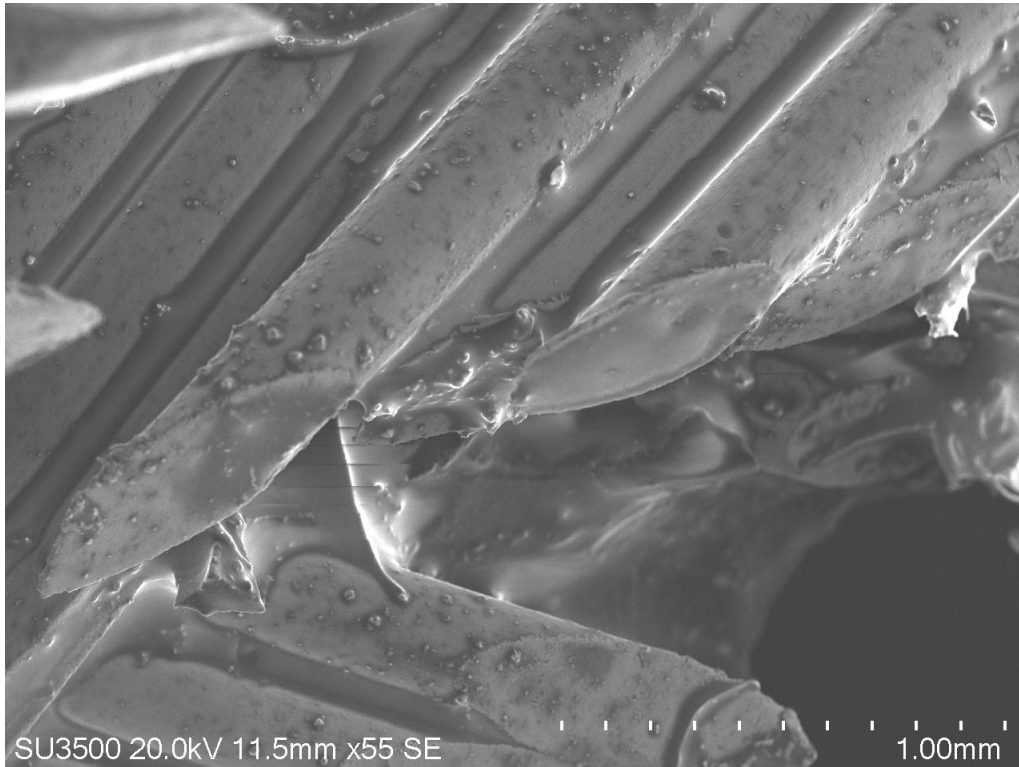
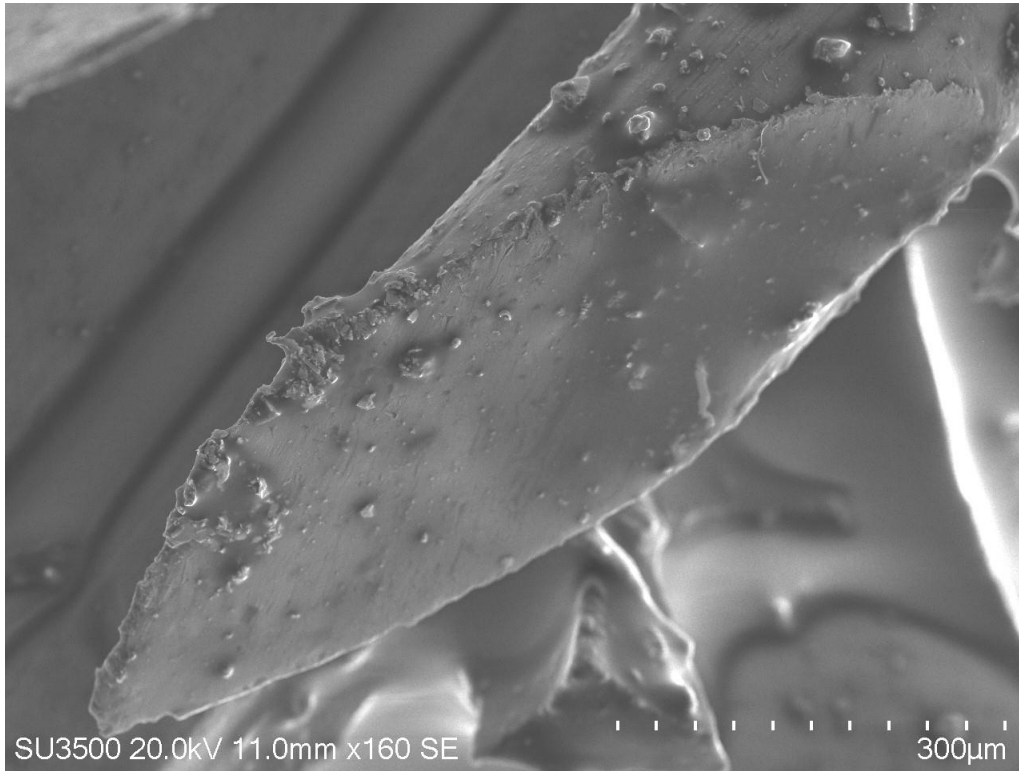
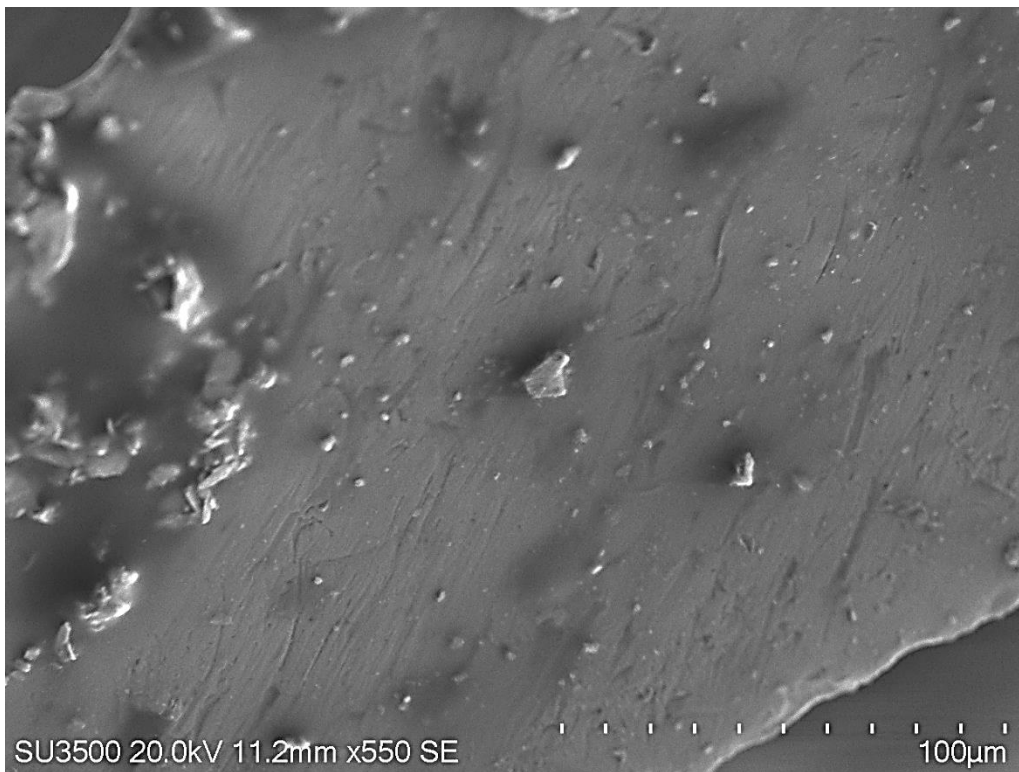
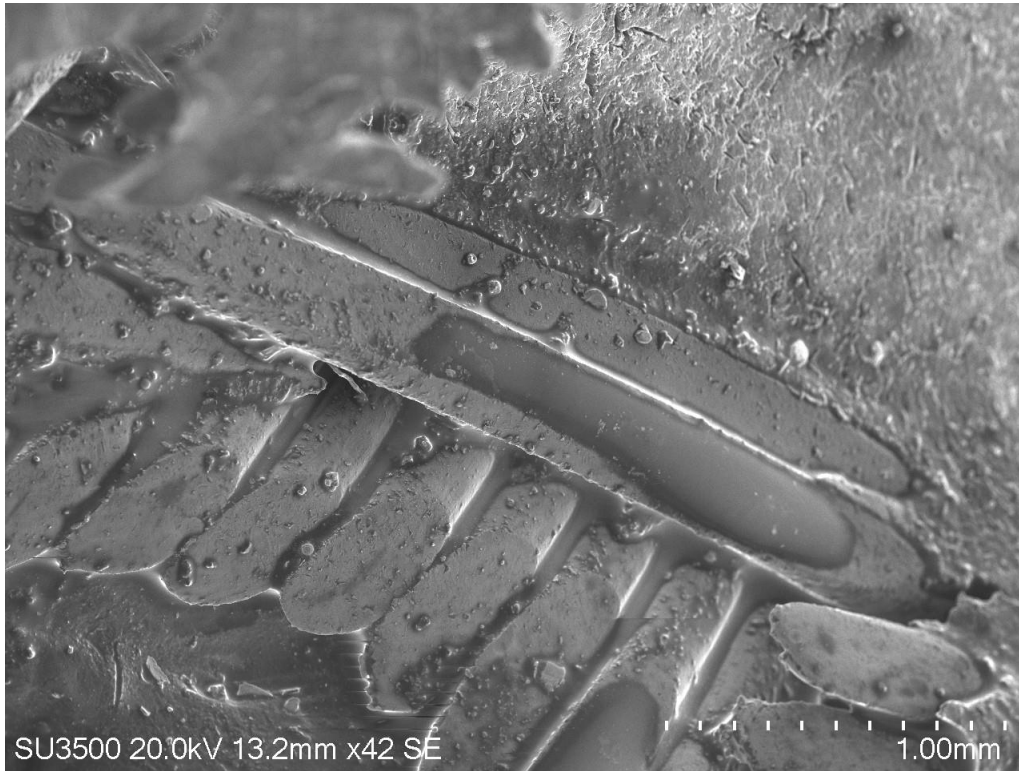
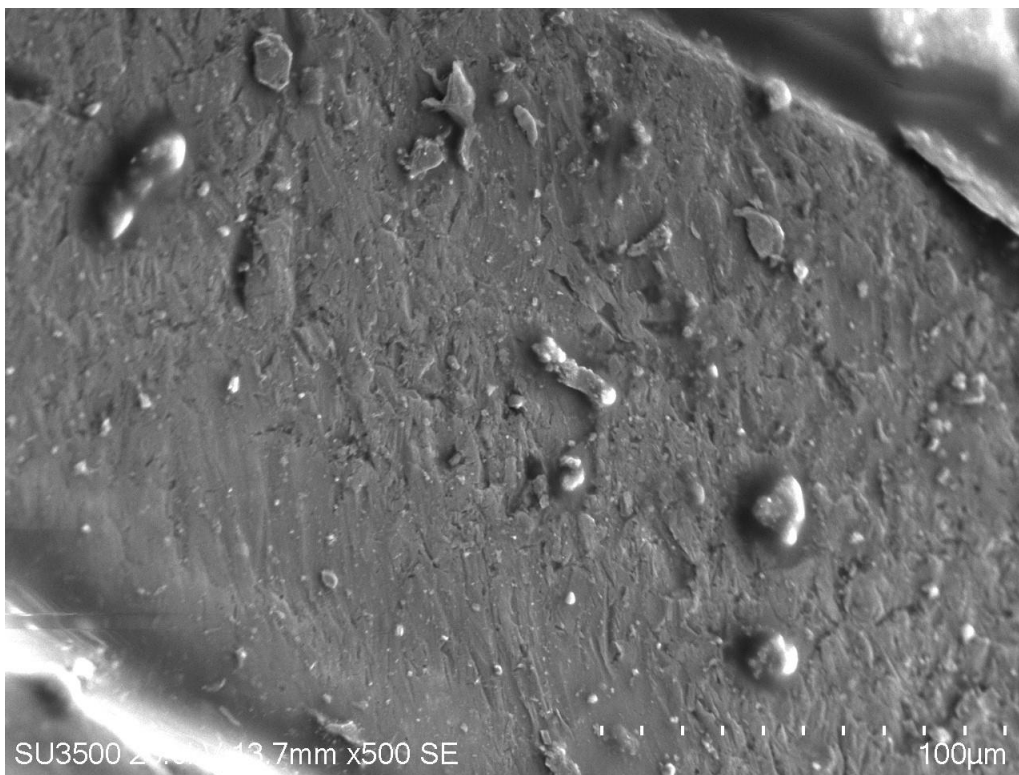
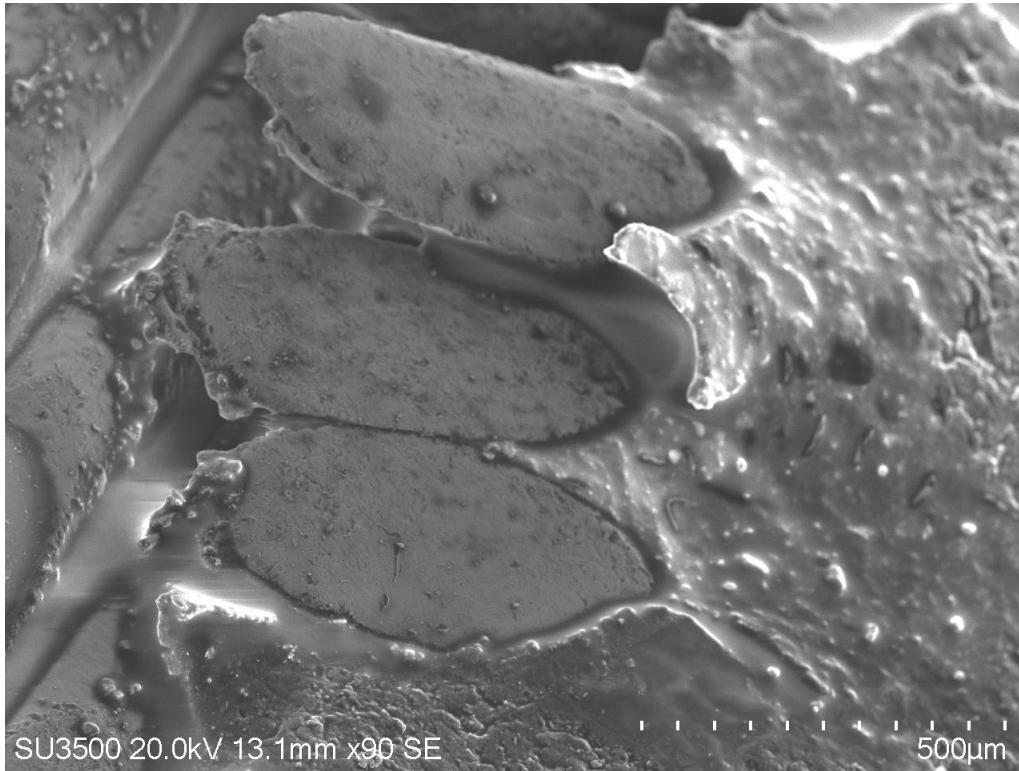
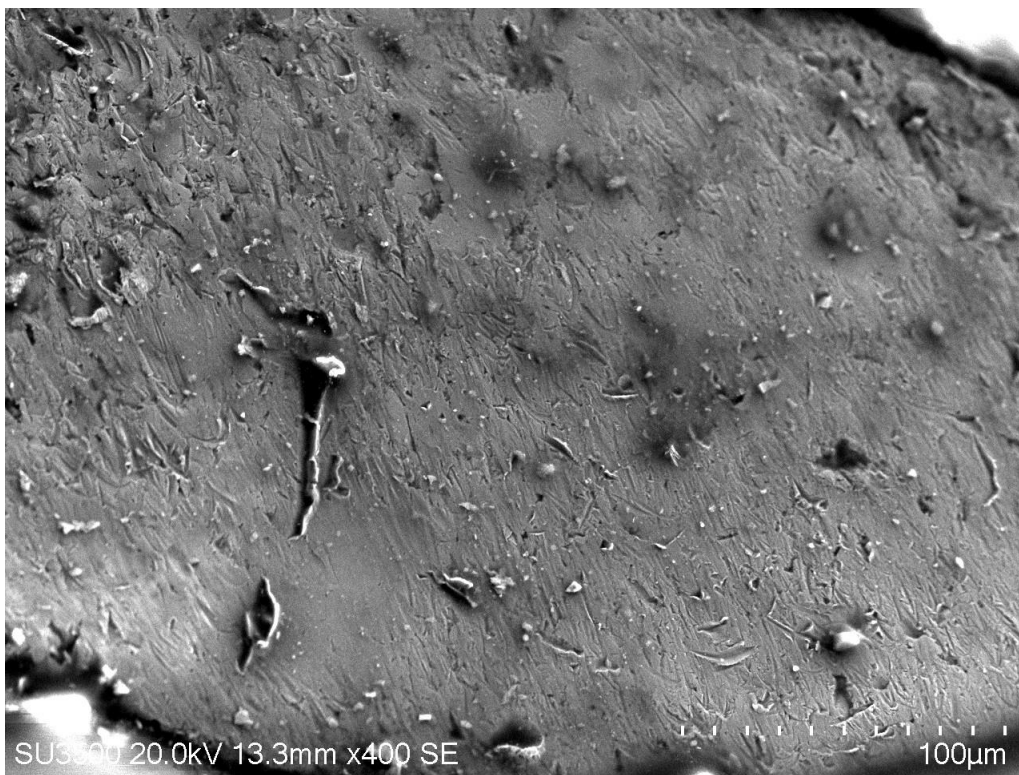
- vi) Figure 42 and Figure 43 show another example of broken wire strands, exhibiting wear marks on the flat tip.
- vii) The damaged area observed on the inner surface of the ring at 8 o'clock was also examined using SEM, Figure 44. The results showed scratch marks, indentation/impact marks, suggesting the presence of wear marks on the inner surface of ring, Figure 45, Figure 46, and Figure 47. The wear characteristics resembled those observed on the worn wire strands within the reinforcement layer of the hydraulic hose.

FIGURE 33. BROKEN WIRE STRANDS IN DAMAGED AREA 3

FIGURE 34. FLAT PORTION OF THE BROKEN WIRE STRANDS IN DAMAGED AREA 3

FIGURE 35. WEAR MARKS ON THE FLAT SURFACE OF BROKEN WIRE STRANDS IN DAMAGED AREA 3

FIGURE 36. WEAR MARKS ON THE FLAT SURFACE OF BROKEN WIRE STRANDS IN DAMAGED AREA 3

FIGURE 37. BROKEN WIRE STRANDS IN STRANDS IN DAMAGED AREA 3

FIGURE 38. BROKEN WIRE STRANDS IN STRANDS IN DAMAGED AREA 3

FIGURE 39. WEAR MARKS ON THE FLAT SURFACE OF BROKEN WIRE STRANDS IN DAMAGED AREA 3

FIGURE 40. EXPOSED WIRE STRANDS IN DAMAGED AREA 3

FIGURE 41. WEAR MARKS ON THE FLAT SURFACE OF WIRE STRANDS IN DAMAGED AREA 3

FIGURE 42. BROKEN WIRE STRANDS IN STRANDS IN DAMAGED AREA 3

**FIGURE 43. WEAR MARKS ON THE FLAT SURFACE OF WIRE STRANDS IN
DAMAGED AREA 3**

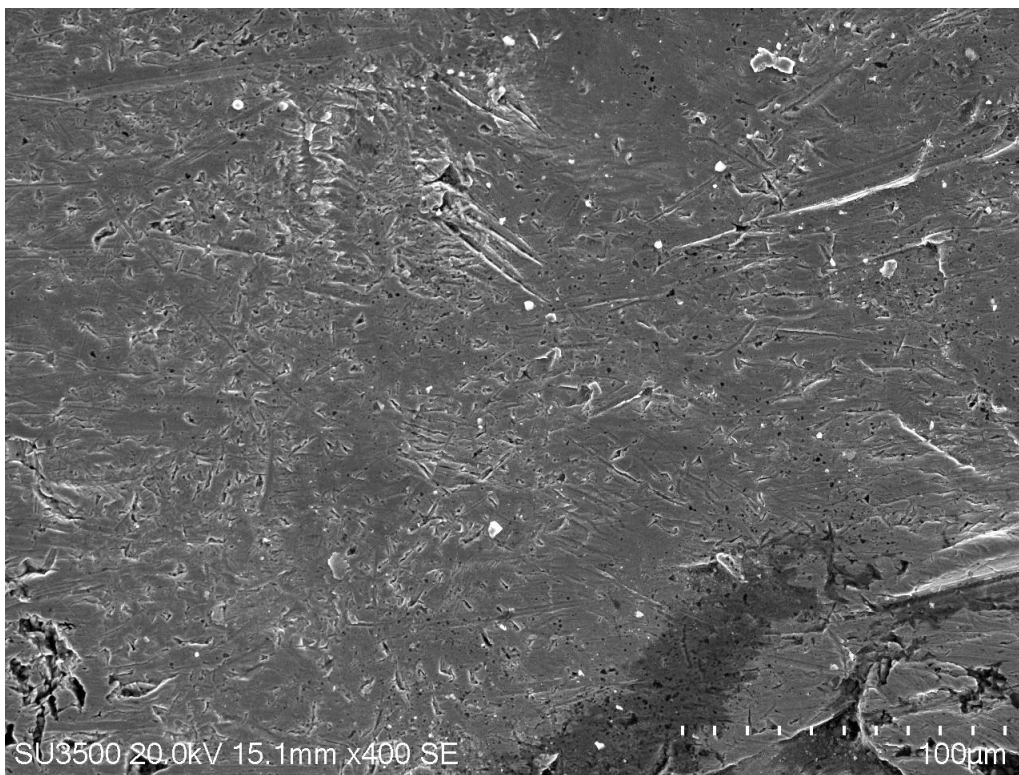
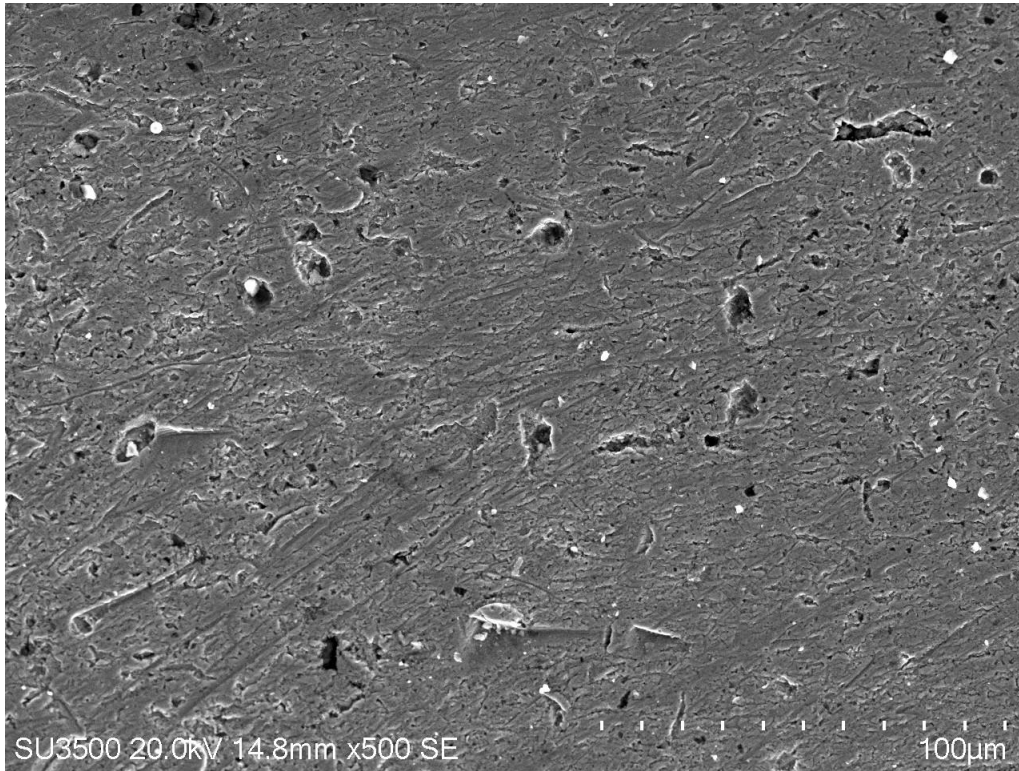
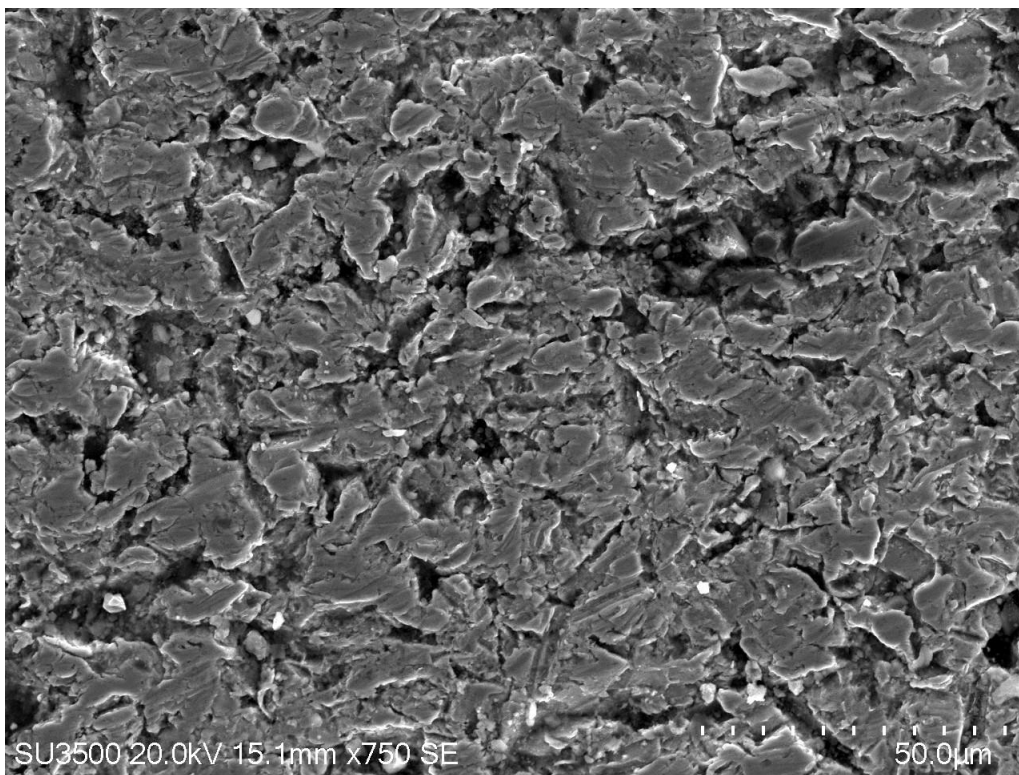
FIGURE 45. WEAR MARKS ON THE INNER SURFACE OF THE RING

FIGURE 46. WEAR MARKS ON THE INNER SURFACE OF THE RING

FIGURE 47. WEAR MARKS ON THE INNER SURFACE OF THE RING

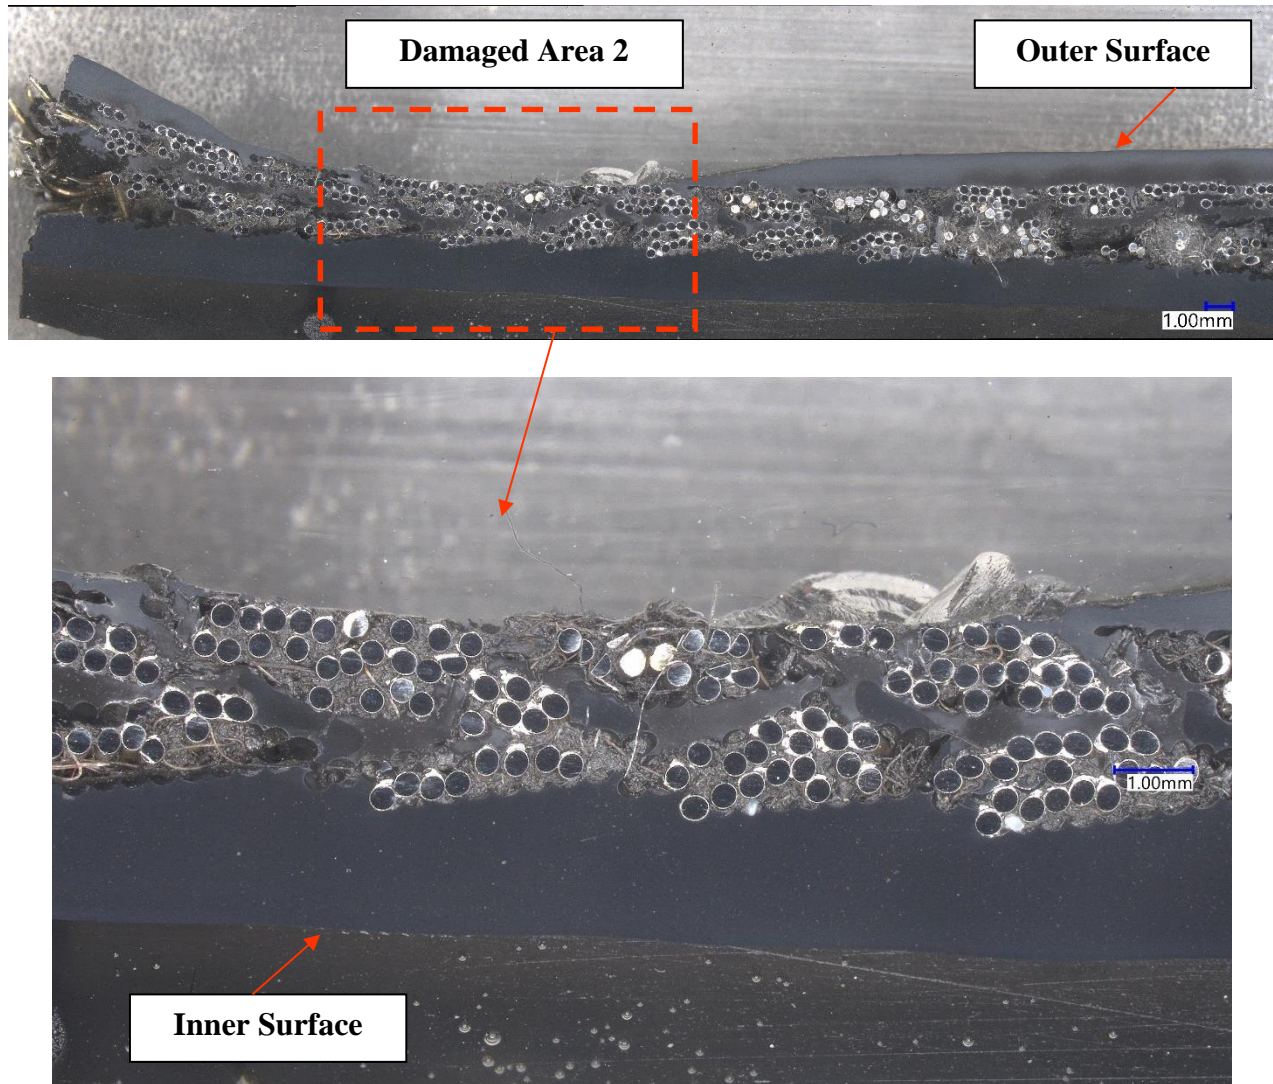
- i) Figure 48 presents a general image of the prepared cross-sectional metallographic sample in as polished condition. The cross-section shows two layers of black coating and a reinforcement layer (metallic wire strands) situated between them. The outer surface coating was thinner or totally removed in the damaged area resulted in exposure of the wire strands.
- ii) Closer view of the reinforcement layer within the damaged area is presented in Figure 49 and Figure 50. The wire strands exhibited a round cross-section. However, the shape of several wire strands, particularly those situated closer to the outer surface of the hose was compromised. The wire strands that were compromised exhibited a flattened edge when viewed in cross-section.
- iii) Examination after etching revealed tempered martensite structure in the wire strands, Figure 51 and Figure 52.

FIGURE 48. CROSS-SECTIONAL METALLOGRAPHIC SAMPLE AND CLOSER VIEW OF THE DAMAGED AREA

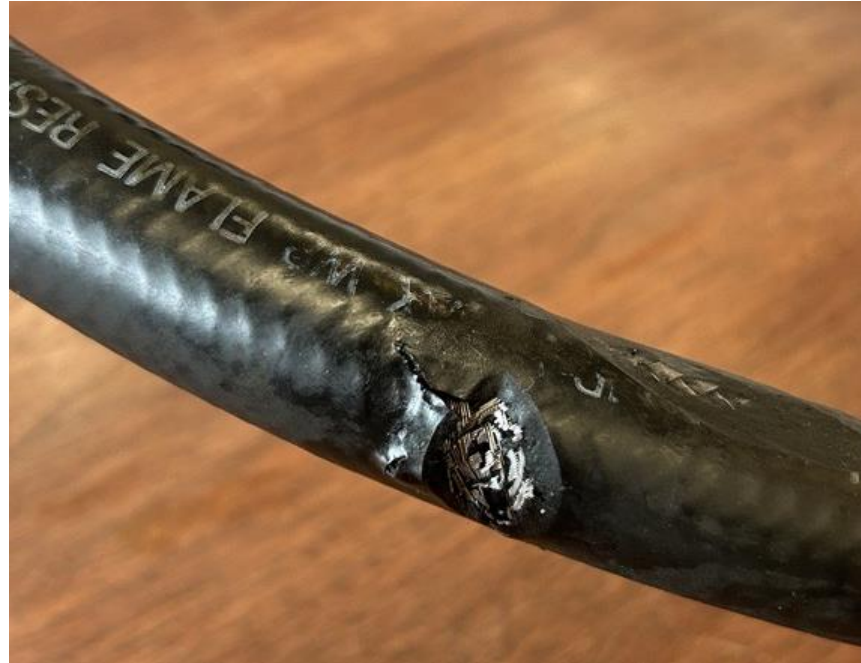
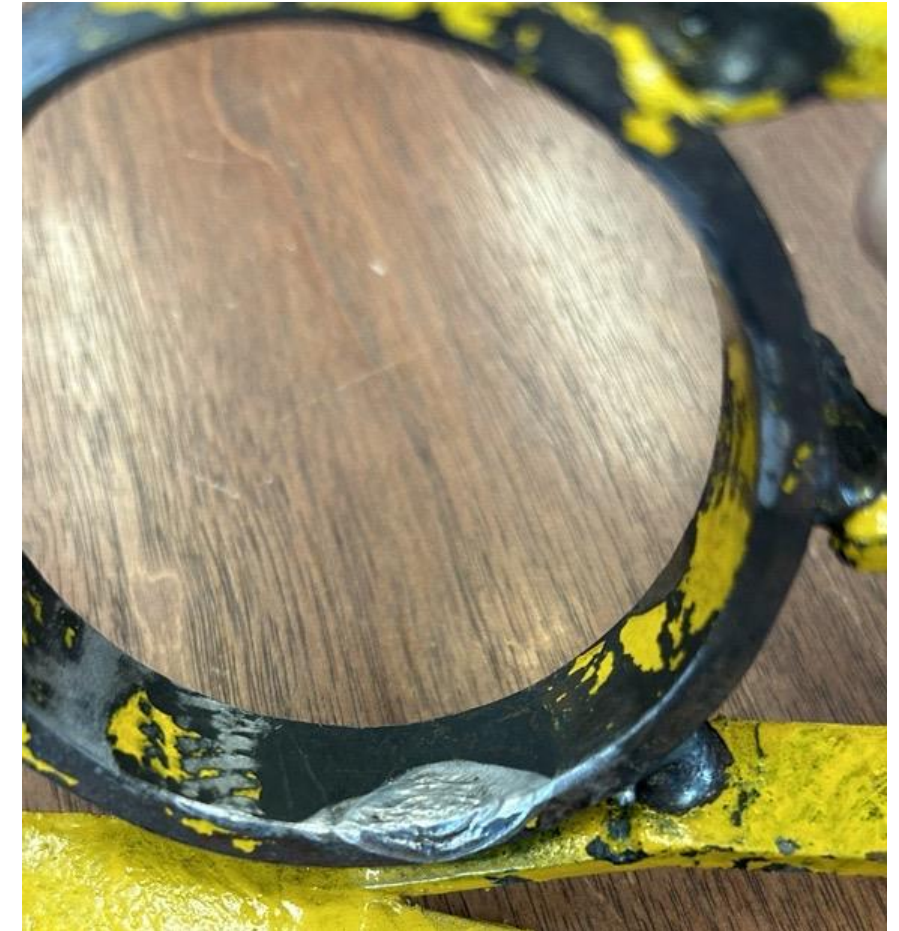
Source of the leak traced to abraded and failed hose routed tightly through and against sharp edge of ring in floor grate.

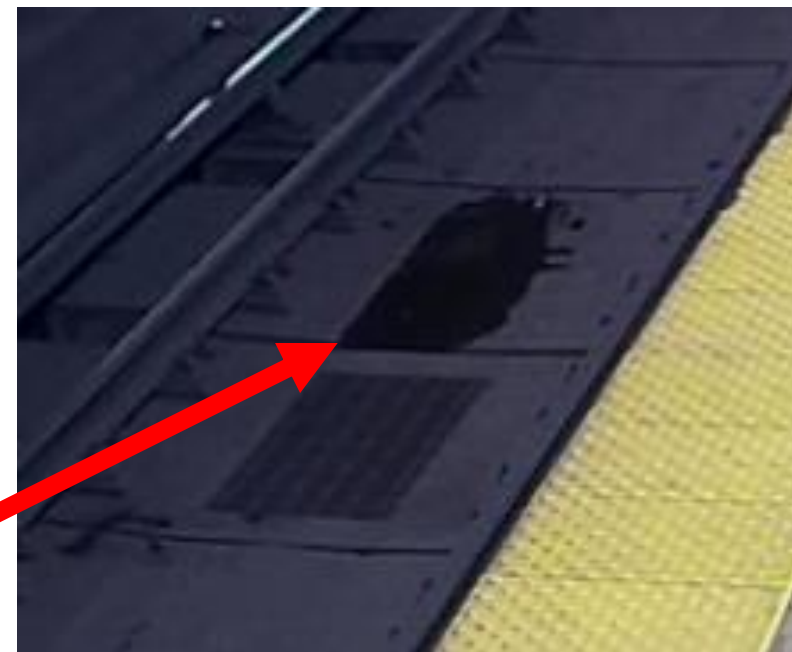
In the meantime, hydraulic fluid continued to flow through breached hose at approx. 150mL per minute (per calculation given hole size) at this new location, as observed later at track level between the running rails after the coupled work cars were moved off from this location.

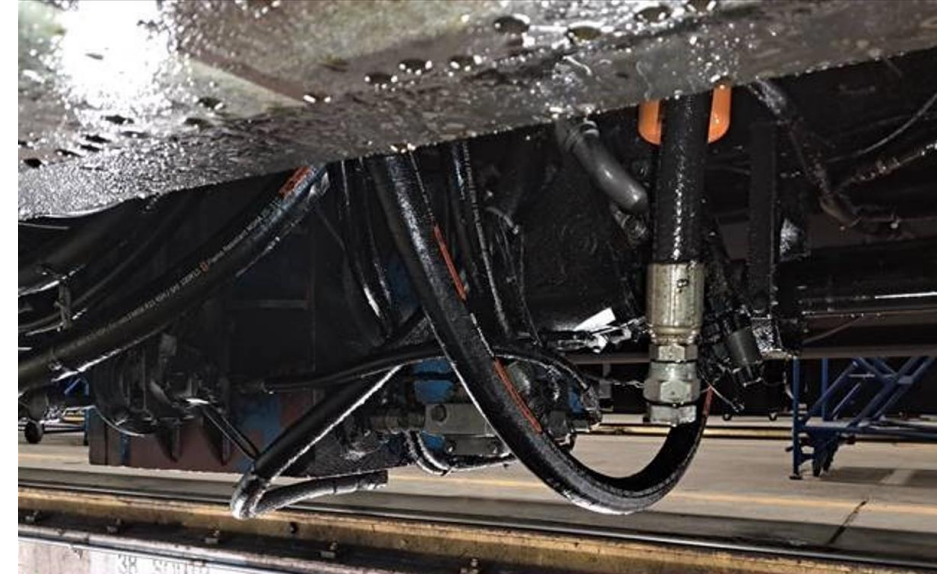
Investigation reveals the hydraulic fluid coating the underside and side sills of RT-56 (because of the initial hose breach/leak under pressure at Spadina) was shaking loose and splattering due to the movement of the coupled RTs as they made their way to first Museum and then on to Greenwood at 25 km/h once they were under TCC control past Museum Station.
