Service Impacts Due to Hydraulic Spills

Summary of Recent Events

May 16, 2024

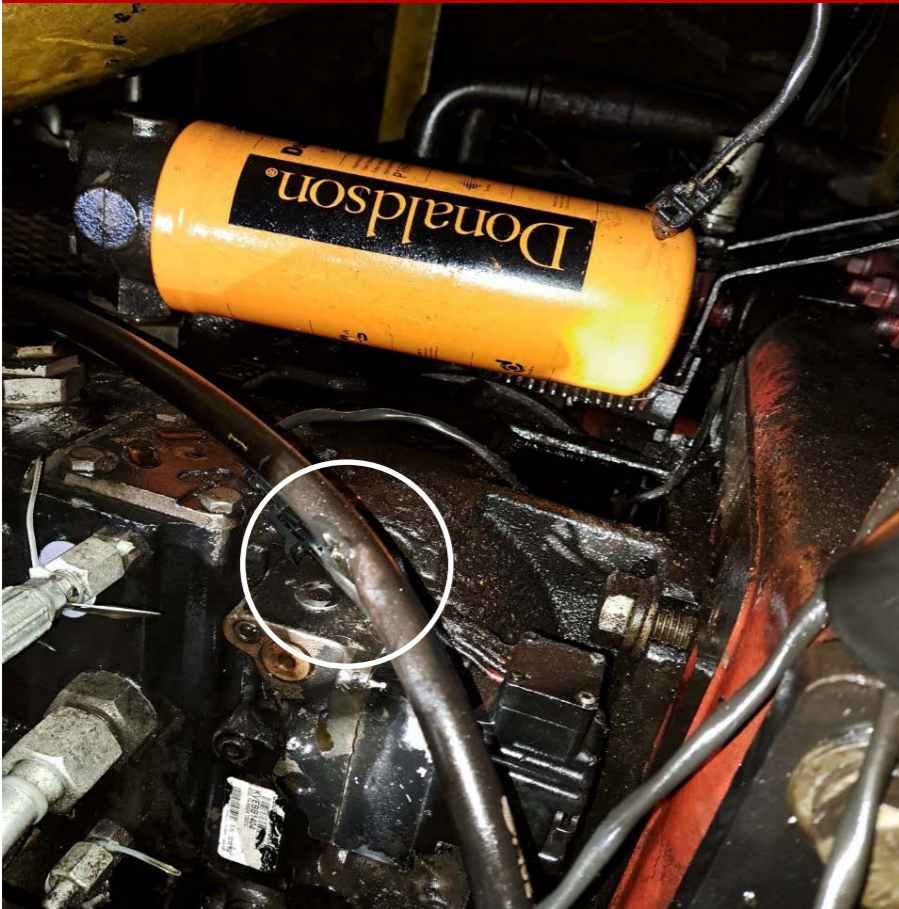
January 14, 2024 Incident – RT-56

Vehicle age:	20 Years (Dec 2004)
Source of spill:	Hydrostatic drive hose
Date of last inspection:	October 26, 2023
Compliance to inspect interval:	Yes
Results of last inspection:	No concerns identified by Vehicle Technician
Corrective actions:	<ol style="list-style-type: none">1. Re-assessment of component life cycles2. Increased technical and workmanship training (Master Sign-Up)3. Improvements to Quality Assurance and Control functions

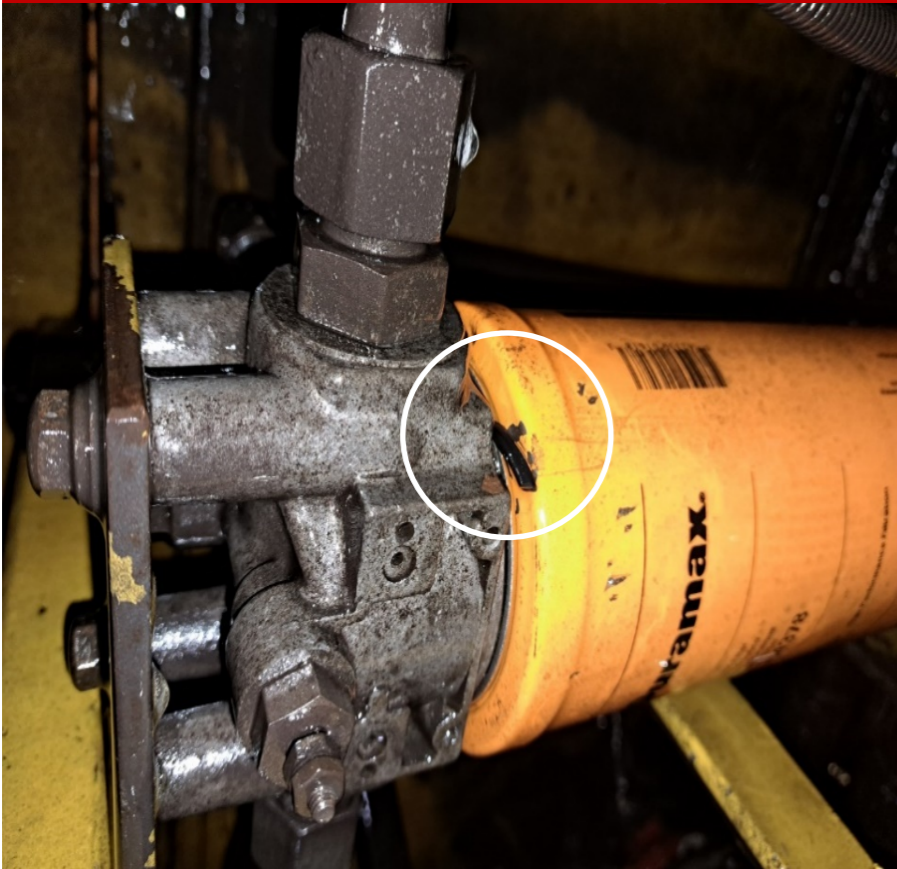
January 17, 2024 Incident – RT-17

Vehicle age:	27 years (Dec 1997)
Source of spill:	O-ring high pressure filter
Date of last inspection:	November 21, 2023
Compliance to inspect interval:	Yes
Results of last inspection:	No concerns identified by Vehicle Technician
Corrective actions:	<ol style="list-style-type: none">1. Re-assessment of component life cycles2. Increased technical and workmanship training (Master Sign-Up)3. Improvements to Quality Assurance and Control functions

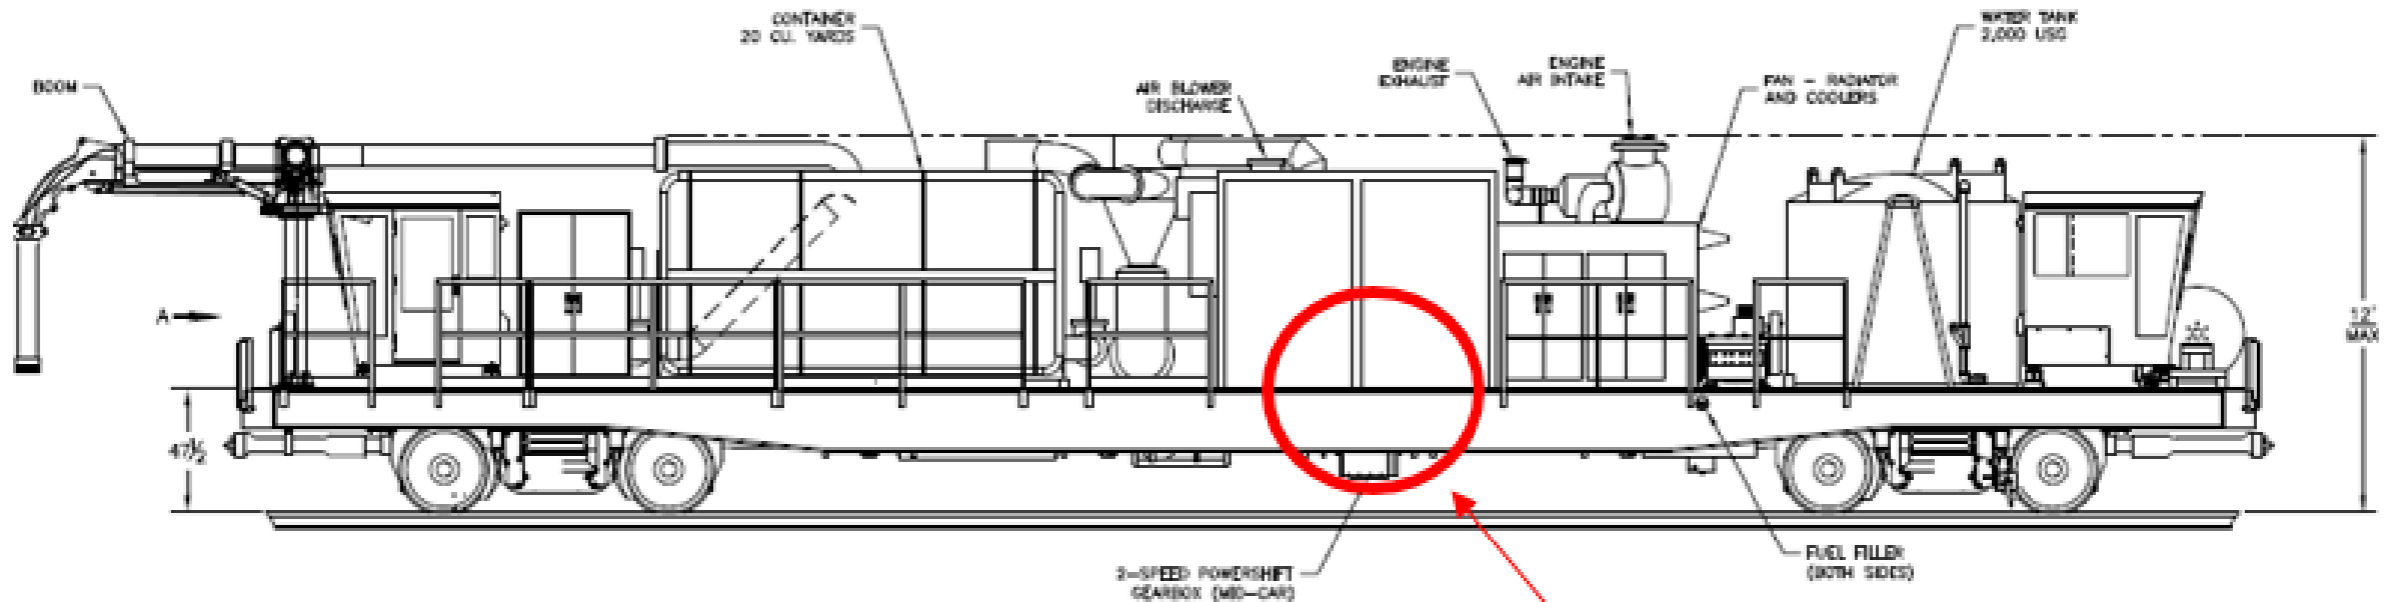
RT-56 – Vacuum Work Car

**Approximate location
of January 14 and May
13 failures**

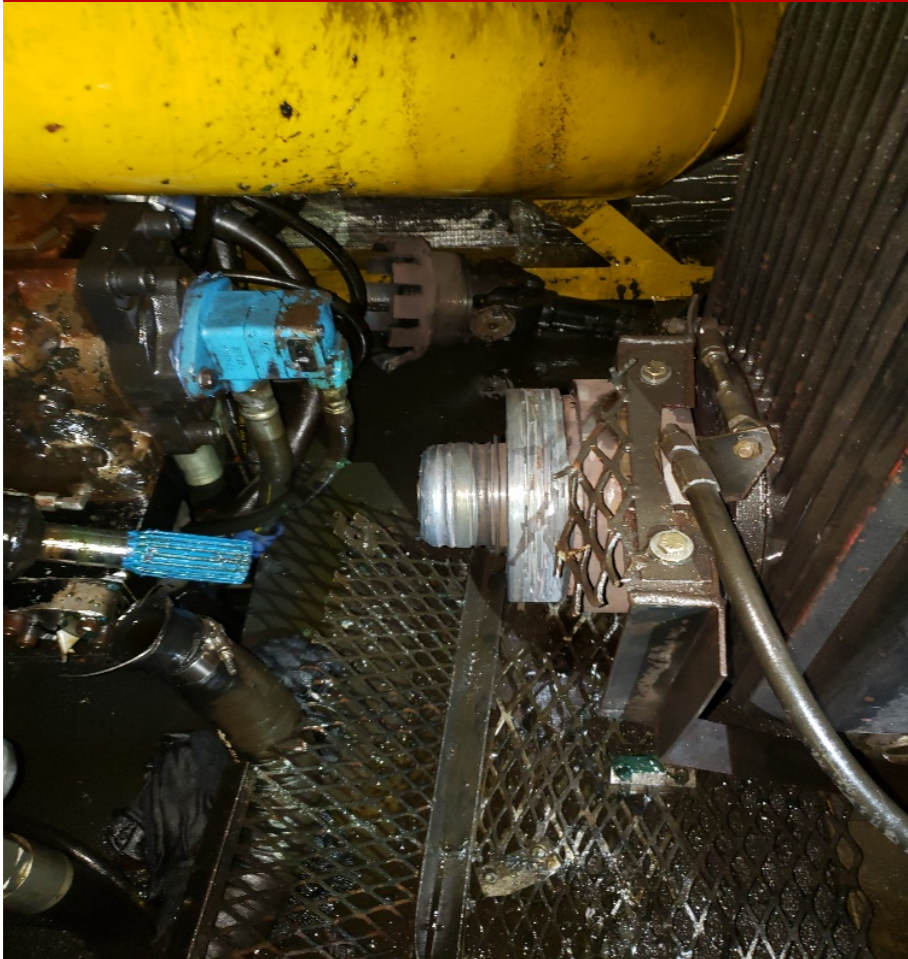
May 15, 2024 Incident – RT-84

Vehicle age:	13 Years (Oct 2011)
Source of spill:	Hydrostatic hose*
Date of last inspection:	March 12, 2024
Compliance to inspect interval:	Yes
Results of last inspection:	No concerns identified by Vehicle Technician

- *Damage found to clutch plate, drive shaft and other mechanical components. Damage to hydrostatic drive hose is suspected to be a result of mechanical failures still under investigation.
- Clutch design life 7-10 years. Last replaced in 2019.
