SRT DERAILMENT-ELLESMERE STATION

FORENSIC ASSESSMENT REPORT

Rail Infrastructure Consultation
Toronto Transit Commission
Toronto, Ontario
2023-10-12

FIRM PROJECT NO.: 067065

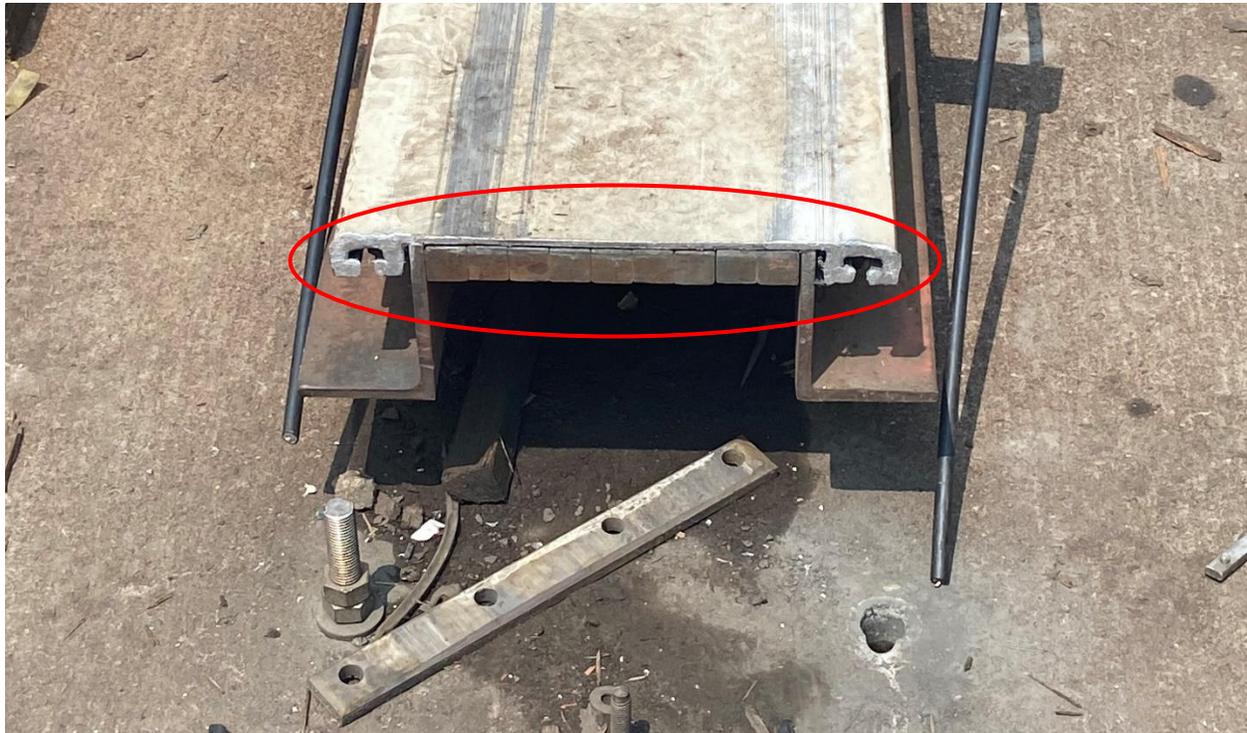
The prevailing working hypothesis suggests that bolts 1 and 3 (see Figure 34 for reference) were fractured prior to the derailment, as indicated by their fracture surfaces and lack of severe bending deformation. As detailed in Section 0 of the report, the failure of these two bolts resulted from fatigue crack initiation and propagation. This supposition gains further support from the distortion evident on the preceding segment of the reaction rail's top cap, seemingly resulting from contact with the following reaction rail, which made contact with the undercarriage of car 3001 (see Figure 33). This sort of deformation could only occur from recurrent impact with the downstream top cap as it is lifted while a train passes.

Figure 33: Preceding top cap deformation at reaction rail/top cap joint

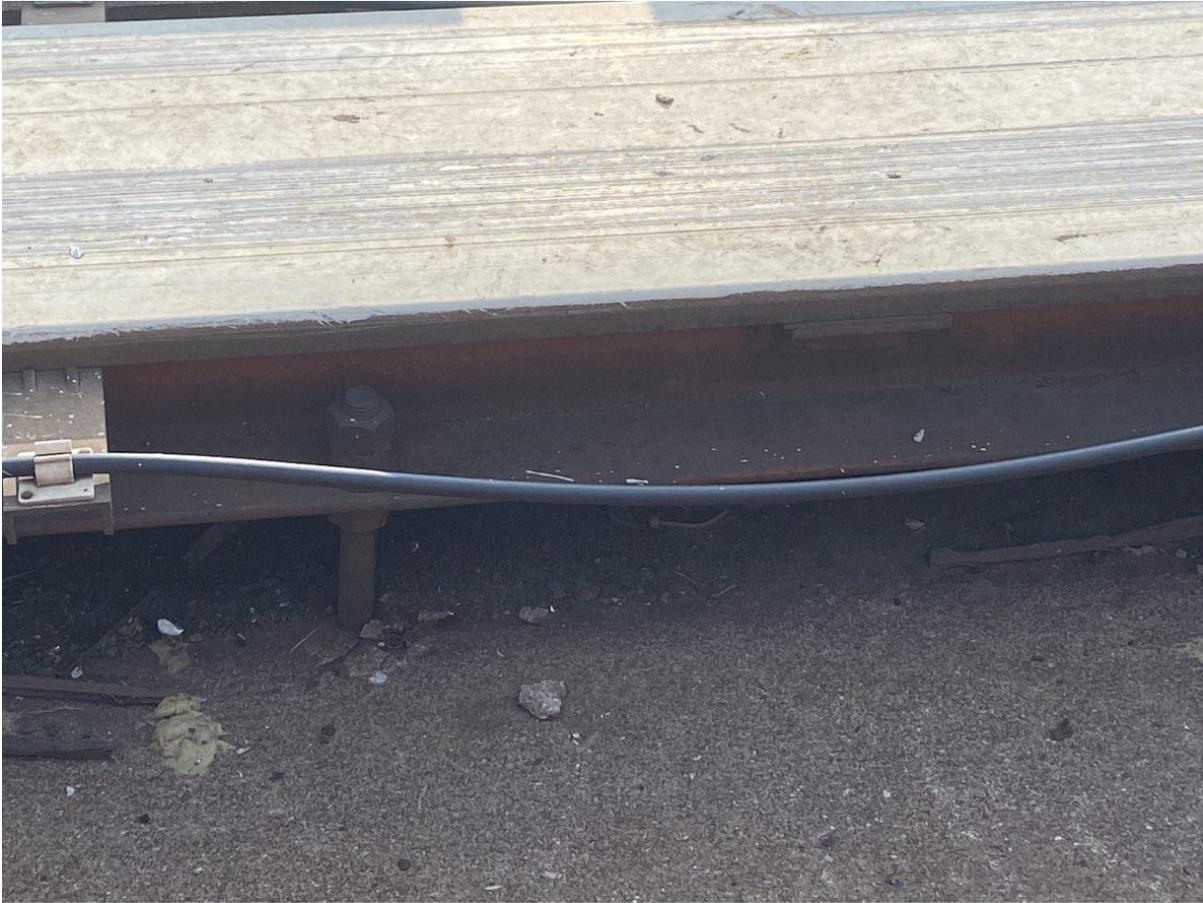
Figure 9: Loose Anchor Bolts near Derailment Site (South end)

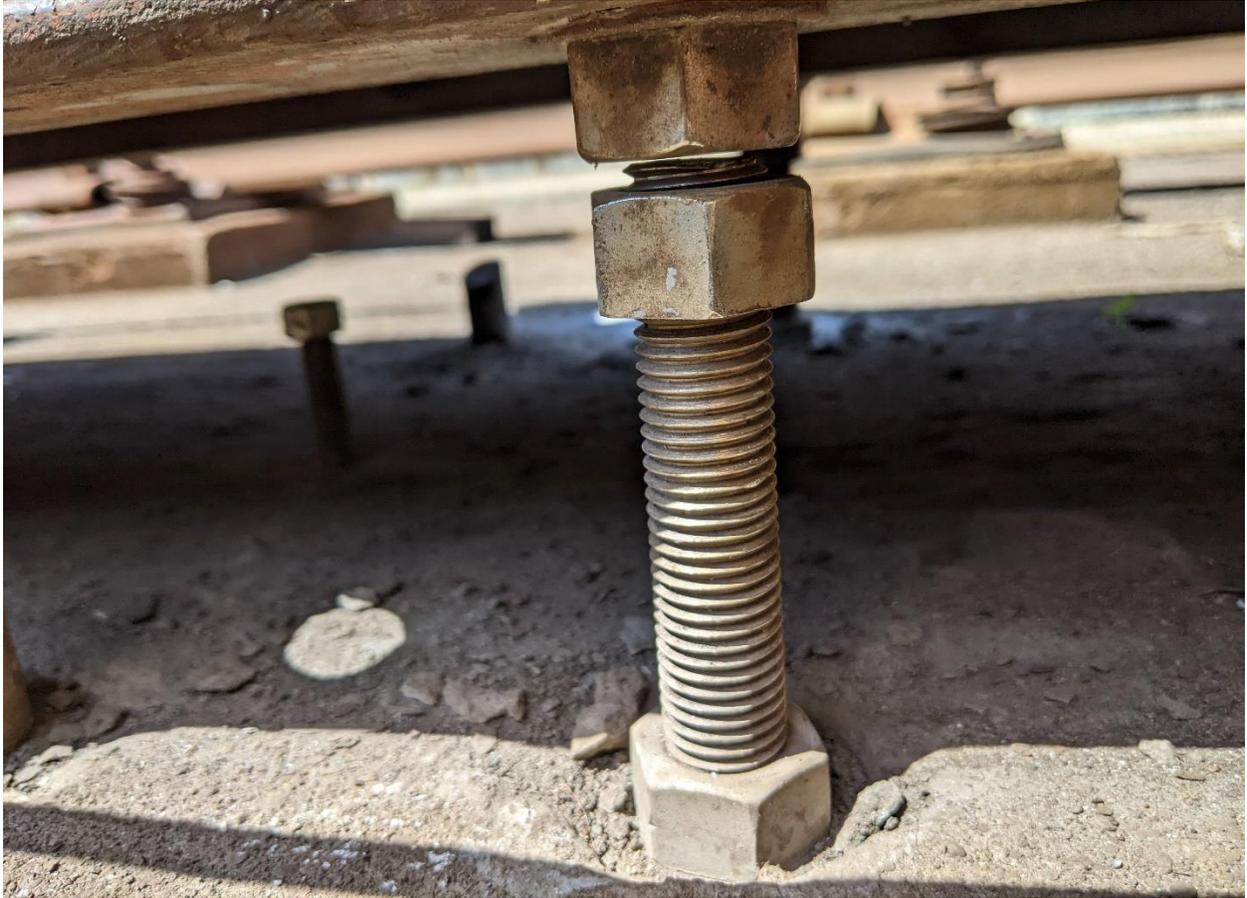
It was noted within the derailment site that numerous newer stainless steel anchor bolts secured the reaction rail frame to the invert slab, and some of the stainless steel bolts showed signs of fracture prior to the derailment. Figure 15 shows a similar fractured and misaligned anchor bolt found approximately 70 m south of the derailment site.

Figure 10: Fractured Anchor Bolt Approximately 70 m South of Derailment Site

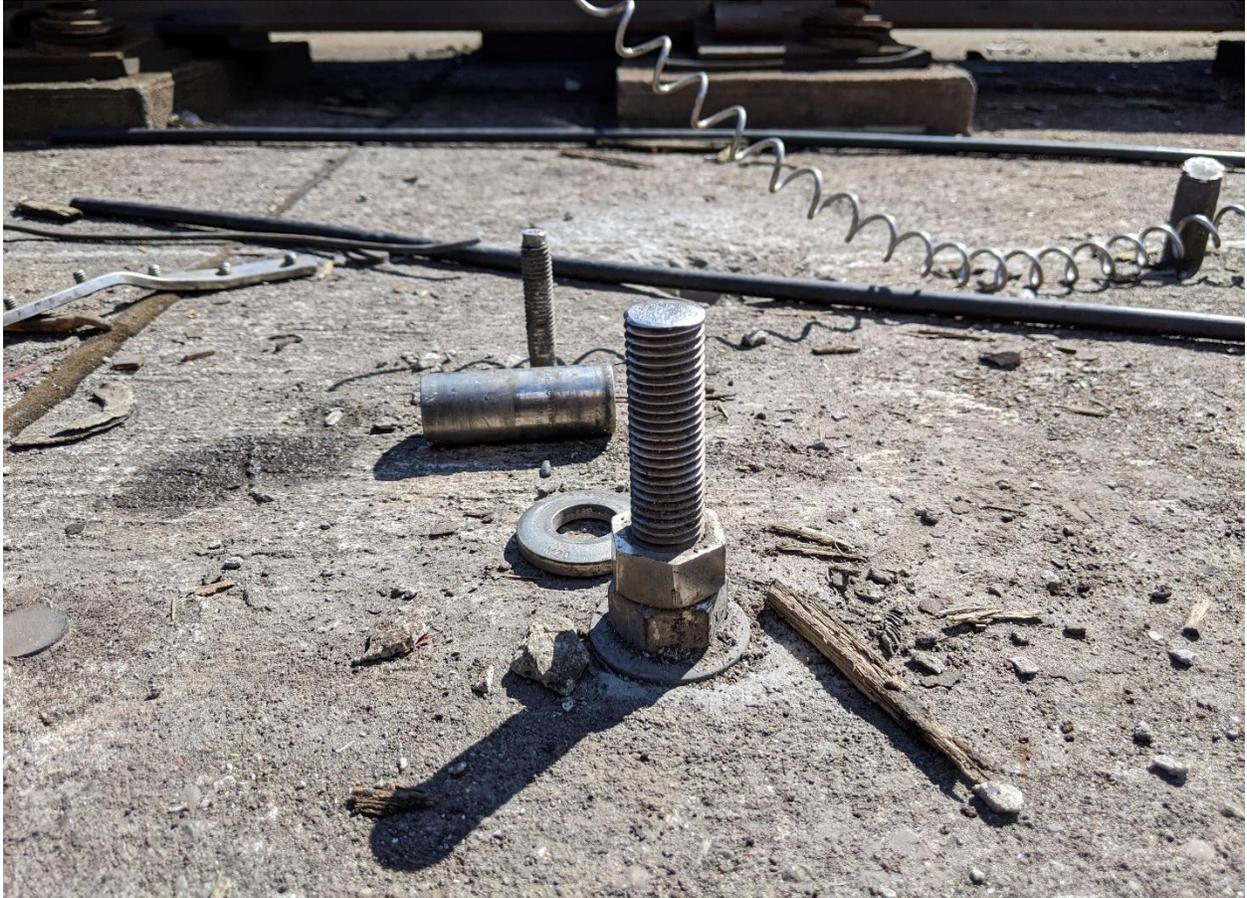
Figure 11: Fractured Anchor Bolt (Anchor No. 3)

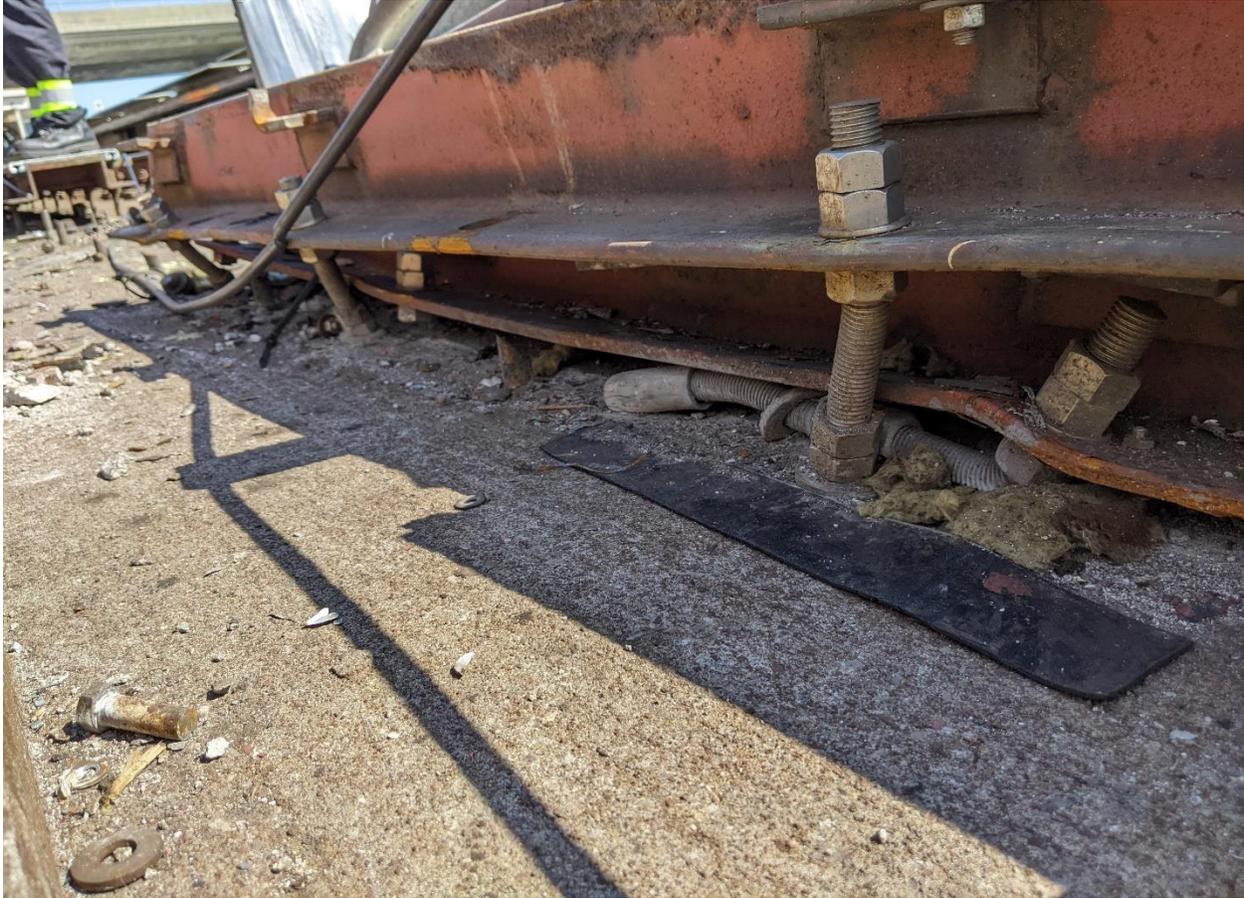
Figure 12: Impacted Reaction Rail Frame, pushed below the Adjacent Reaction Rail Frame. Note the upper portions of Anchor Nos. 1, 3, and 5 attached to the frame.

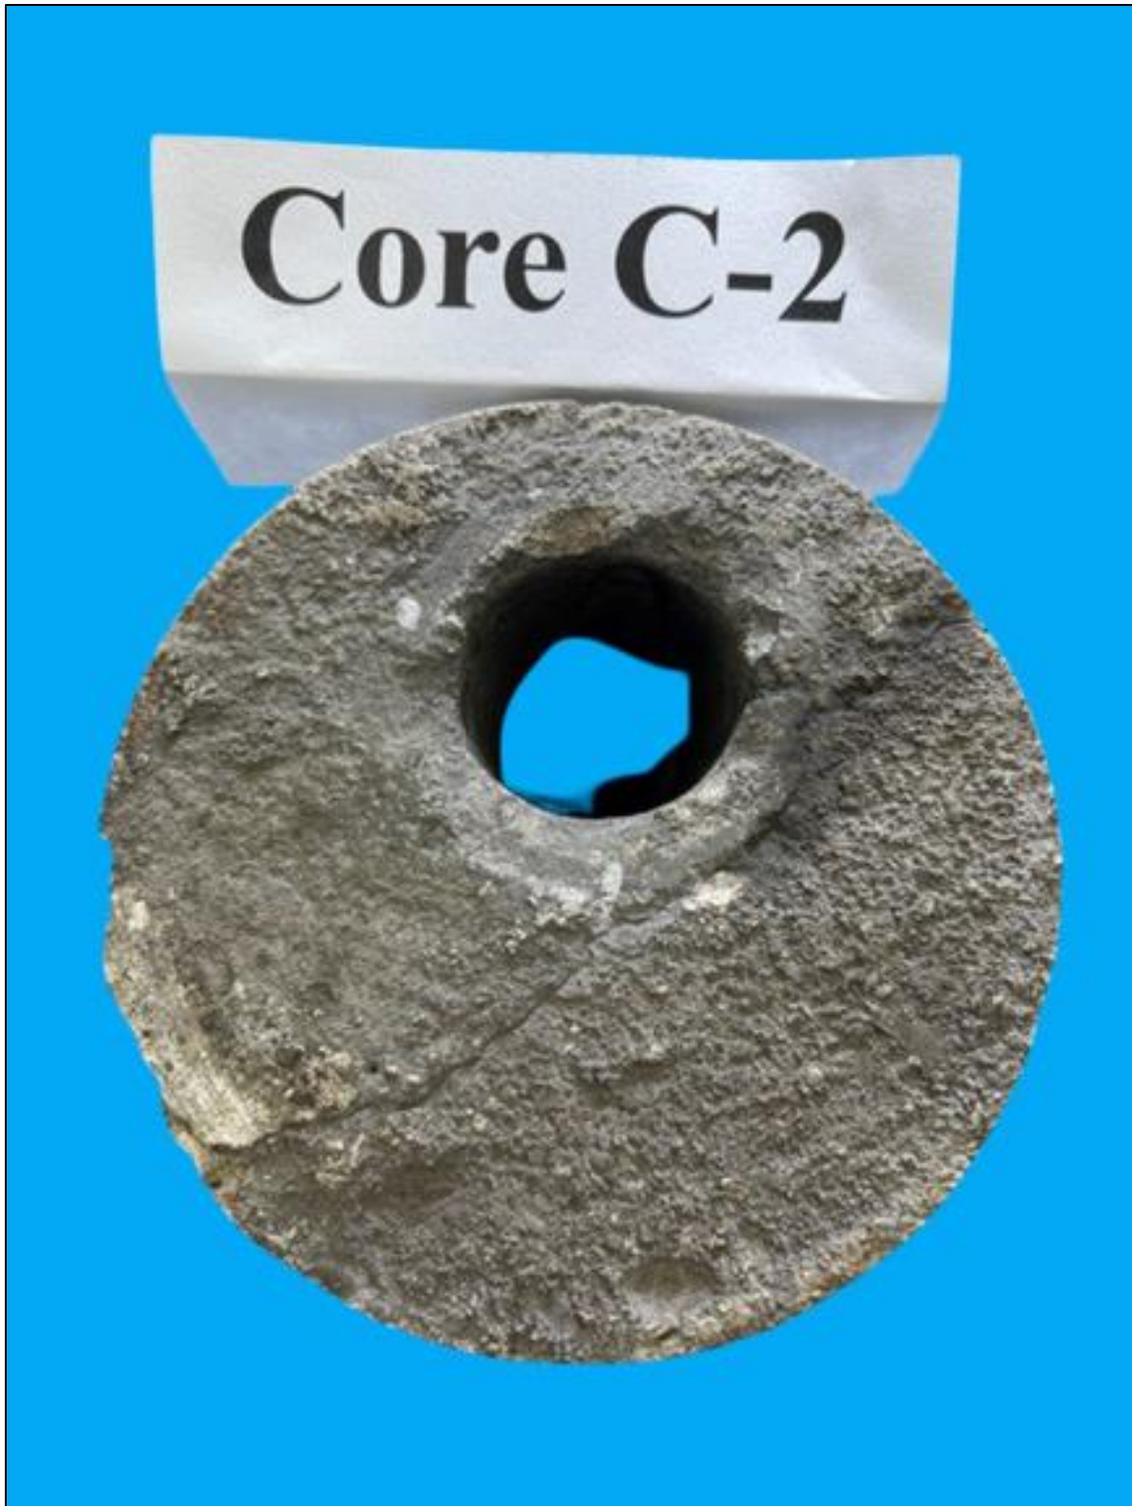
Photo P10 – Core C2 Top View

(Note :the visible crack adjacent to the core hole, across the diameter of the core)

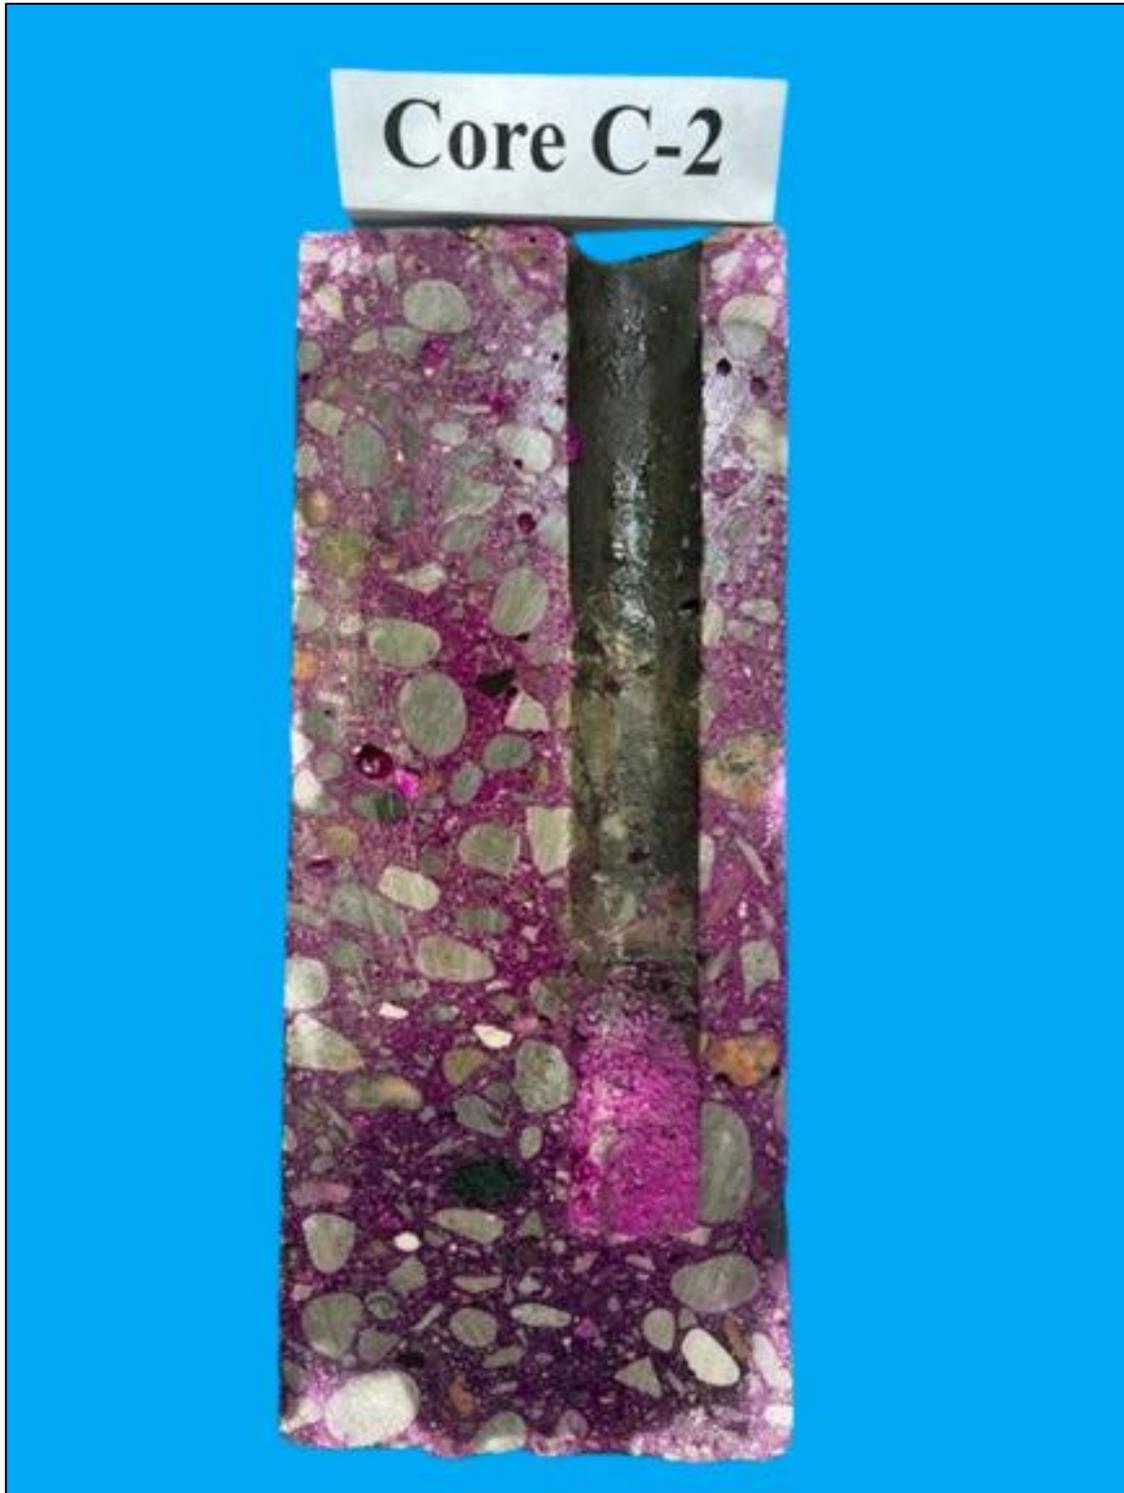
Photo P11 – Core C2

(Showing carbonation tested surface; no visible depth of carbonation was noted.)

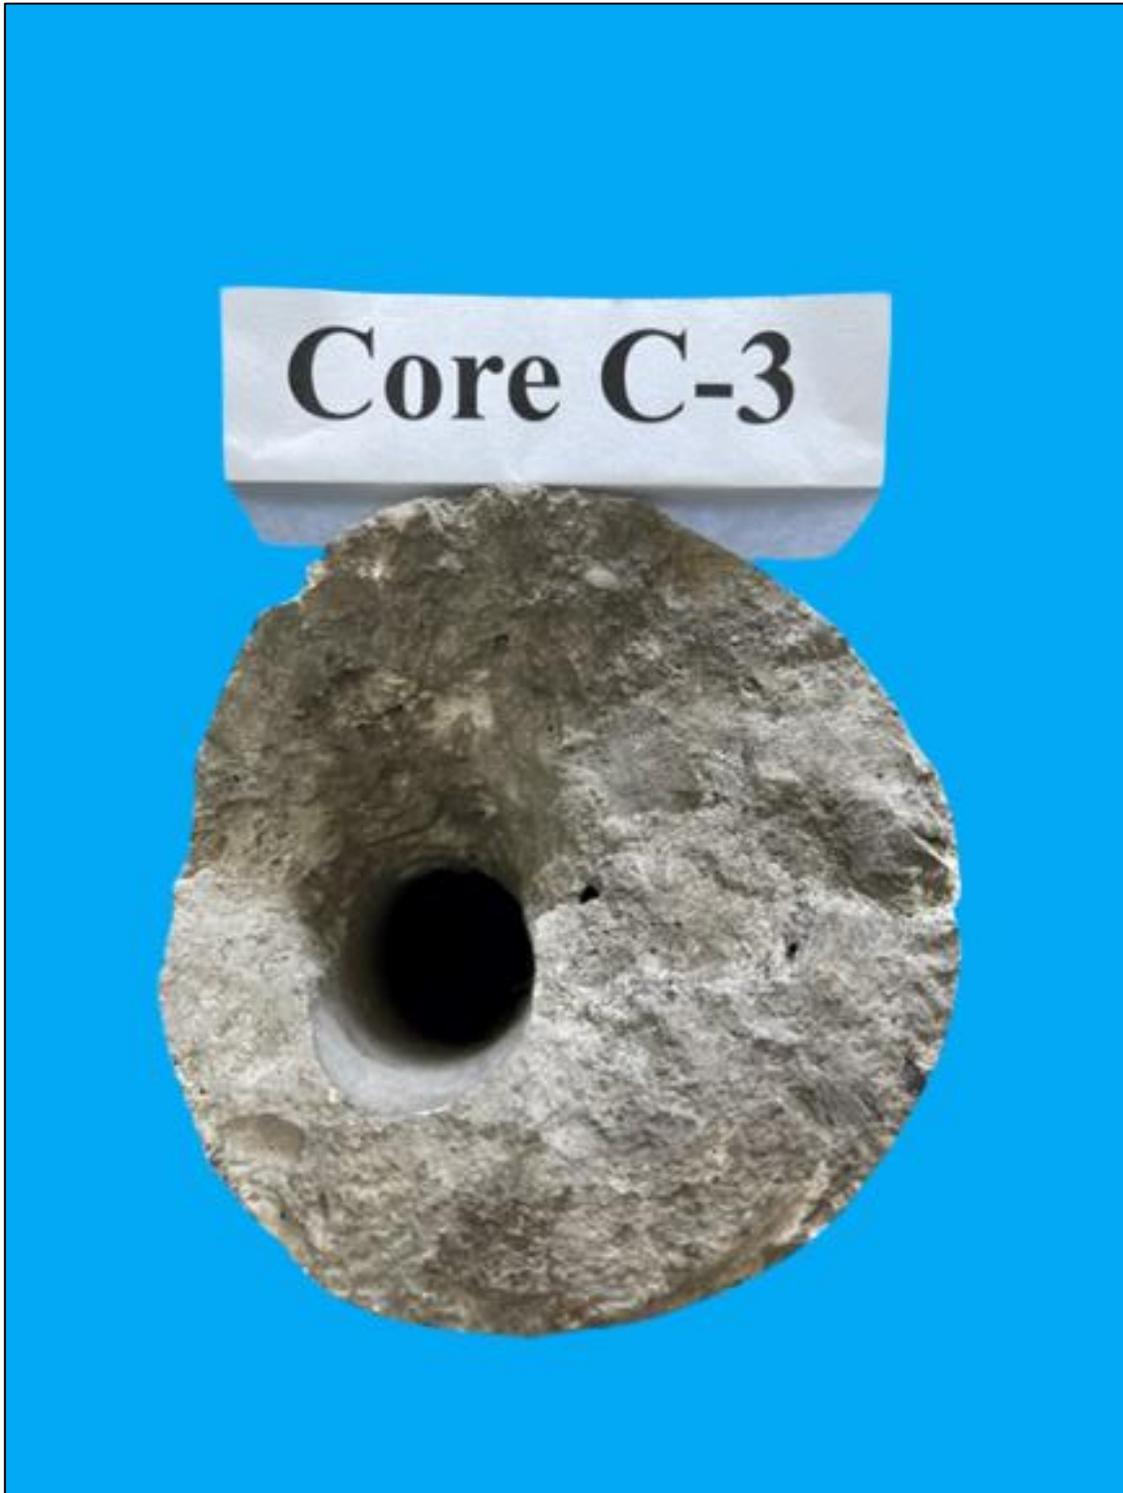
Photo P14 – Core C3 Top View

(Note : the spalled damaged concrete surface at the top of the core)

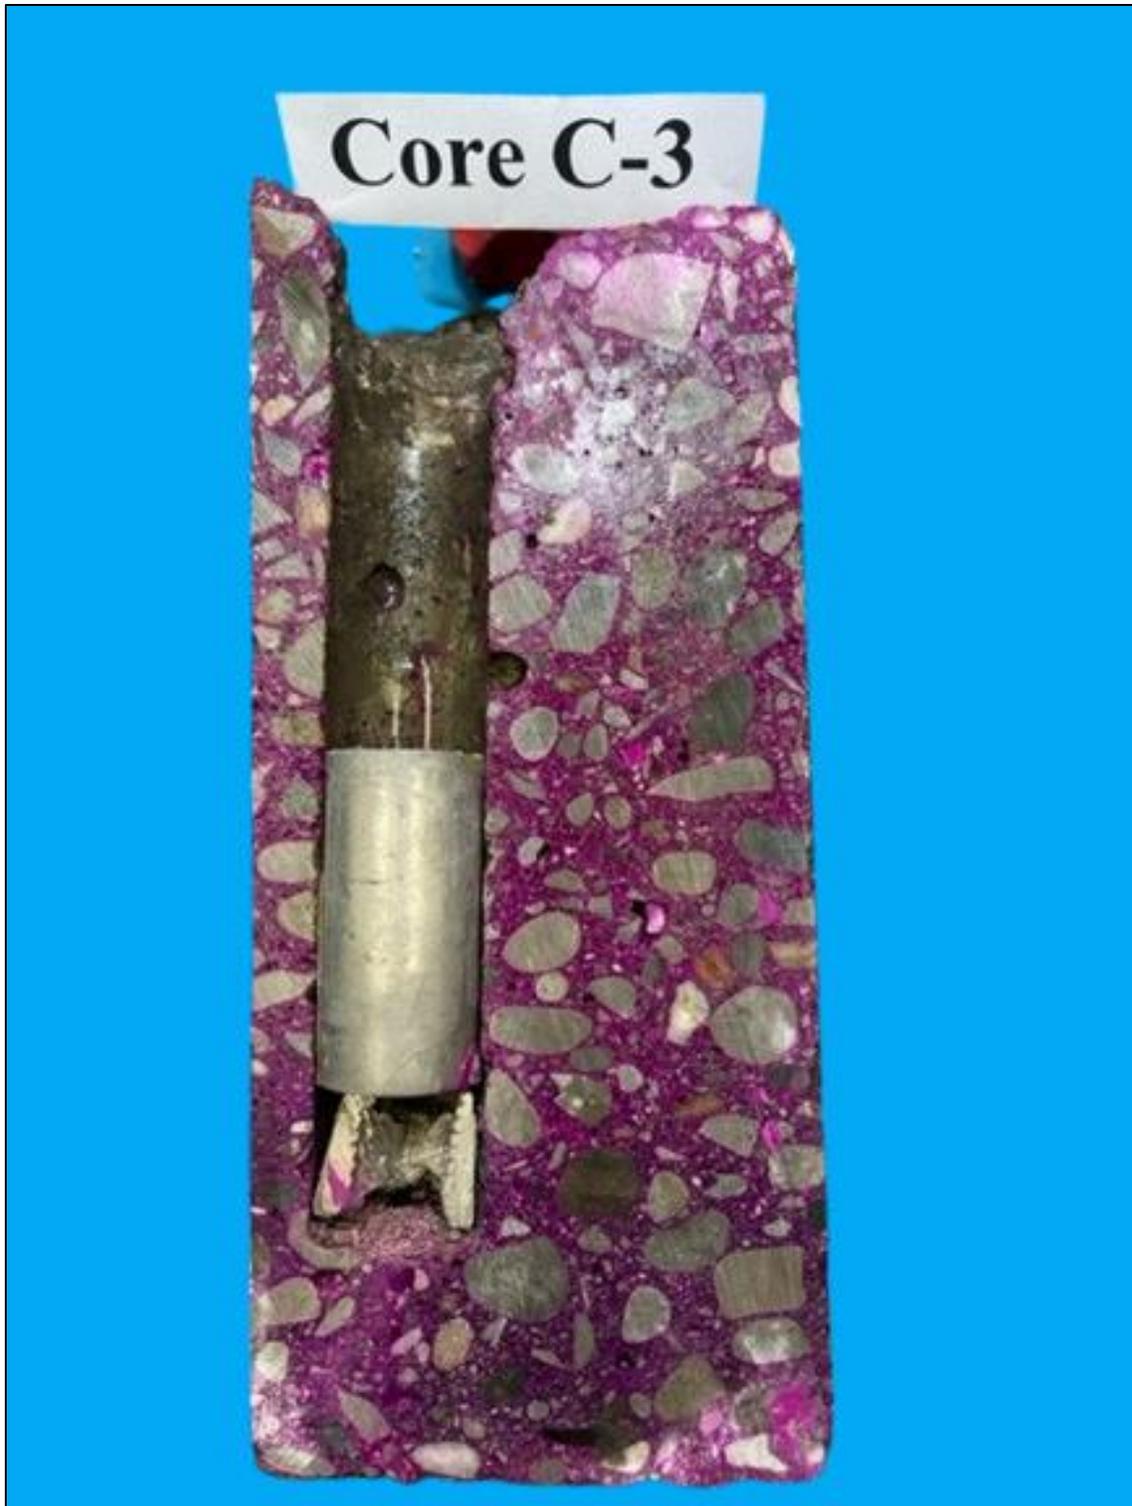
Photo P15 – Core C3

(Showing carbonation tested surface; carbonation depth was determined to be less than 0.5mm.)

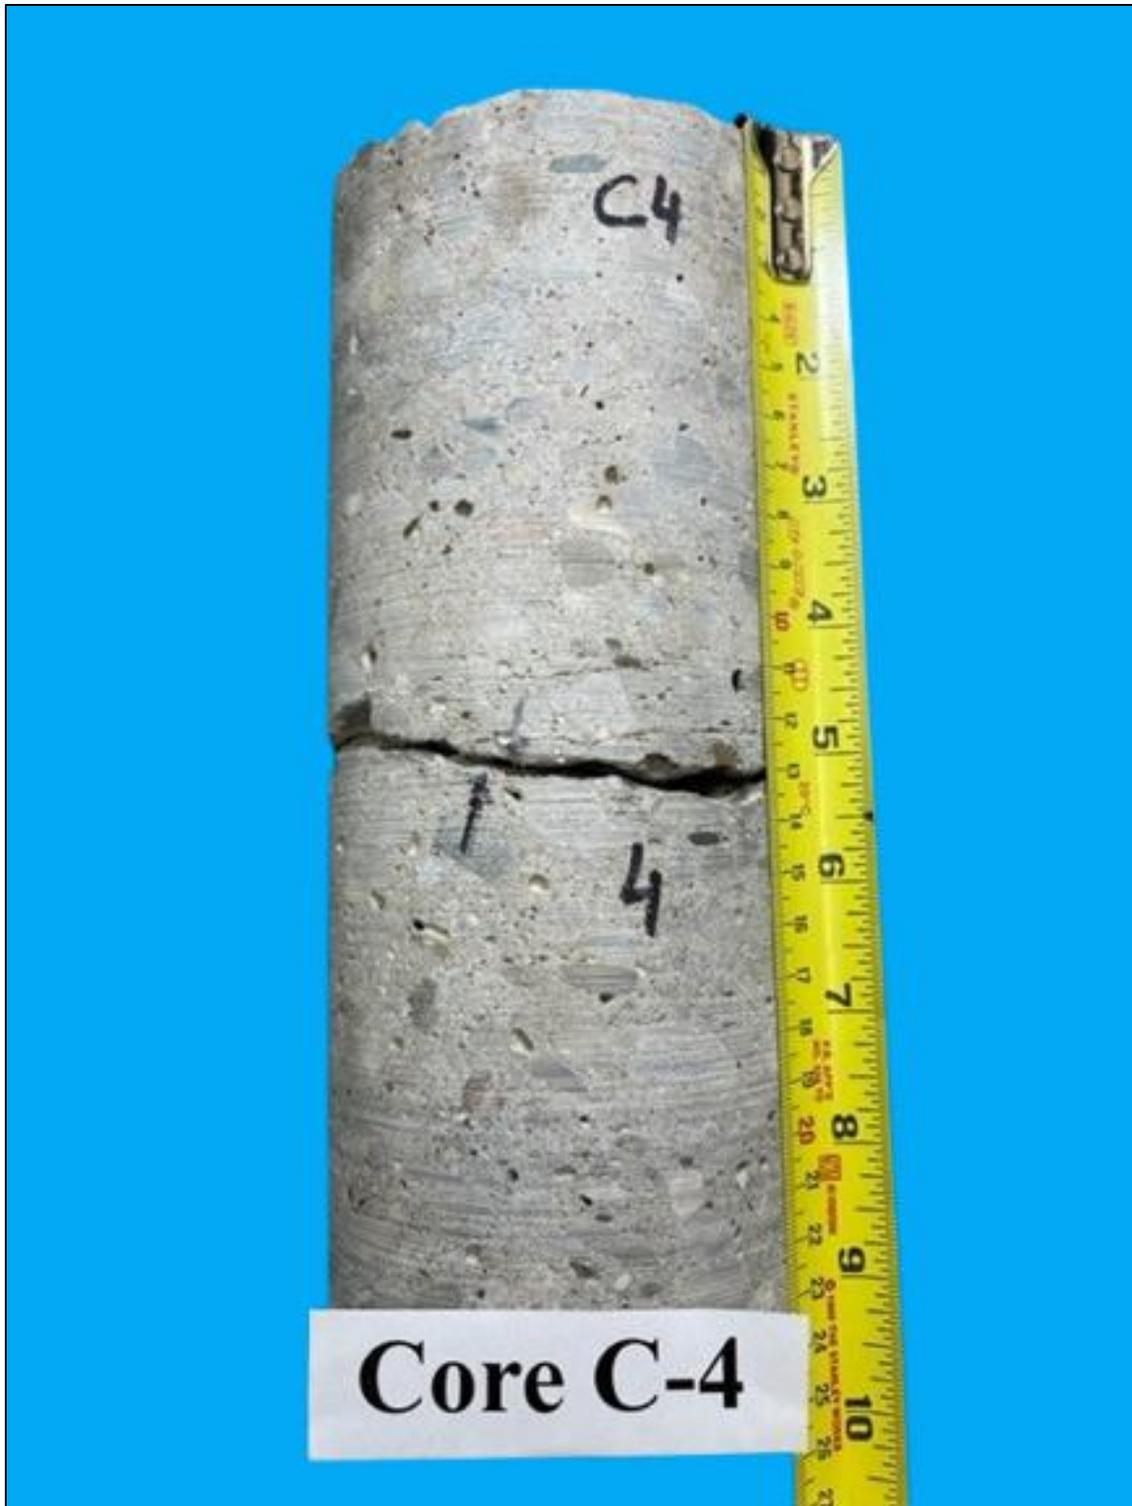
Photo P16 – Core C4

(Note : that the core was retrieved in two pieces, with visible horizontal cracks adjacent to the interface of the pieces)

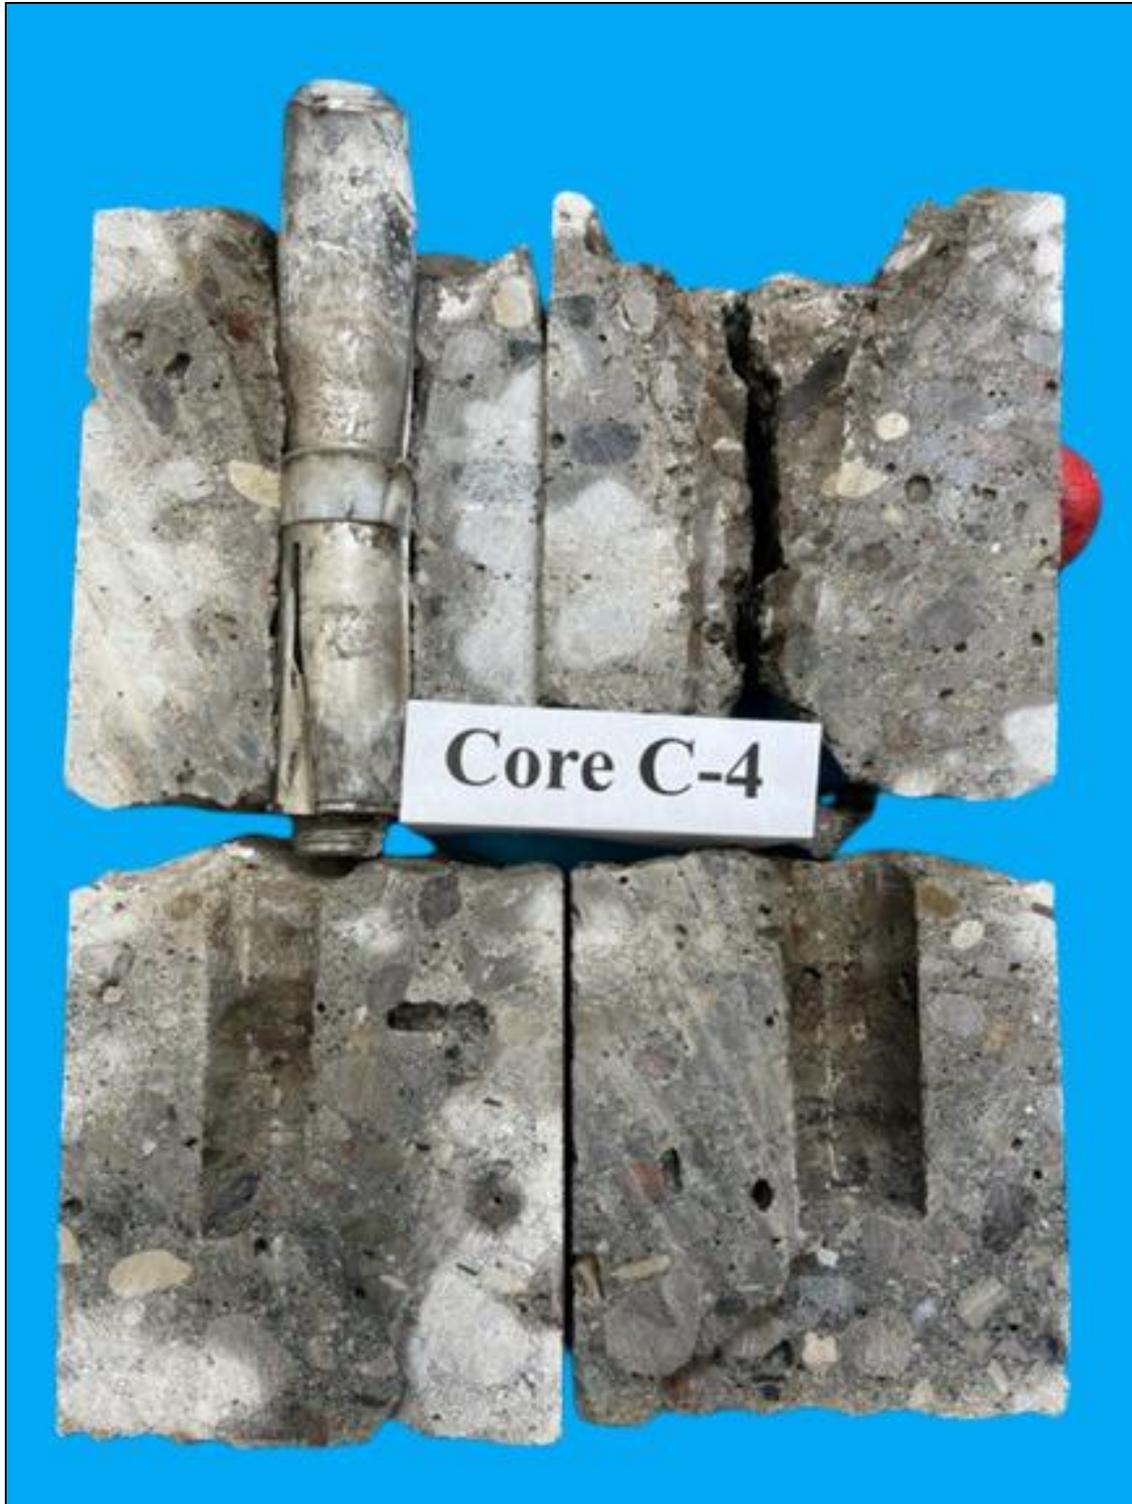
Photo P17 – Core C4 Sawn Sample Faces

(Note :the position of the expansion sleeve and cone, which appears to have been pulled out due to impact damage to the anchor bolt)

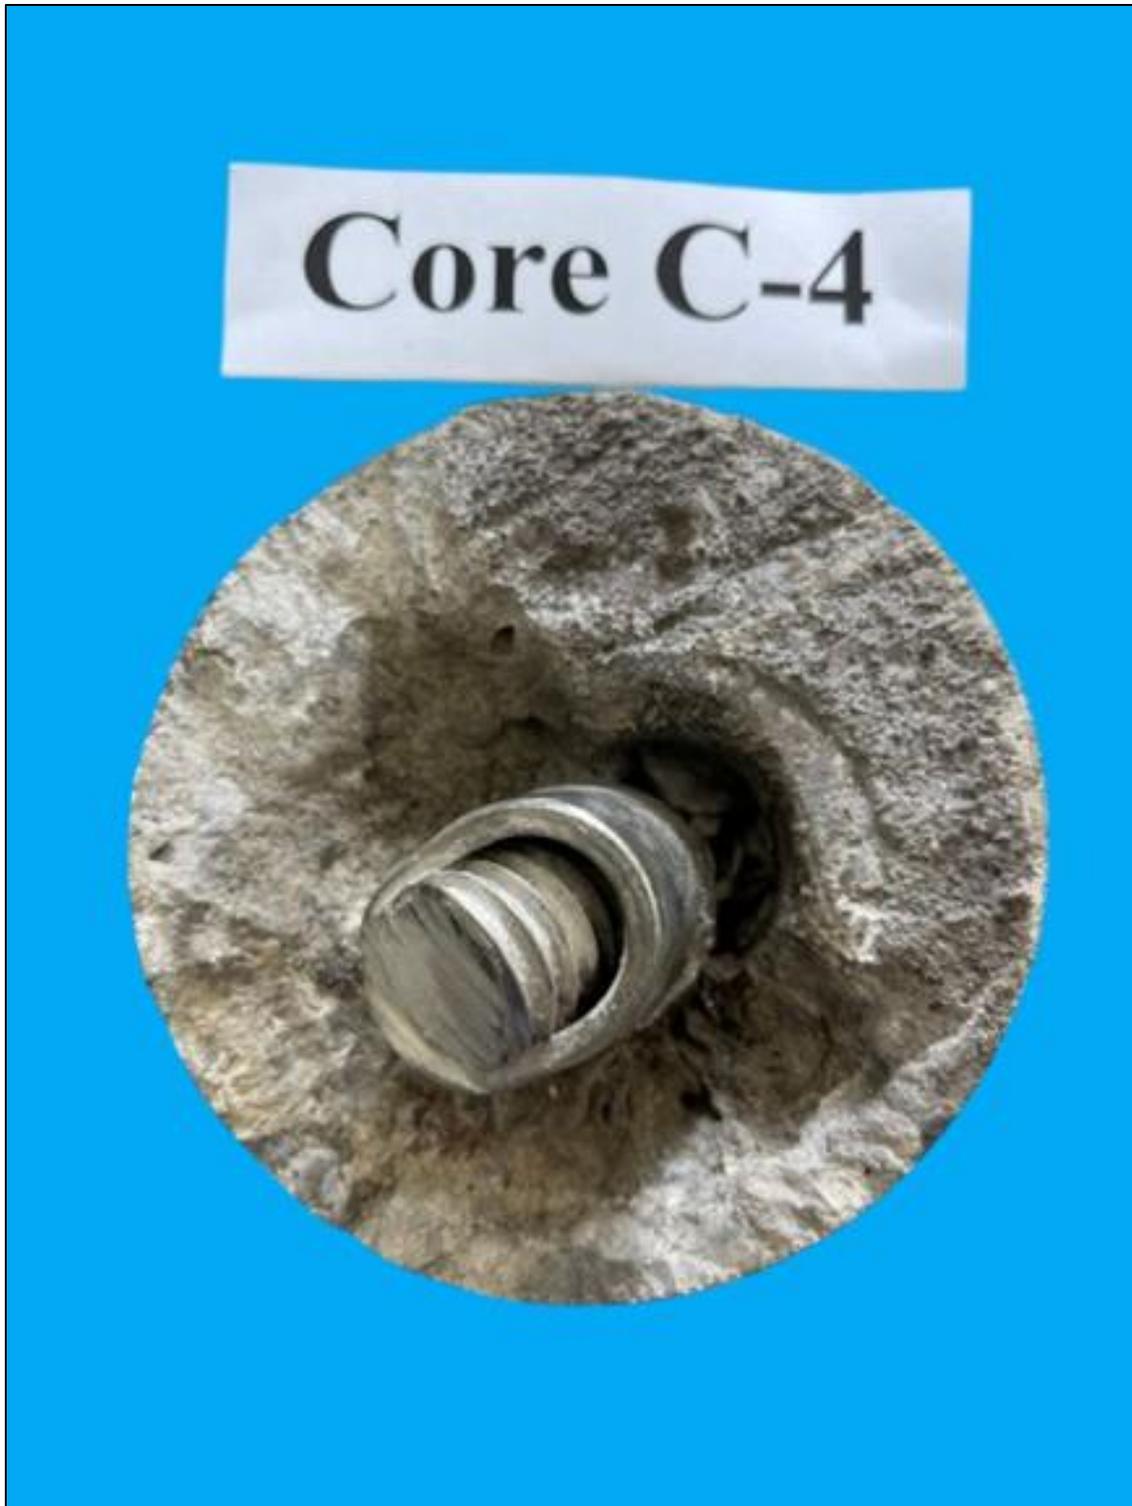
Photo P18 – Core C4 Top View

(Note: the spalled damaged concrete and sheared and bent anchor bolt assembly, due to impact damage.)

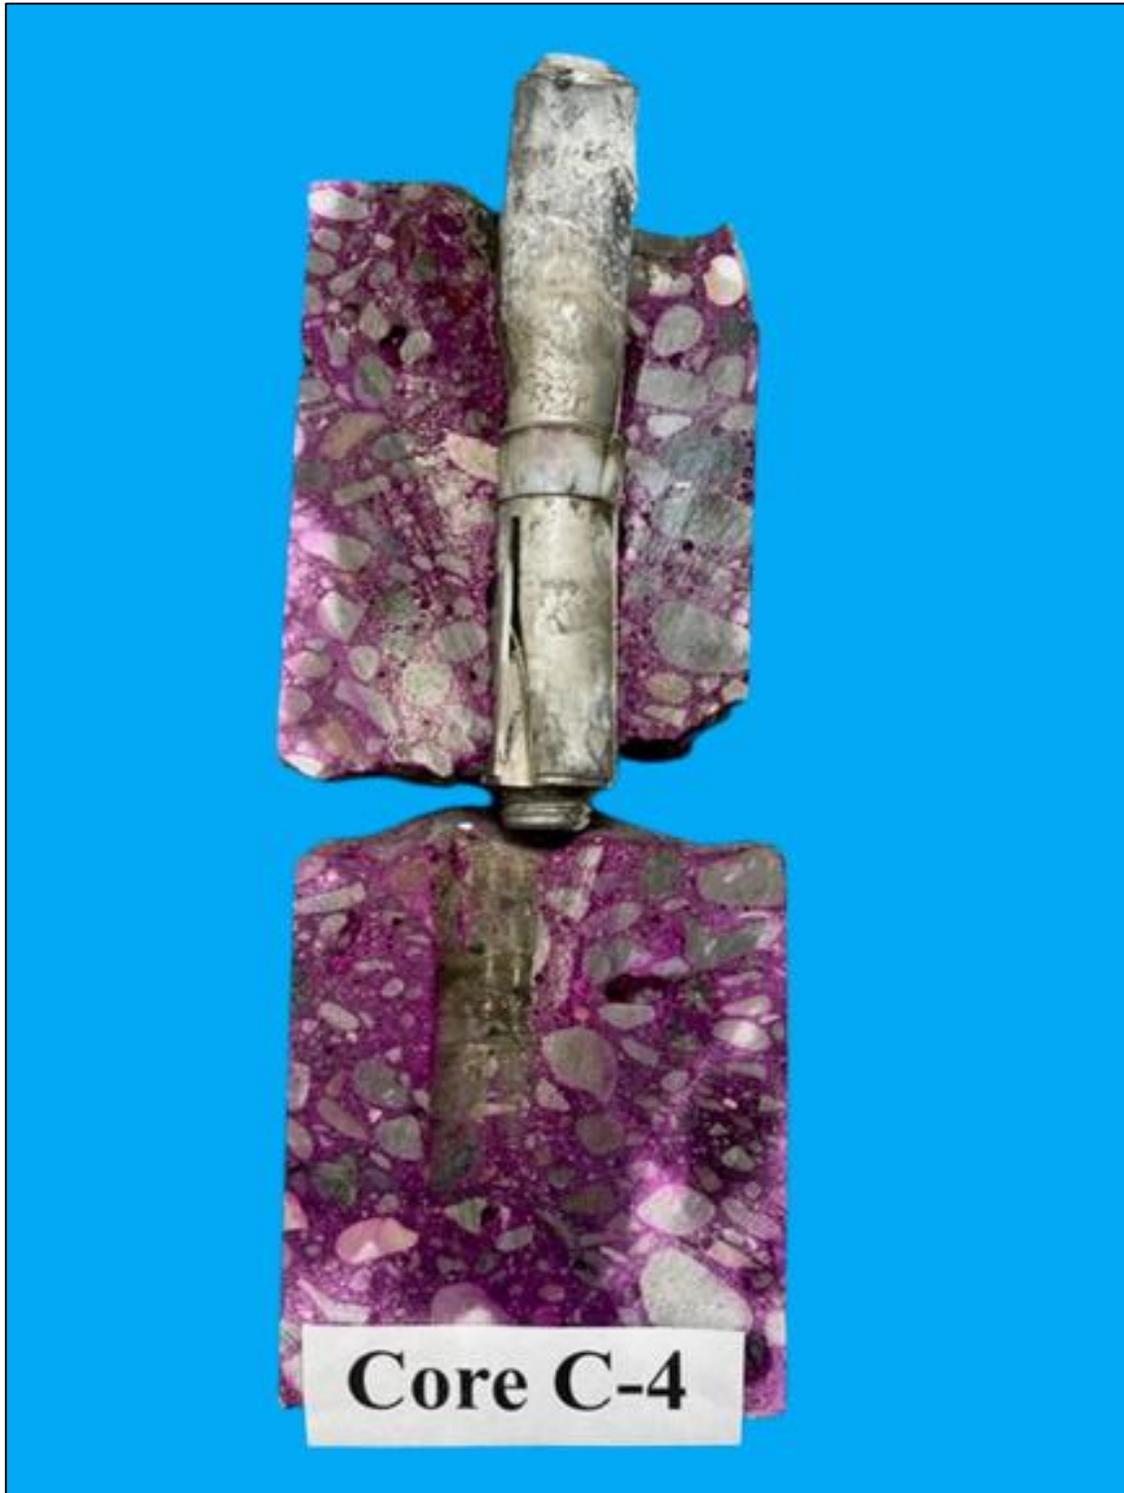
Photo P19 – Core C4

(Showing carbonation tested surface; carbonation depth was determined to be less than 0.5mm)

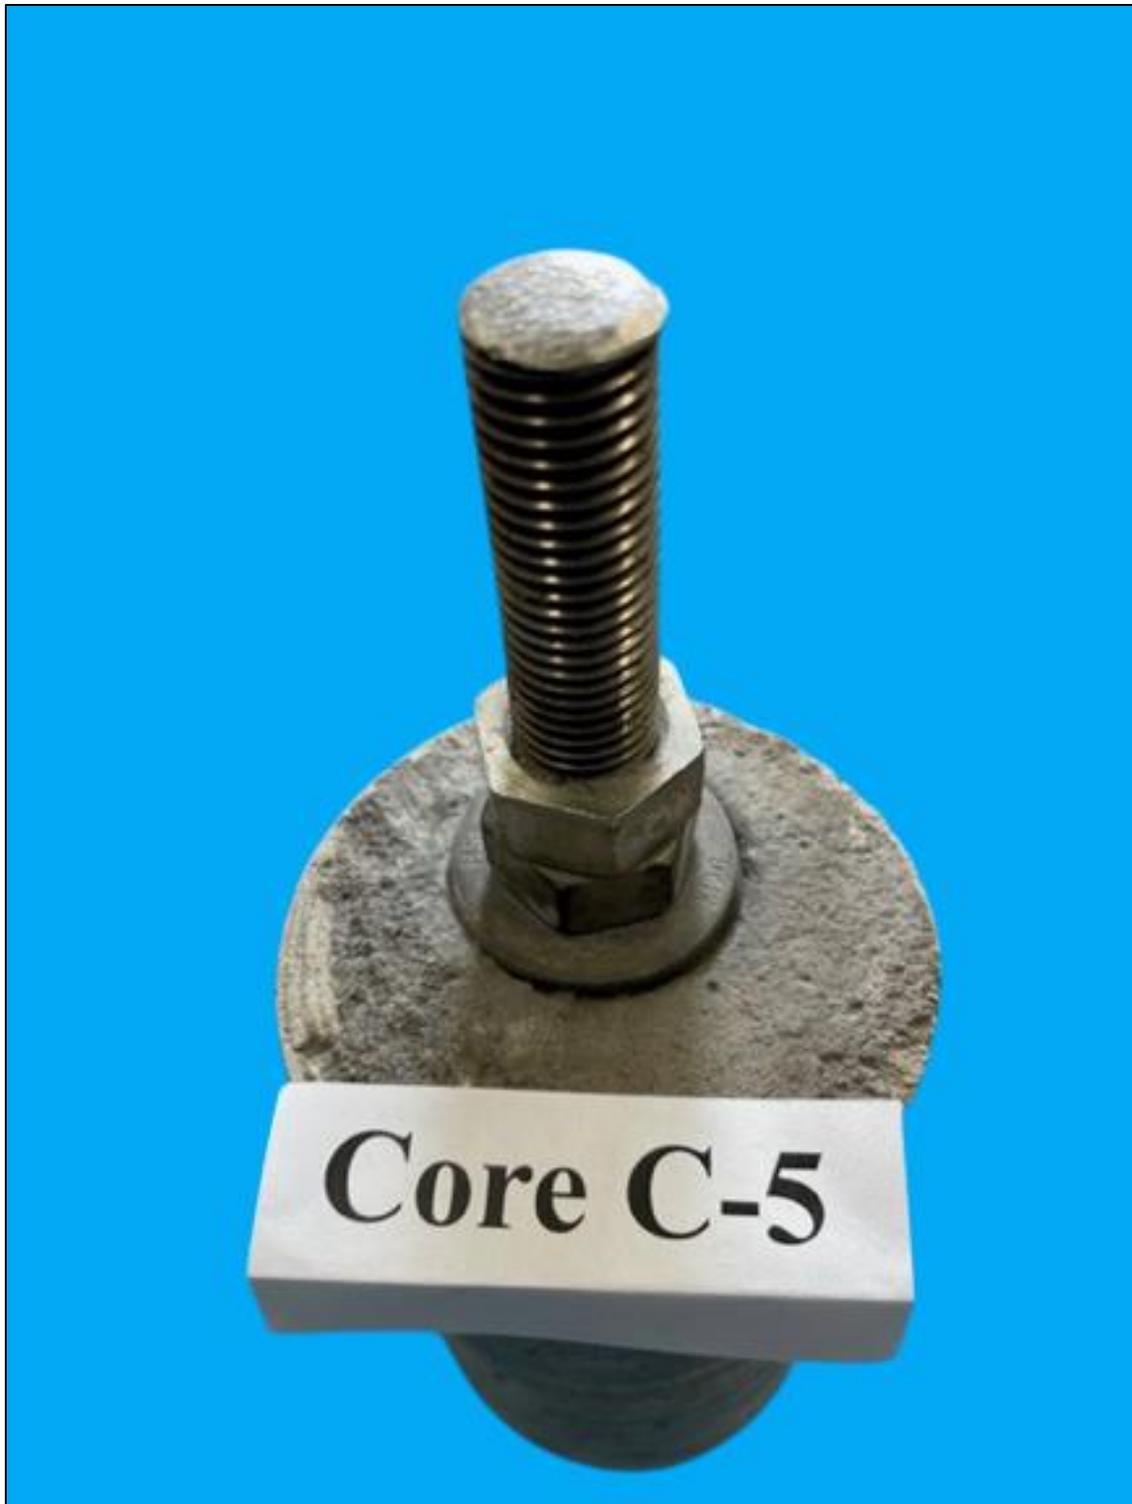
Photo P22 – Core 5 Top View

(Note: the intact concrete and anchor bolt condition)

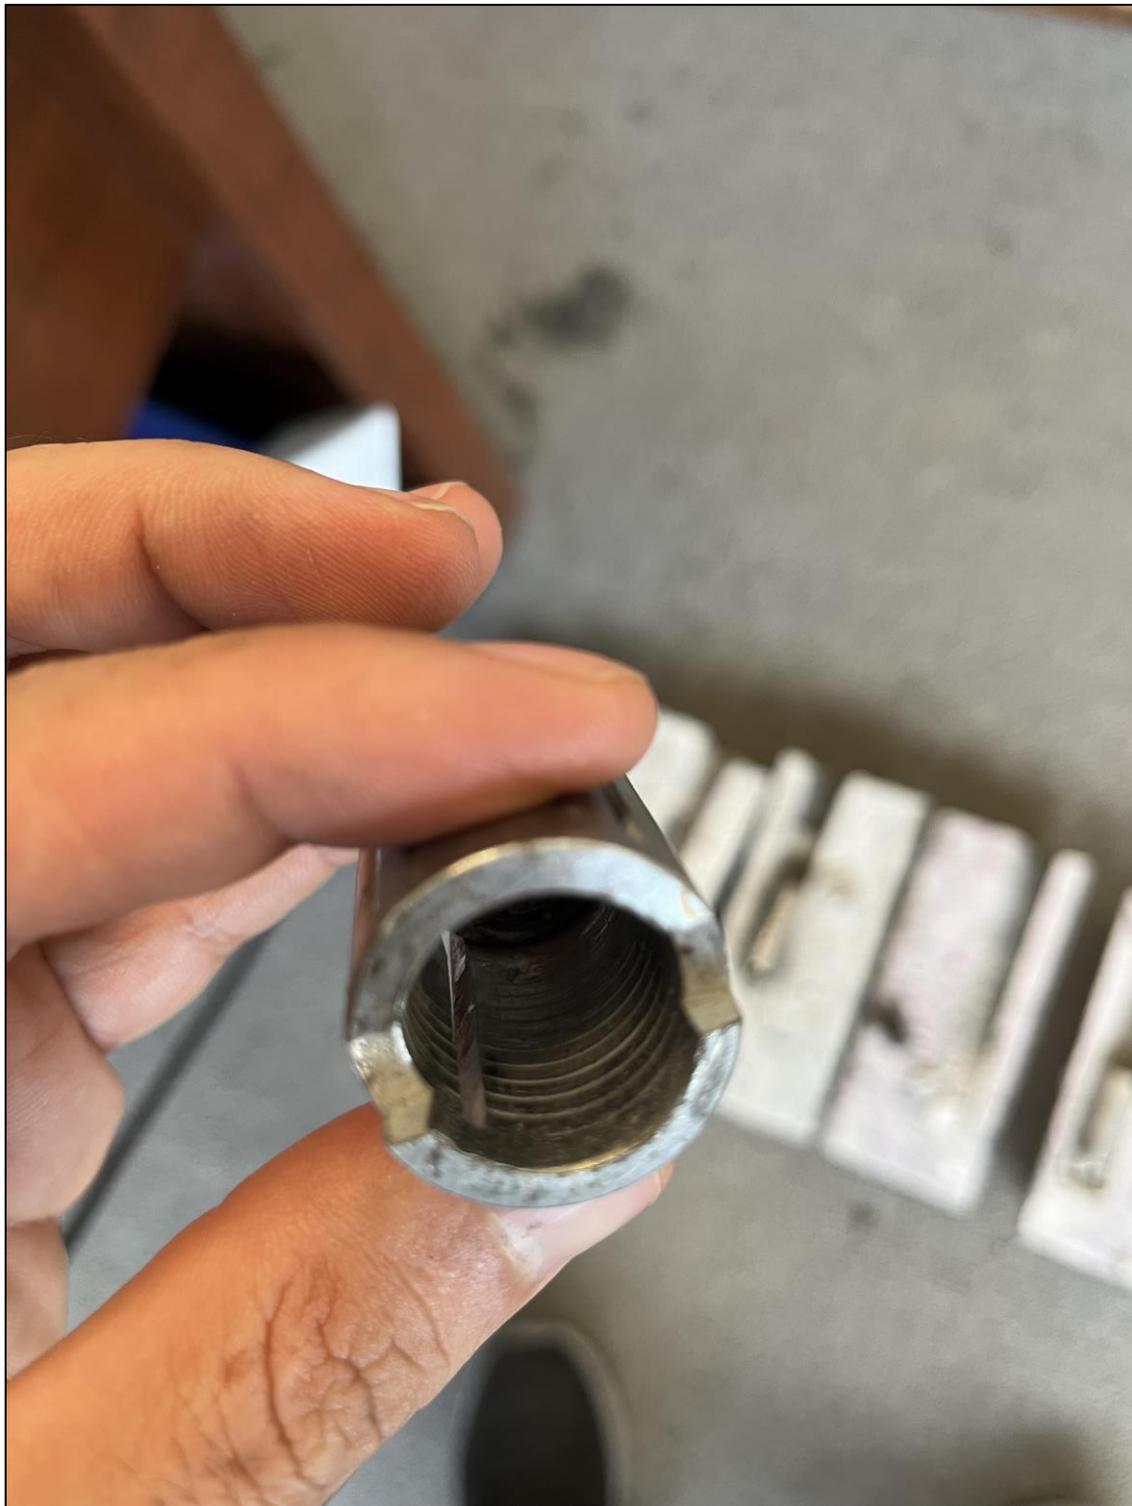
Photo P24– Core C1
(It was noted that the sleeve of C1 has indentations)
