SRT DERAILMENT-ELLESMERE STATION

FORENSIC ASSESSMENT REPORT

Rail Infrastructure Consultation
Toronto Transit Commission
Toronto, Ontario
2023-10-12

FIRM PROJECT NO.: 067065

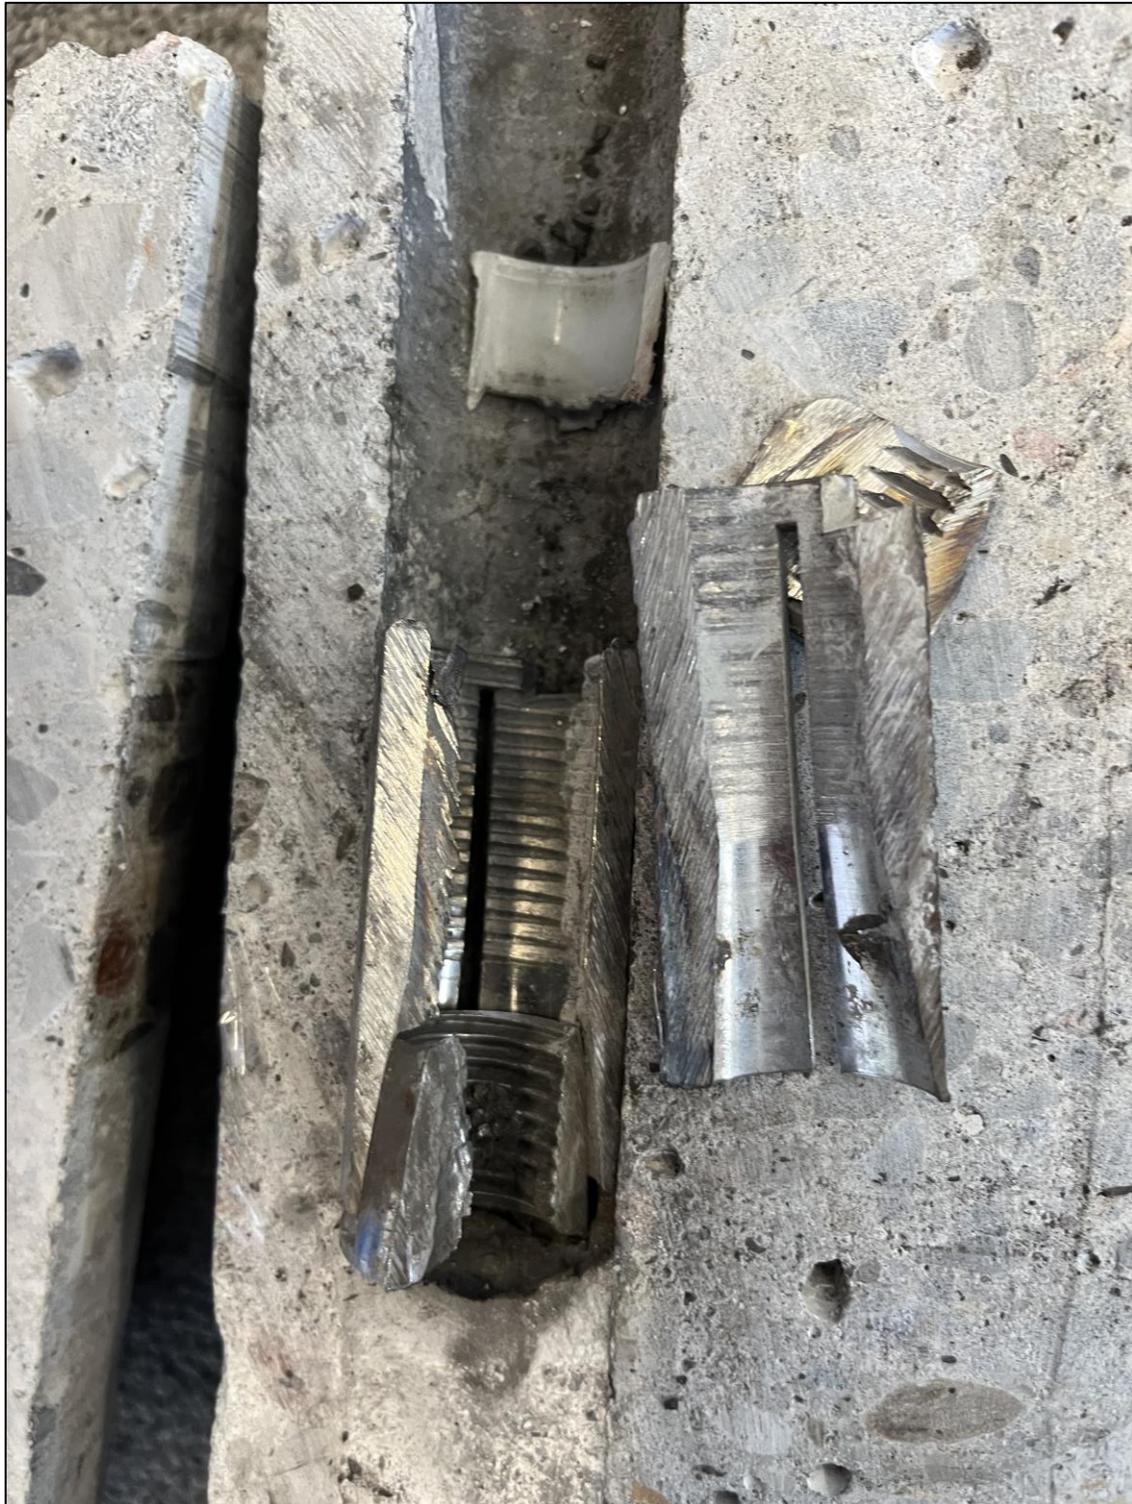
Photo P25 – Core C2

(It was noted that the sleeve of C2 has indentations)

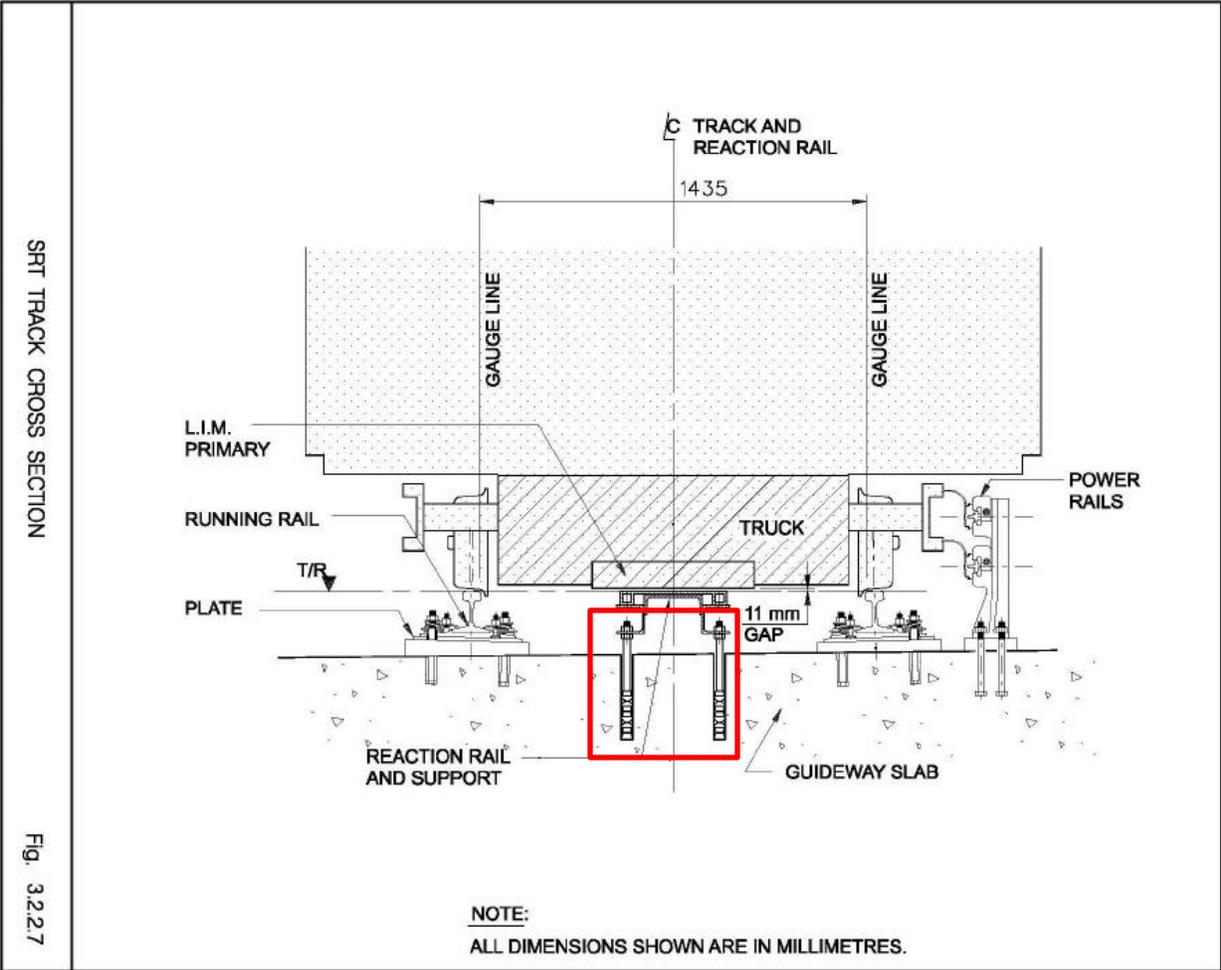
FIGURE 1. SCHEMATIC OF SRT TRACK CROSS SECTION AND FAILED BOLTS OUTLINED IN RED.

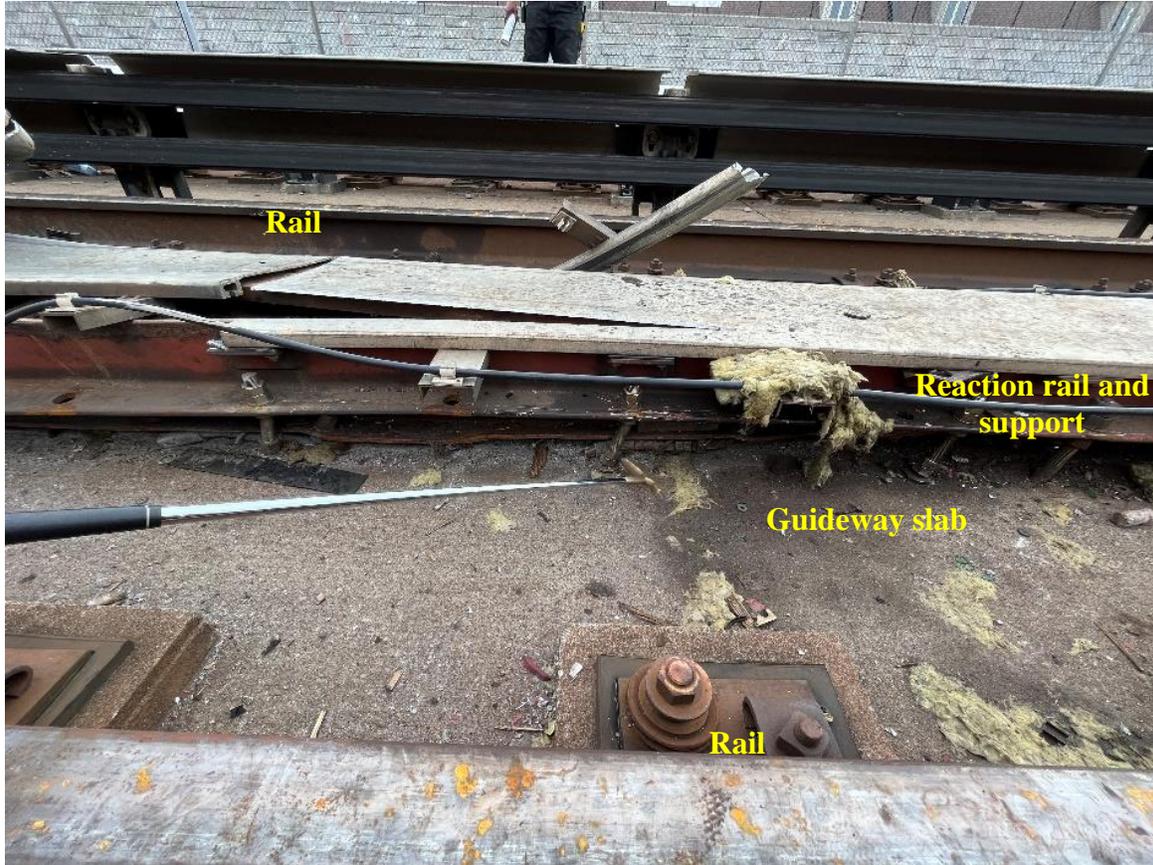
FIGURE 2. IMAGE PROVIDED BY CLIENT OF DERAILMENT DAMAGE.

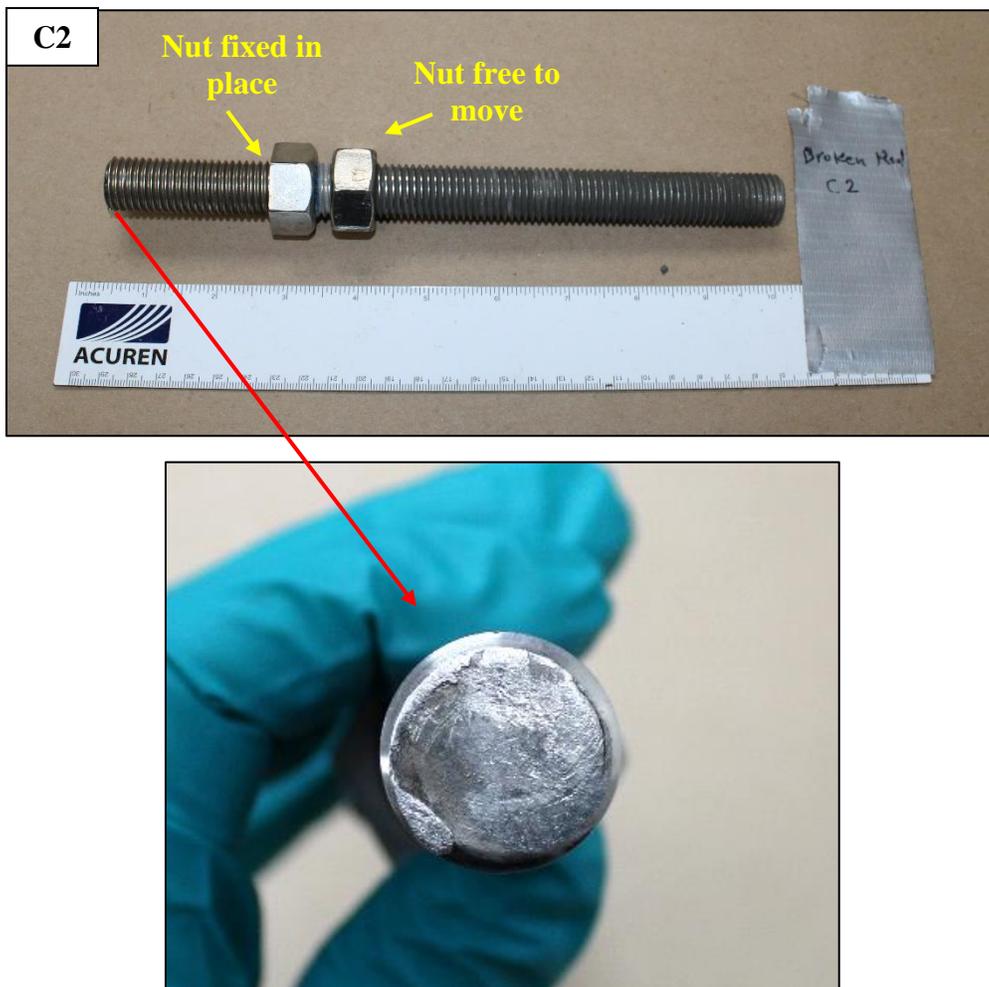
FIGURE 5. PHOTOS OF BOLT C2 AND THE FRACTURE SURFACE AT ONE END.

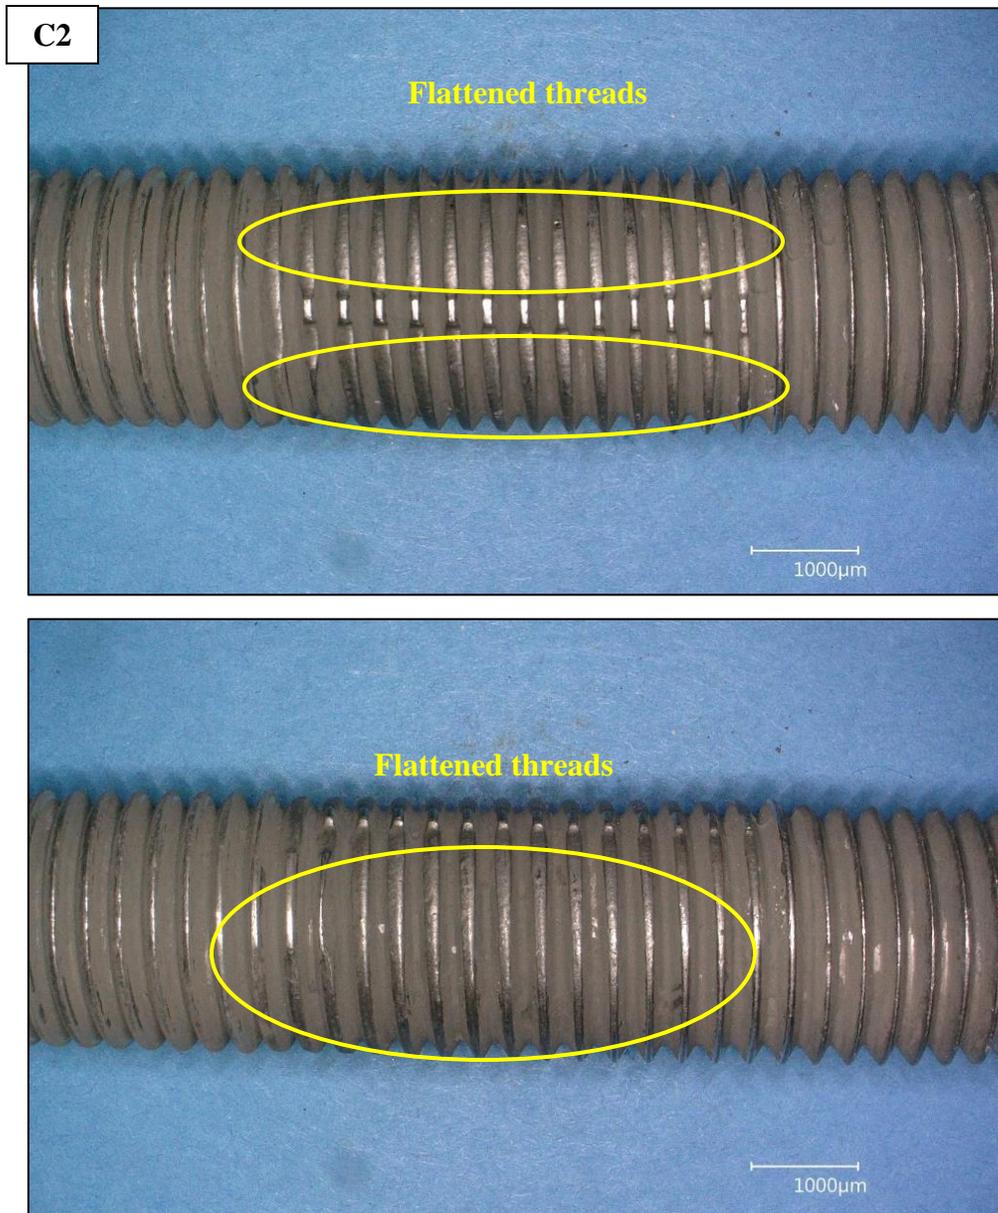
FIGURE 6. PHOTOS OF STRIPPED THREADS ON BOLT C2 REMOTE THE FRACTURE.

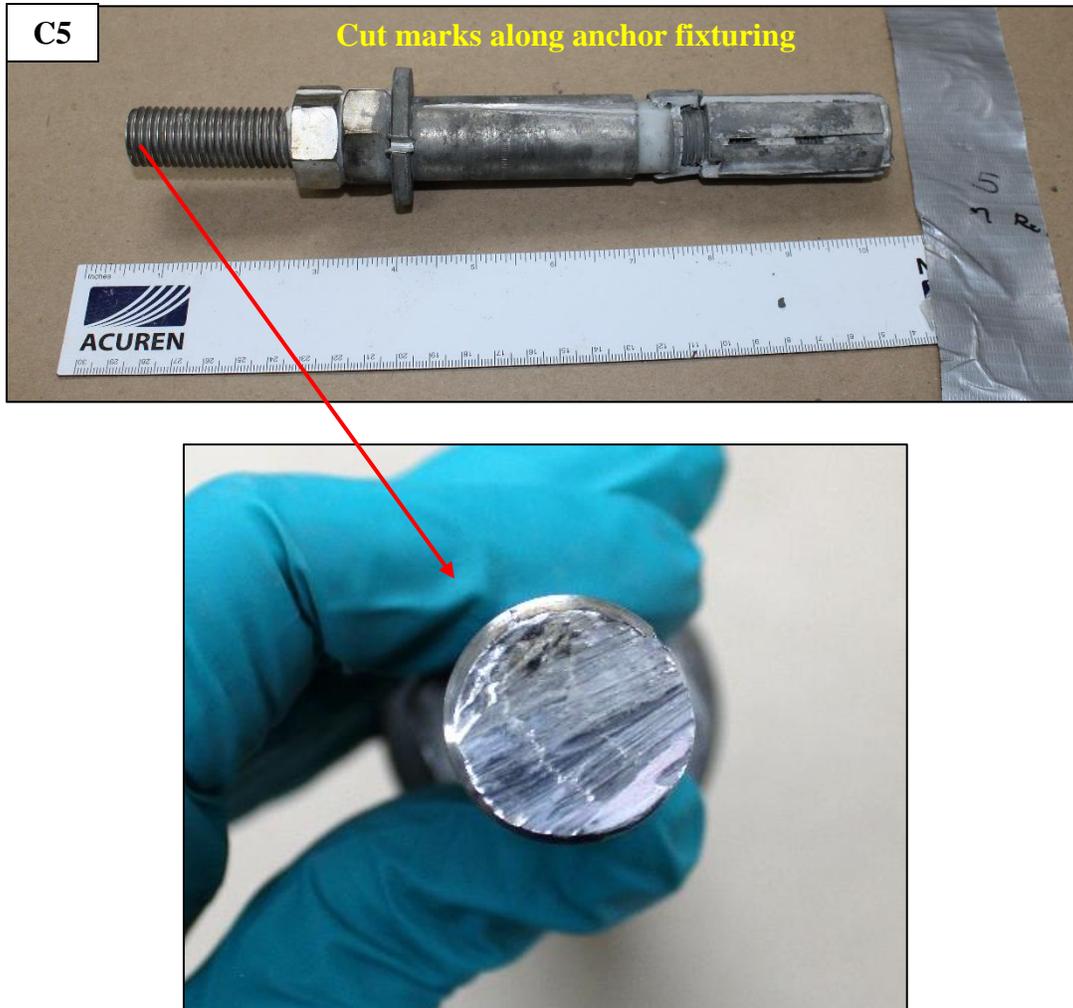
FIGURE 9. PHOTOS OF BOLT C5 AND THE CUT MARKS AND HEAT TINTING OBSERVED ON ONE END. NO FRACTURE SURFACE WAS VISIBLE.

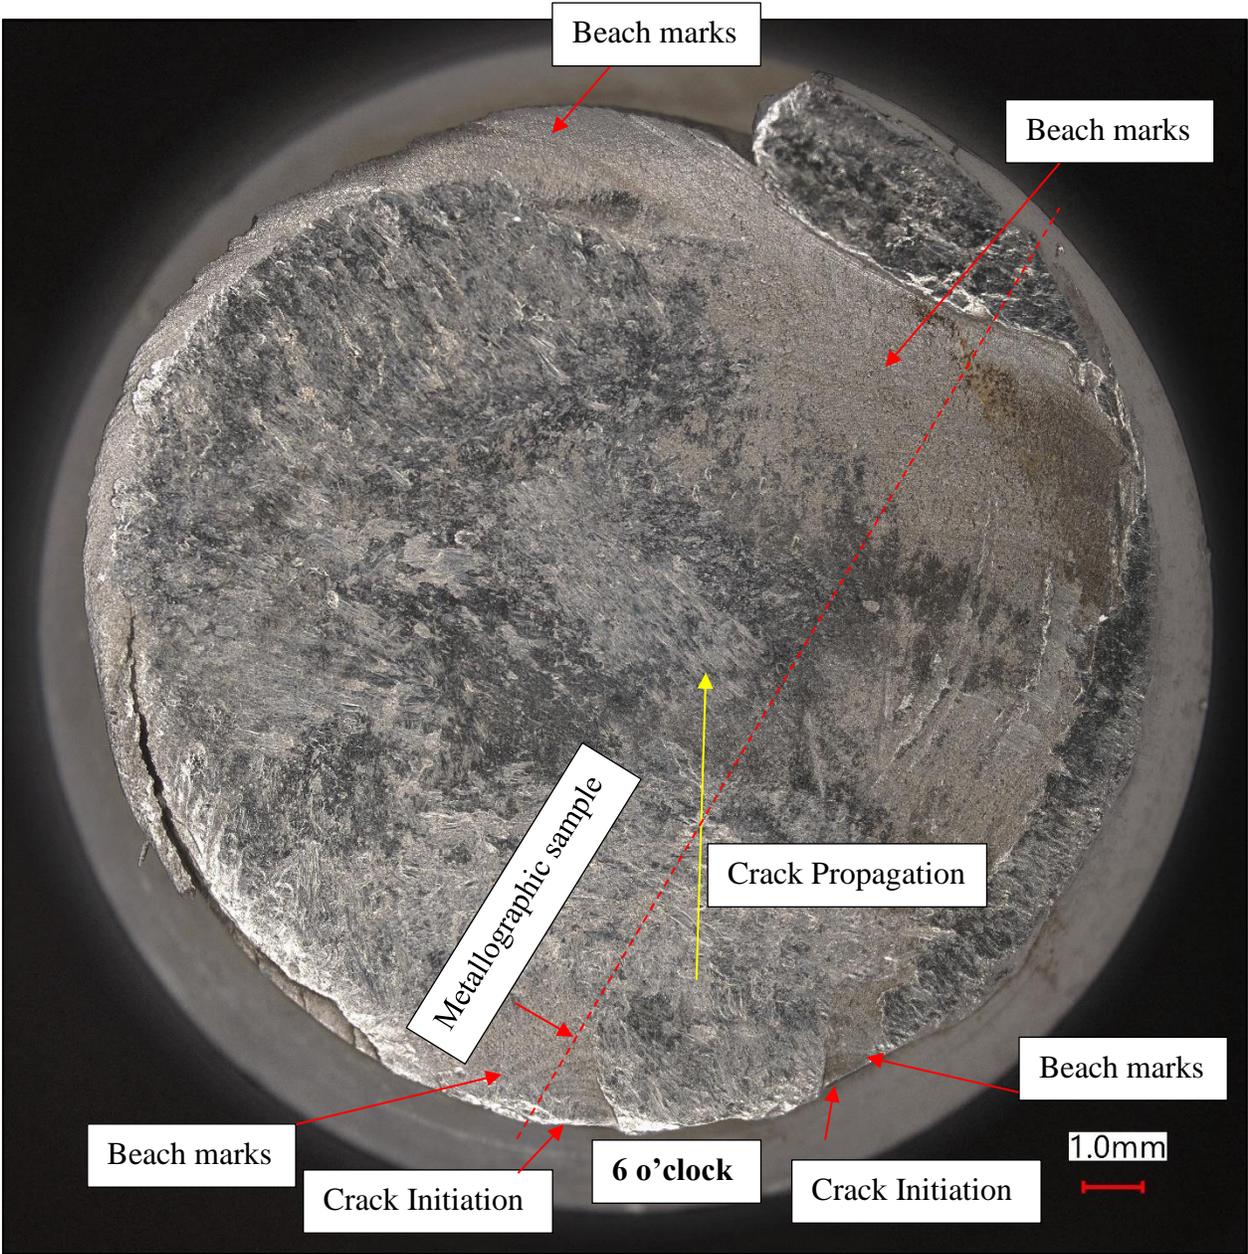
FIGURE 19. FRACTURE SURFACE, BOLT C2

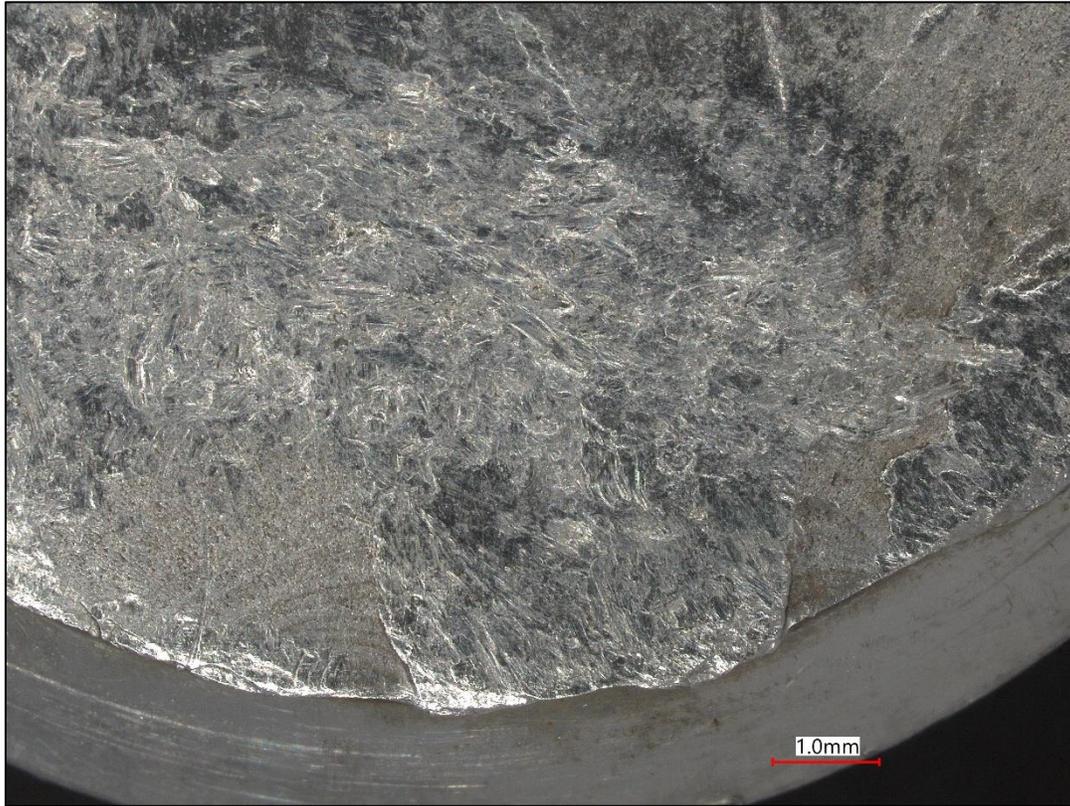
FIGURE 20. MULTIPLE CRACK INITIATION AREA, 6 O'CLOCK, BOLT C2

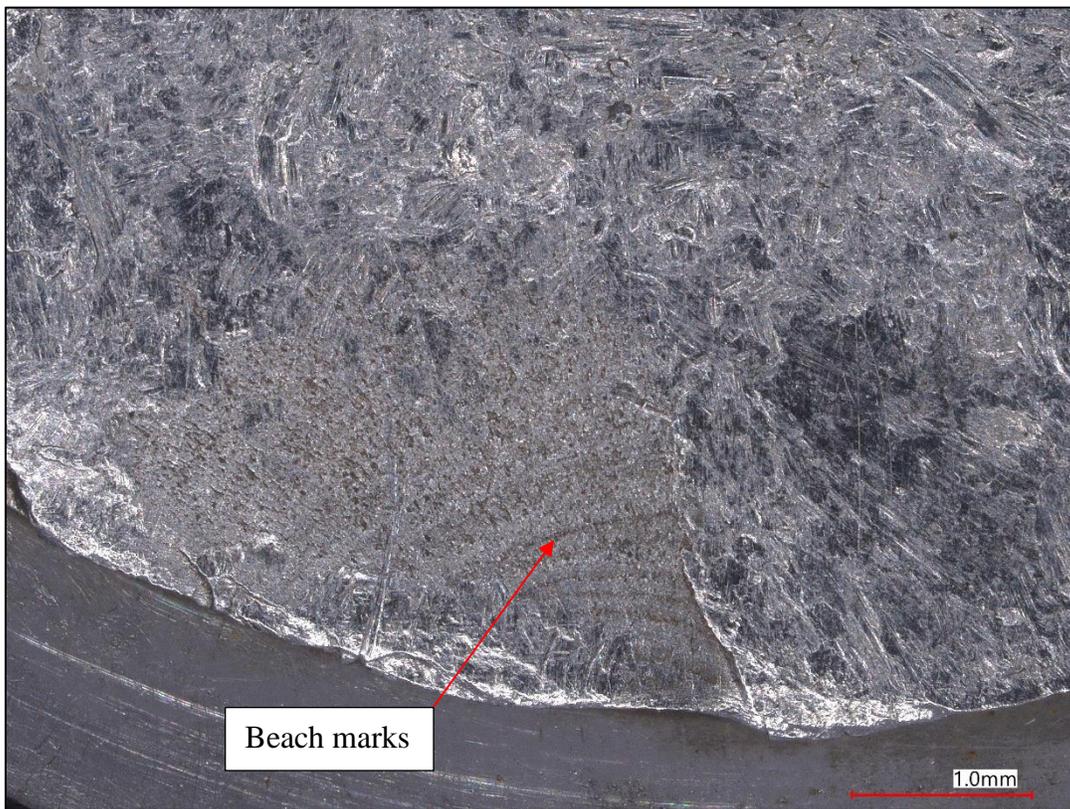
FIGURE 21. CLOSE VIEW OF BEACH MARKS. LEFT OF 6 O'CLOCK, BOLT C2

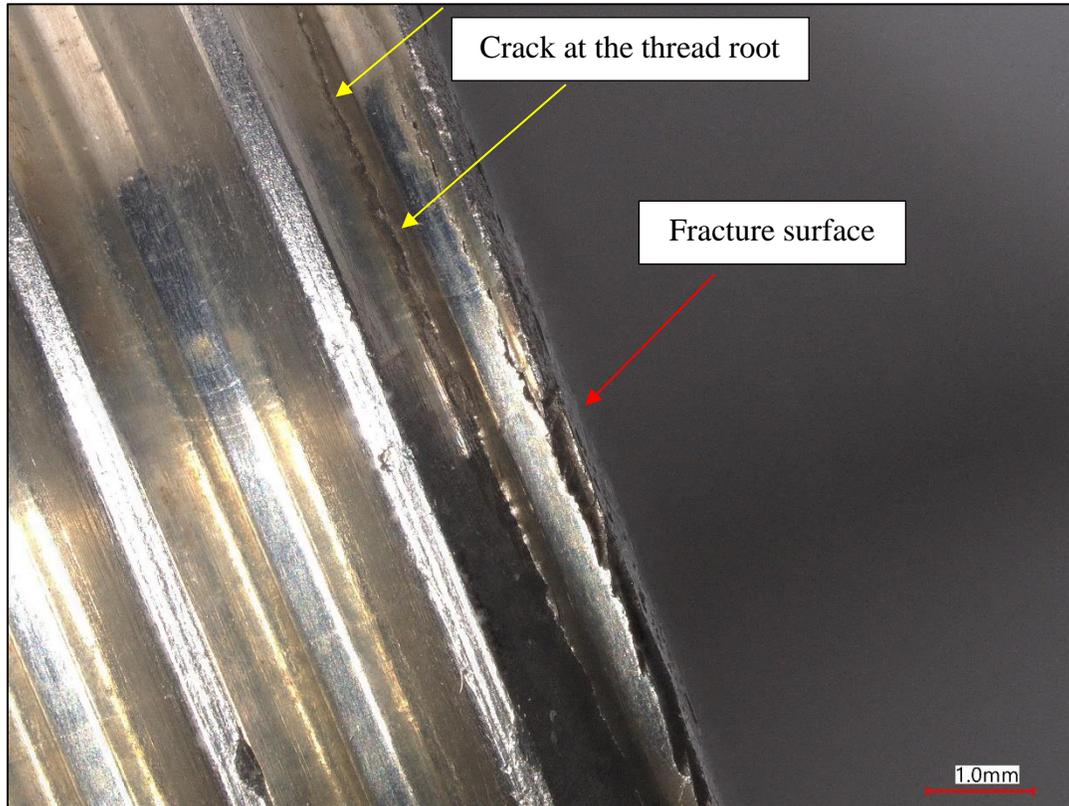
- ix) Figure 24 show thread roots at 6 o'clock region. A crack was observed at the root of the thread adjacent to the fracture surface. No other threads showed cracks.

FIGURE 24. CRACK INITIATION AREA. ADJACENT THREAD ROOTS, BOLT C2

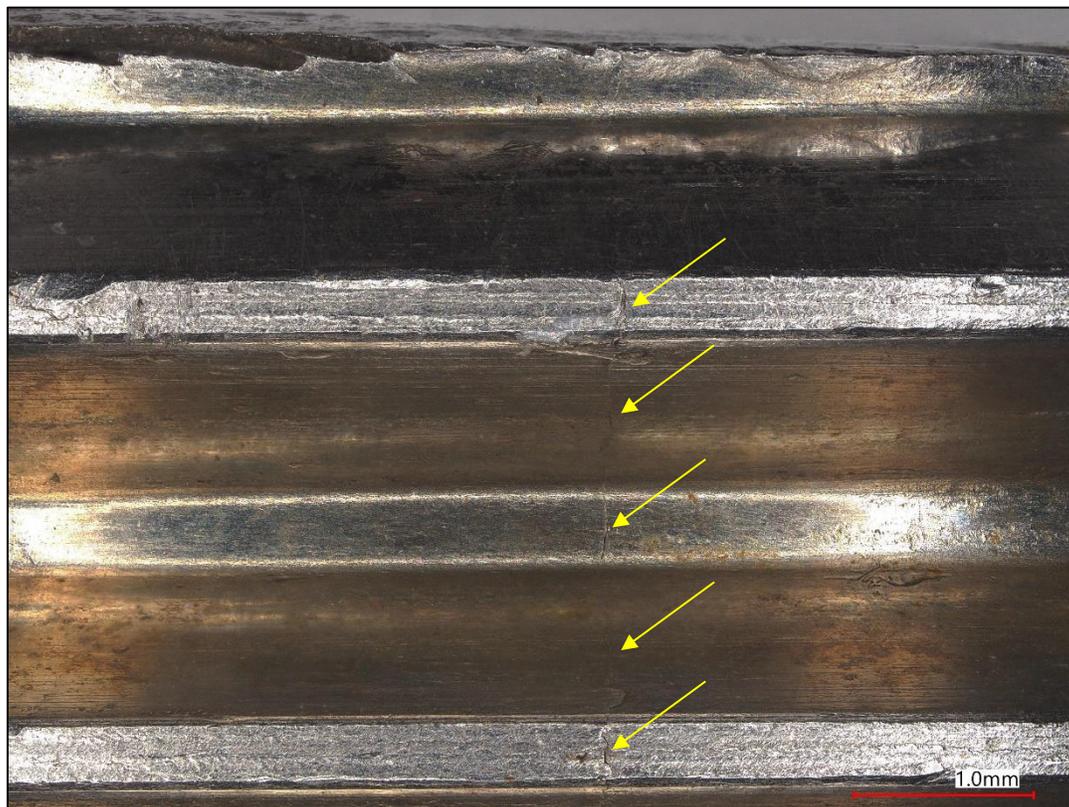
- x) A crack like indication, longitudinal in direction, was observed on the threads of the bolt, Figure 25. The indication was observed on the crests, flanks and the root of the thread.
- xi) No deformation (other than a small damage that formed after crack initiation and crack propagation) was observed in the vicinity of fracture area.
- xii) Figure 26 show the fracture surface of Bolt C5. The fracture surface was completely damaged, covered with scratch marks, removing all fracture features. Some pink foreign residues were also observed.
- xiii) We did not observe any secondary crack at the thread roots in the vicinity of the fracture. Figure 28 shows some of the threads in the vicinity of the fracture surface.
- xiv) Crack like longitudinal indications were observed on bolt C5 as well. Figure 29 shows on of those longitudinal indications.

FIGURE 25. LONGITUDINAL CRACK LIKE INDICATION, BOLT C2

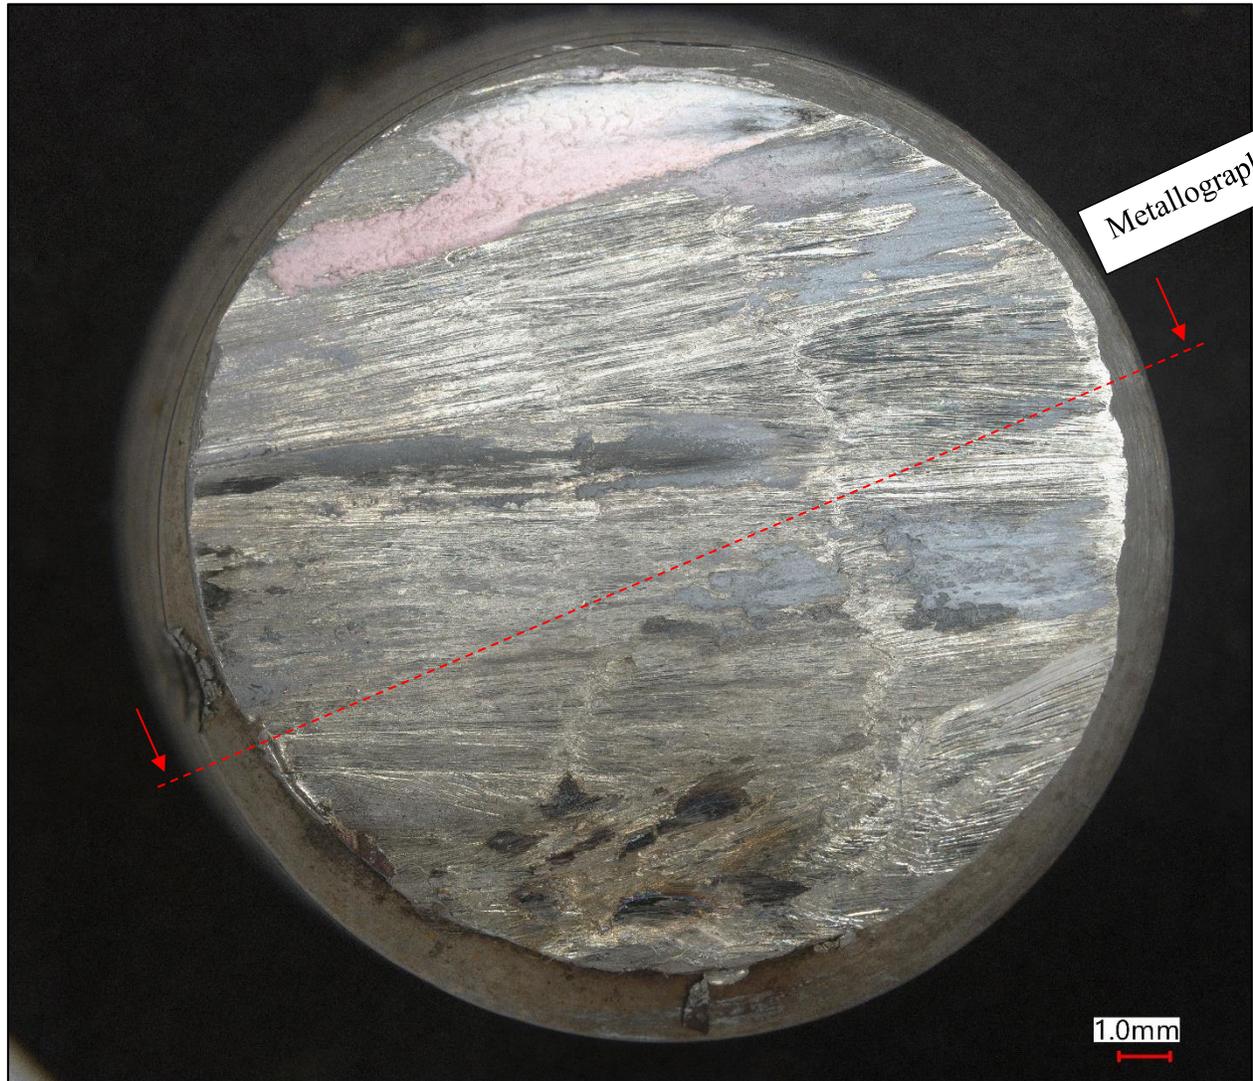
FIGURE 26. FRACTURE SURFACE, BOLT C5

- xiv) No deformation was observed in the vicinity of the fracture surfaces of both bolts, C2 and C5, suggesting the crack initiated and propagated in a brittle manner.

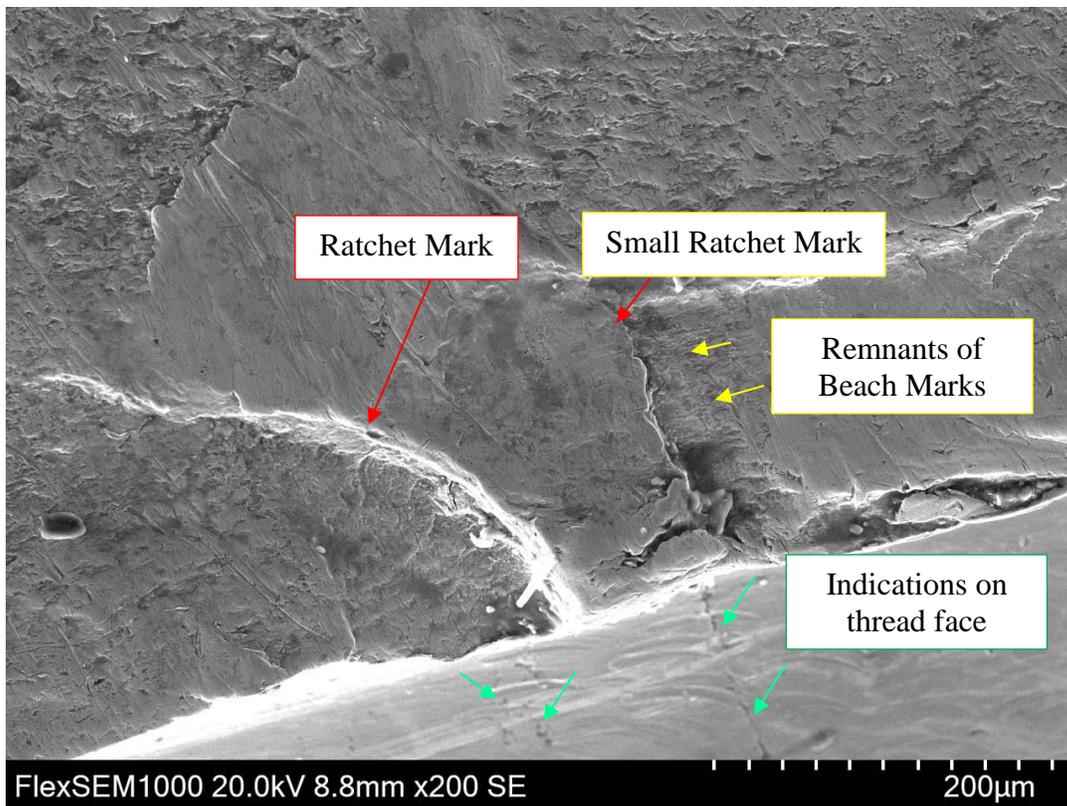
FIGURE 31. CLOSE VIEW OF THE RATCHET MARKS, BOLT C2

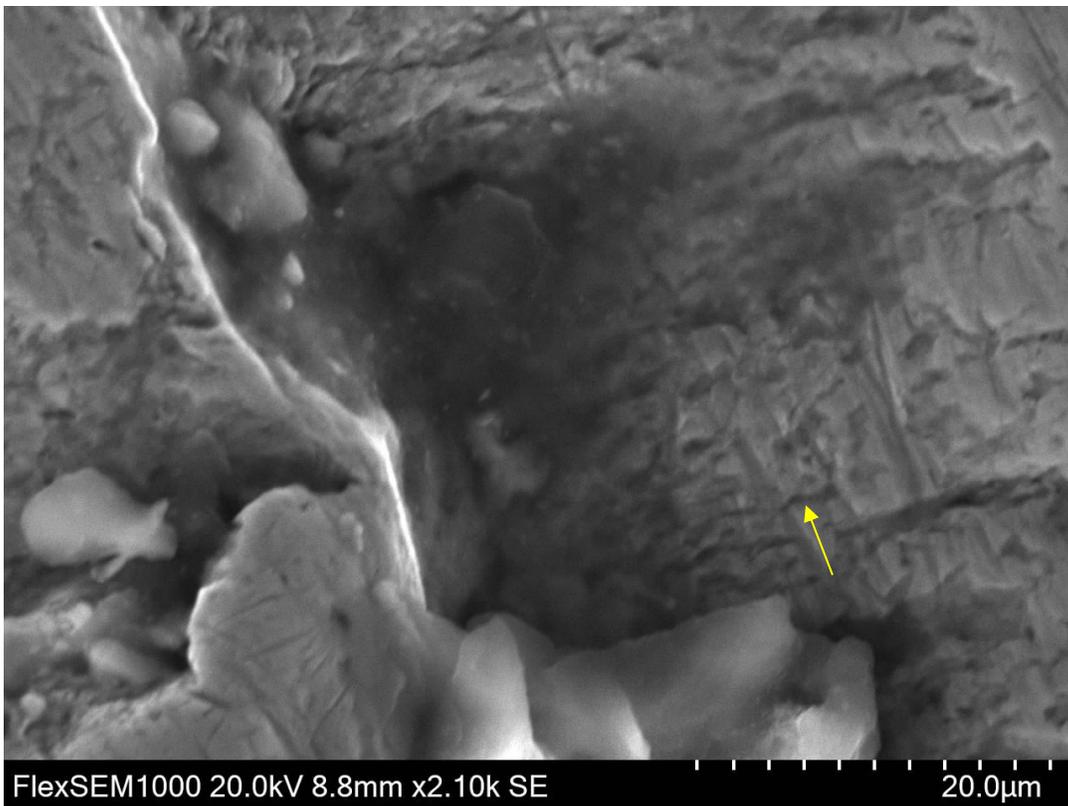
FIGURE 33. BURNISHED BEACH MARK, BOLT C2

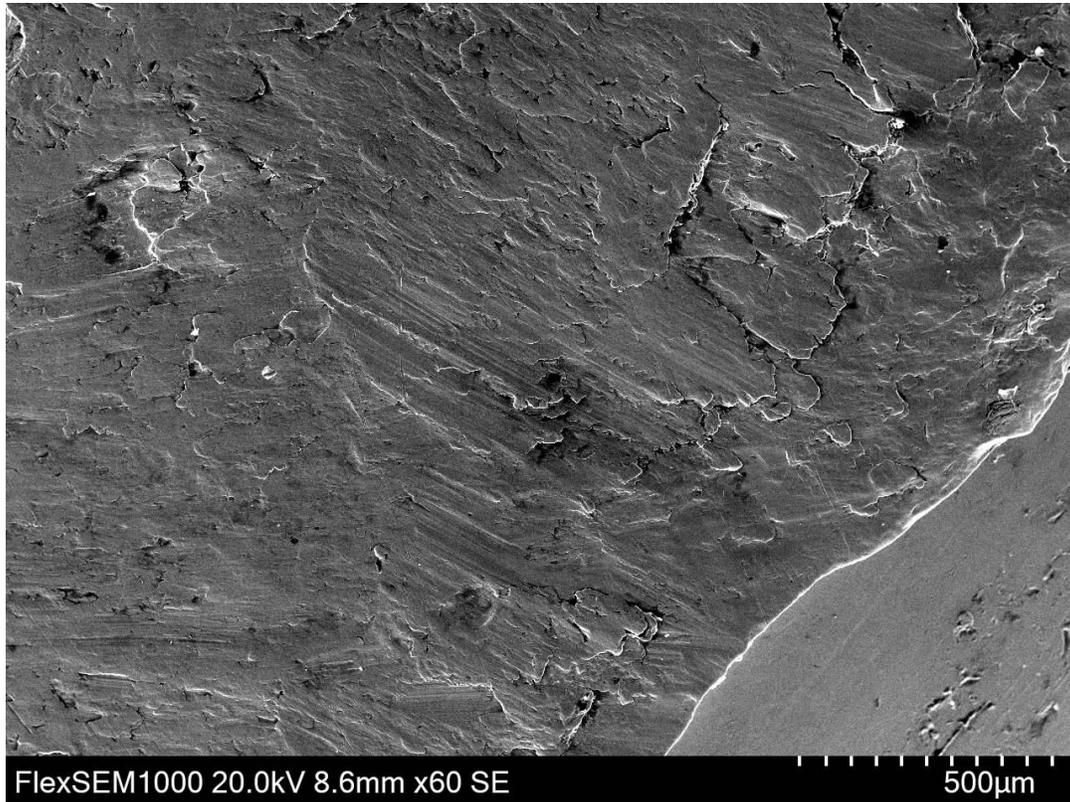
FIGURE 34. DAMAGED/BURNISHED AREA ON 12 -02 O’CLOCK REGION, BOLT C2

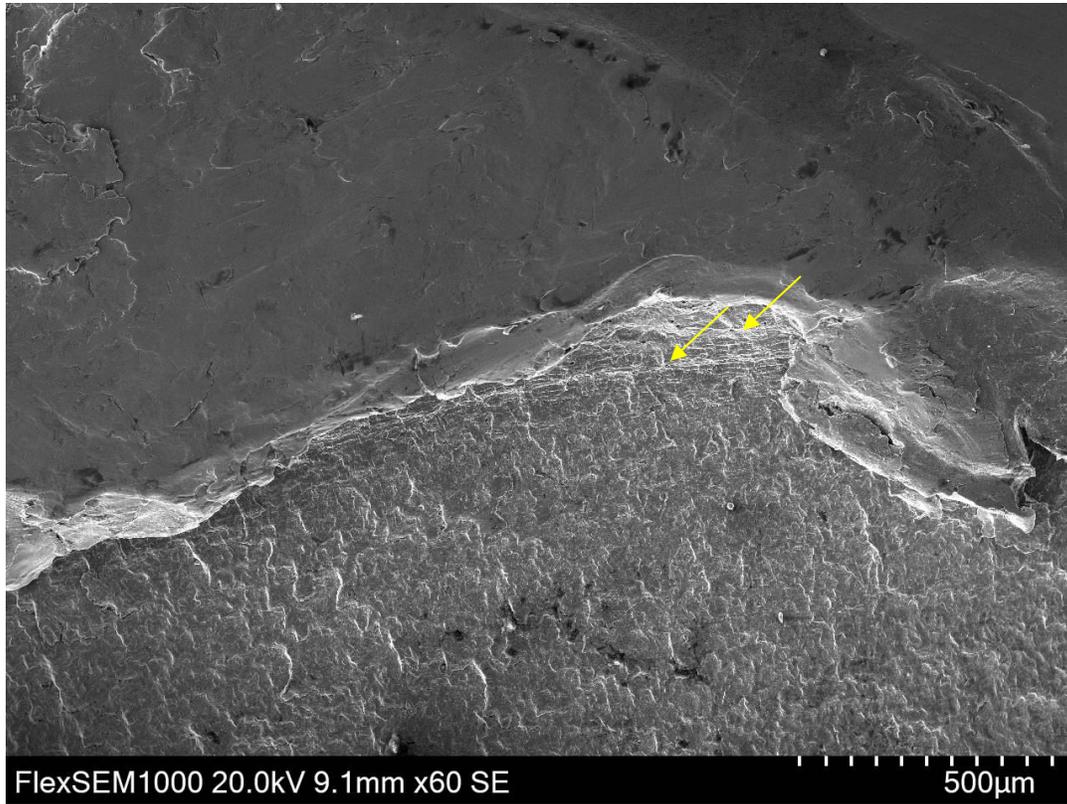
FIGURE 36. BEACH MARKS AT 12 O'CLOCK REGION, BOLT C2

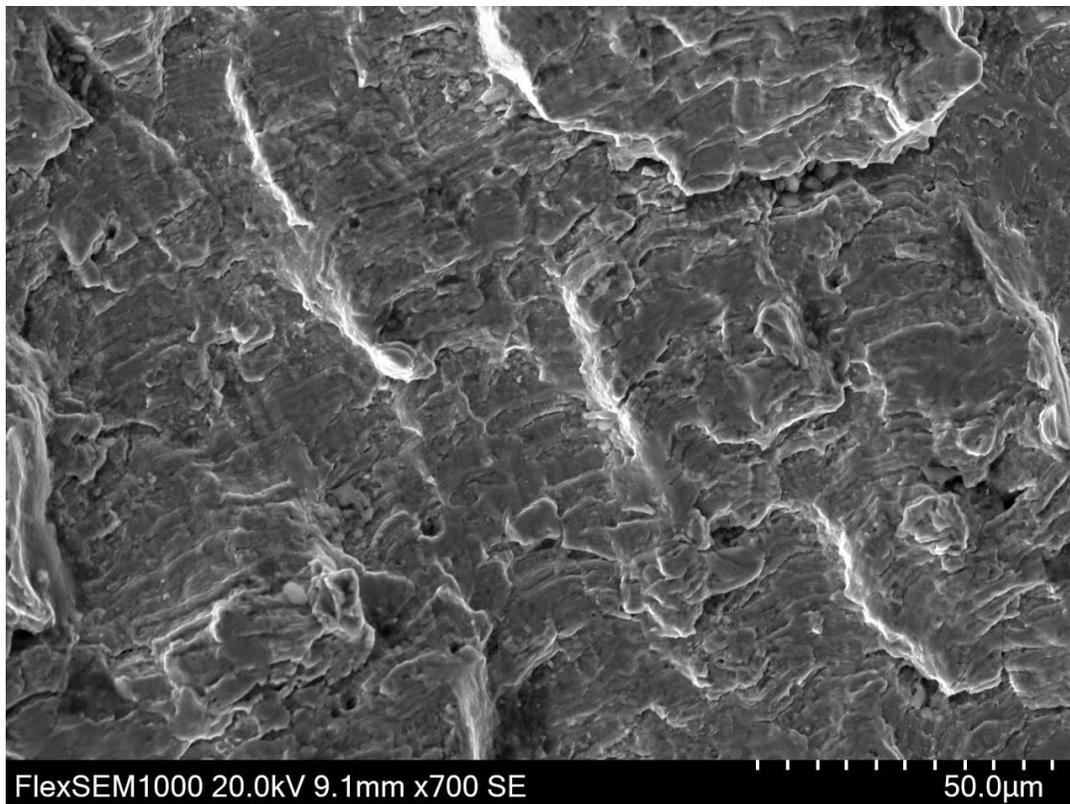
FIGURE 39. BURNISHED FRACTURE FEATURES 12 O'CLOCK REGION, BOLT C2

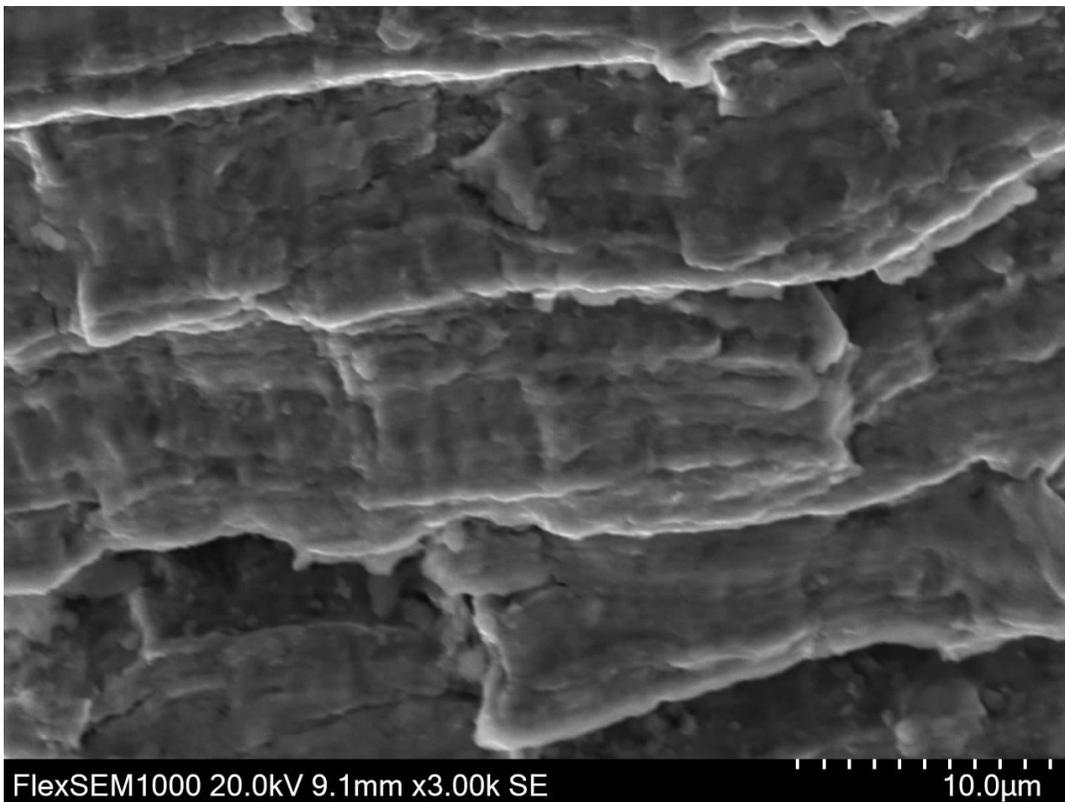
FIGURE 41. STRIATIONS IN THE AREA WITH BEACH MARKS. 12 O'CLOCK REGION, BOLT C2

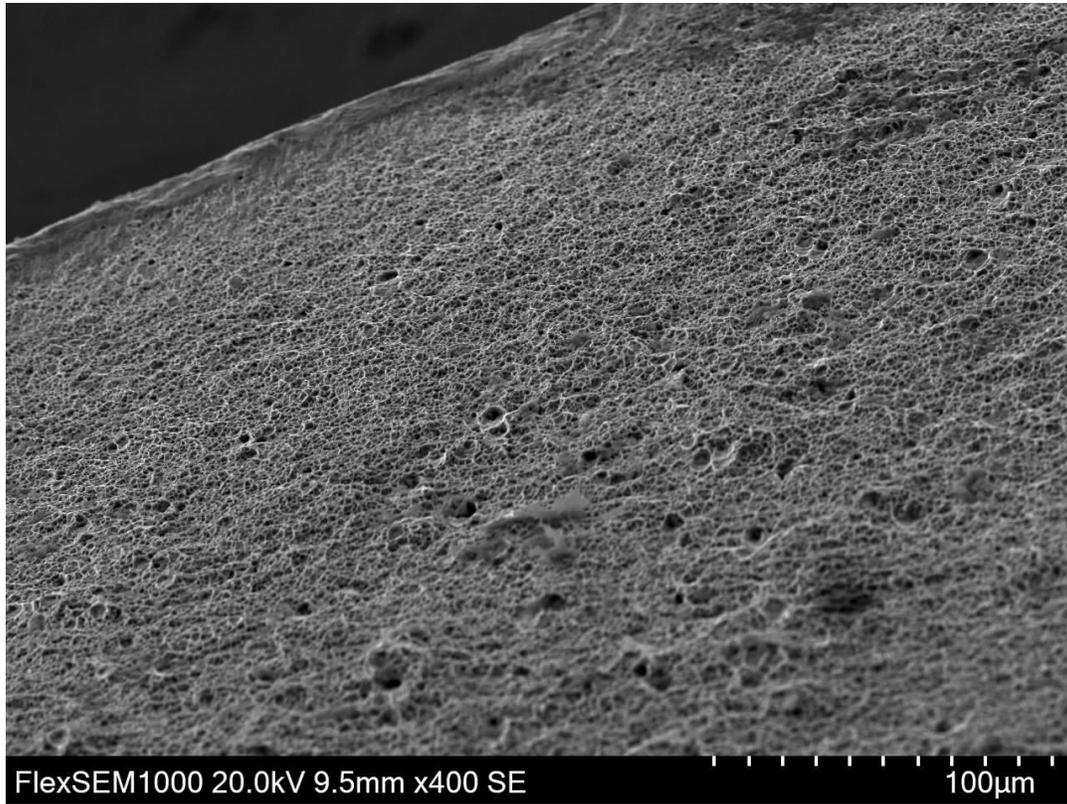
FIGURE 44. DIMPLES OBSERVED ON THE FINAL FRACTURE AREA, BOLT C2

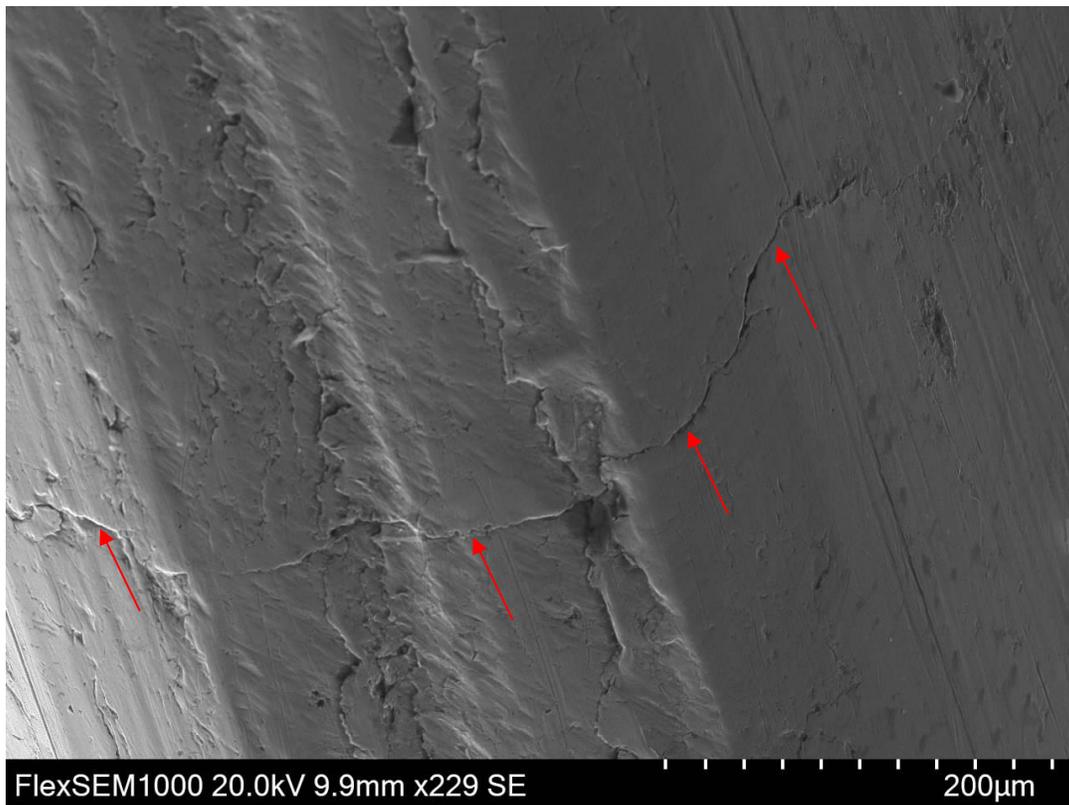
FIGURE 47. CLOSE VIEW OF ONE OF THE CRACK LIKE INDICATIONS, BOLT C2.

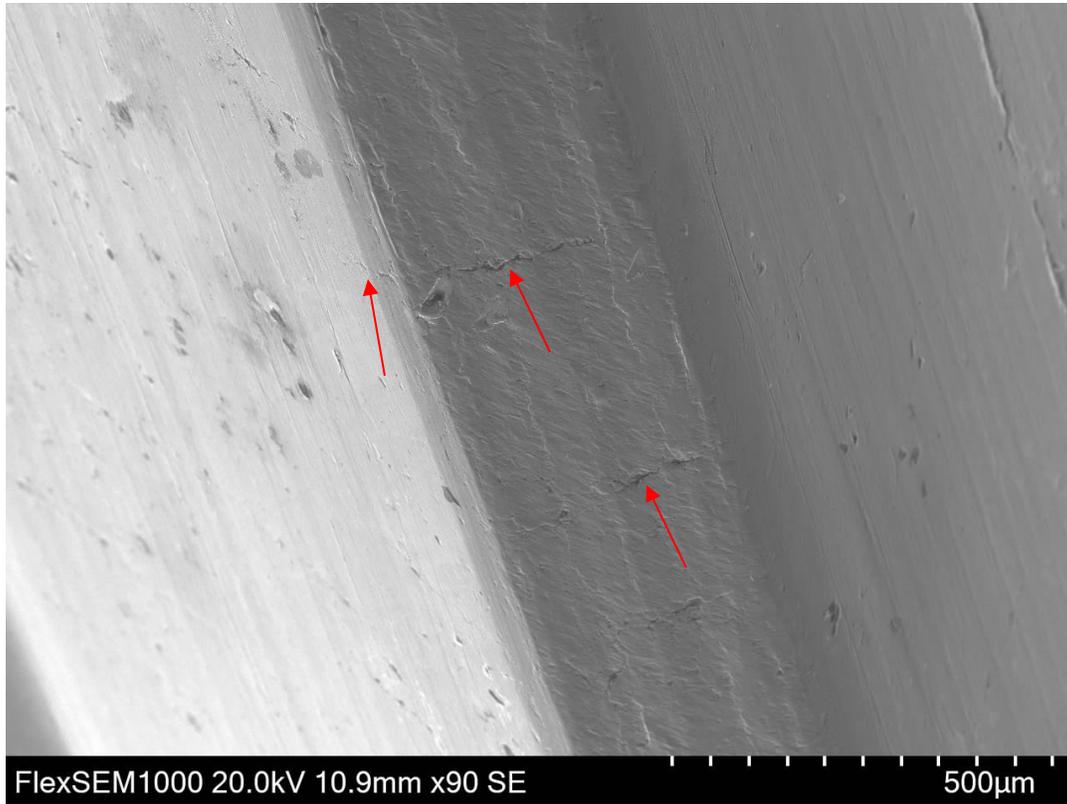
FIGURE 48. MICRO-CRACK LIKE INDICATIONS ON THE THREADS, BOLT C2

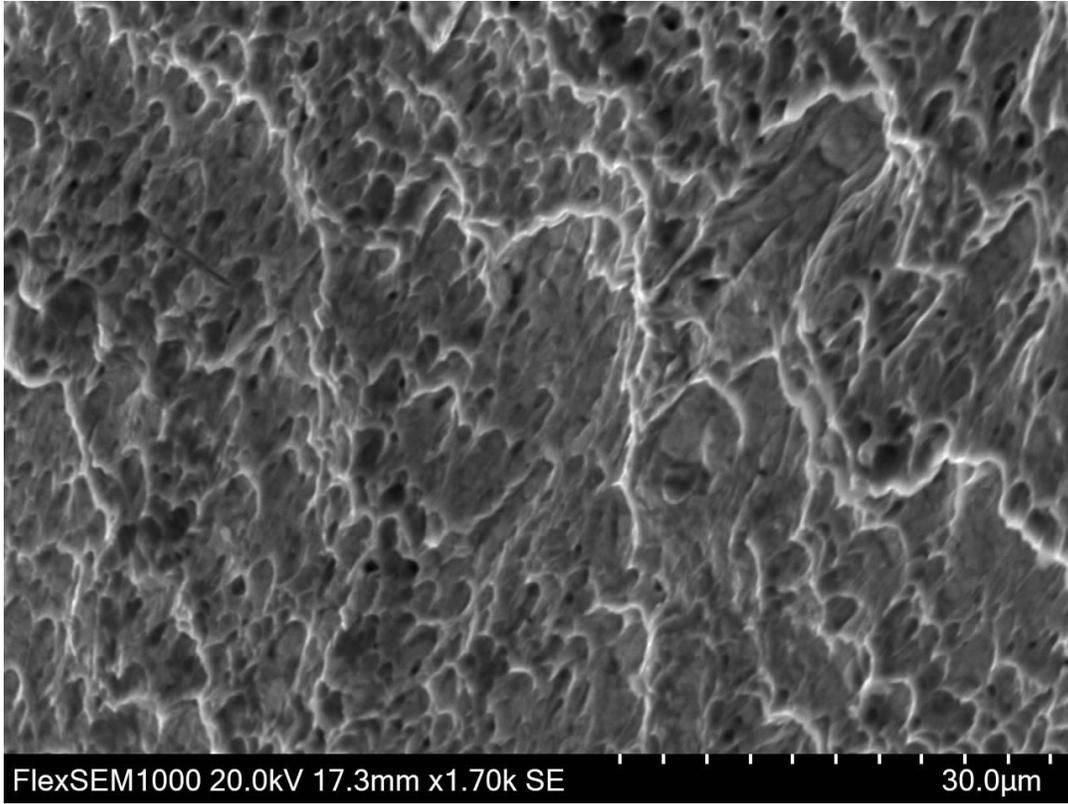
- xiii) Figure 51 shows a pocket between the thread face and fracture surface. This area showed dimples (See Figure 52), ductile transgranular fracture. Appearance suggests the pocket area was not part of the main fracture. It could be part of the final fracture area.

FIGURE 52. SHEARED DIMPLES OBSERVED IN THE POCKET IN FIGURE 51
