SRT DERAILMENT-ELLESMERE STATION

FORENSIC ASSESSMENT REPORT

Rail Infrastructure Consultation
Toronto Transit Commission
Toronto, Ontario
2023-10-12

FIRM PROJECT NO.: 067065

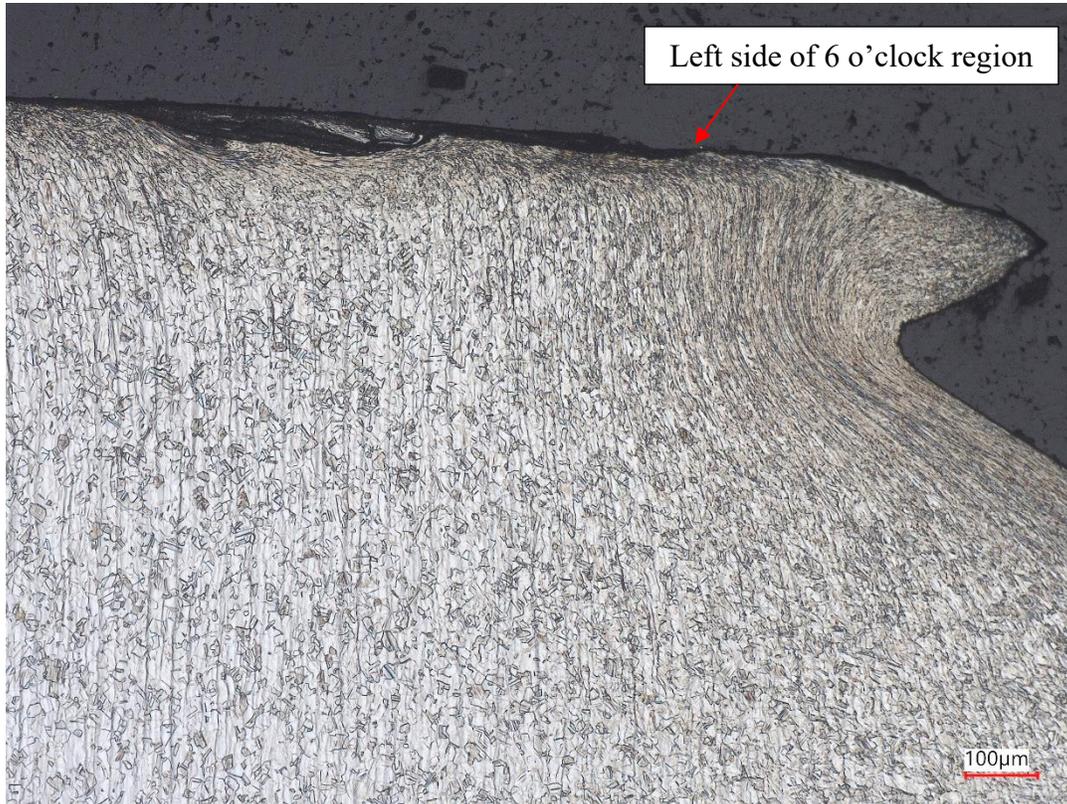
FIGURE 55. DEFORMATION OBSERVED IN AREAS CLOSE TO THE FRACTURE SURFACE, BOLT C2

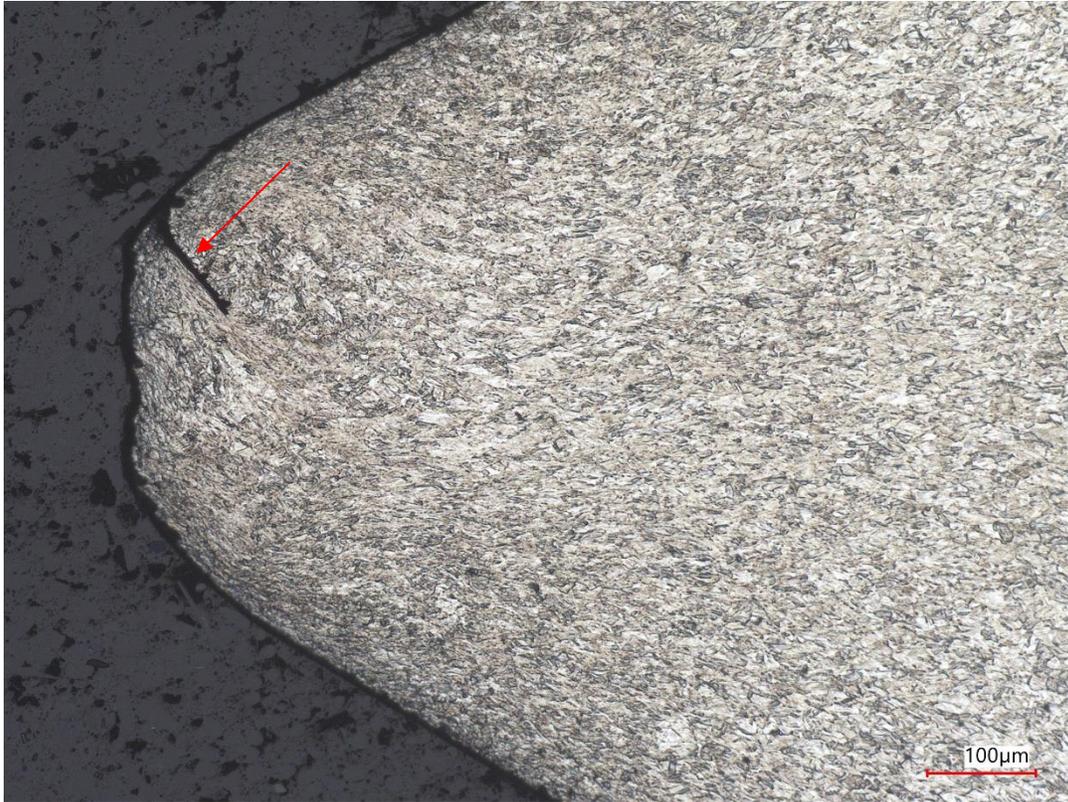
FIGURE 57. FOLDS OBSERVED AT THE CREST OF THE THREAD, BOLT C2

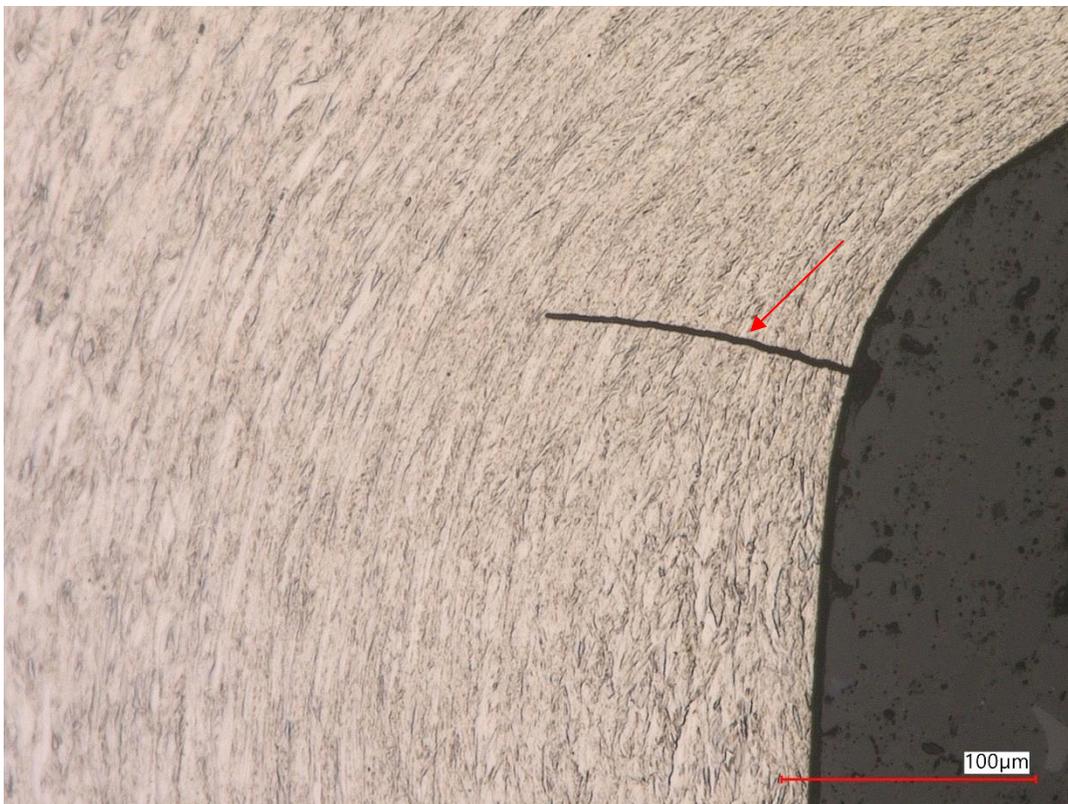
FIGURE 58. CRACK OBSERVED AT THE ROOT OF THE THREAD, BOLT C2

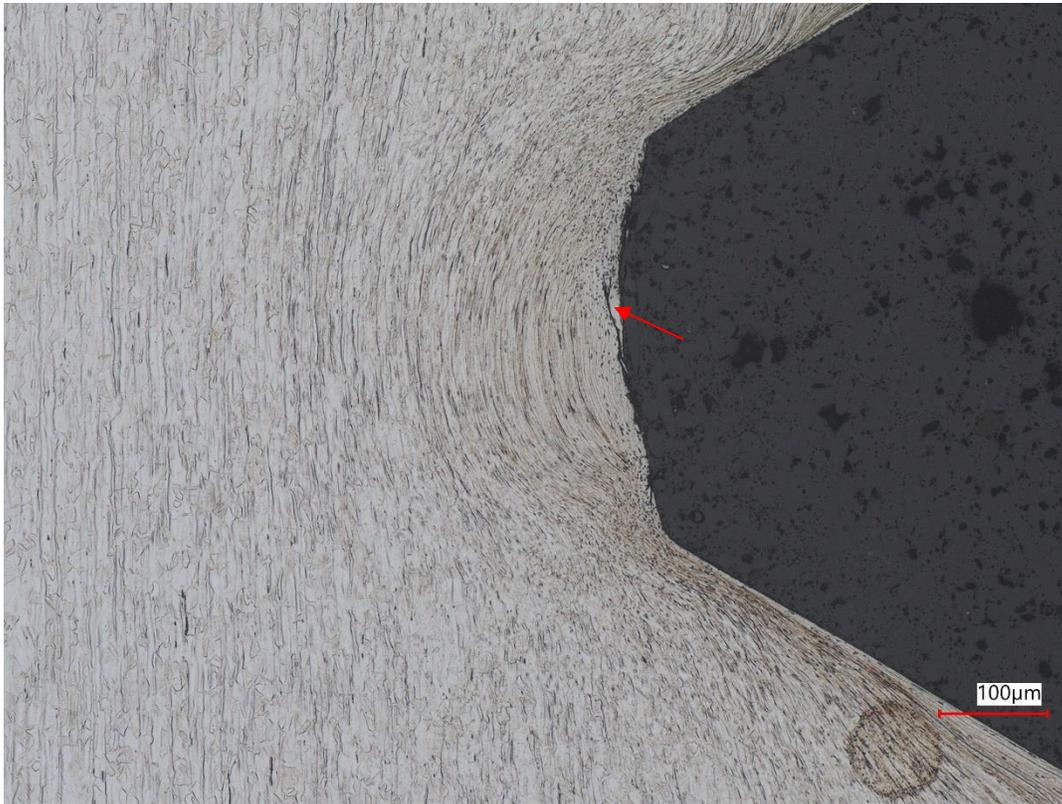
FIGURE 71. FOLD OBSERVED AT THE ROOT OF THE THREAD, BOLT R1

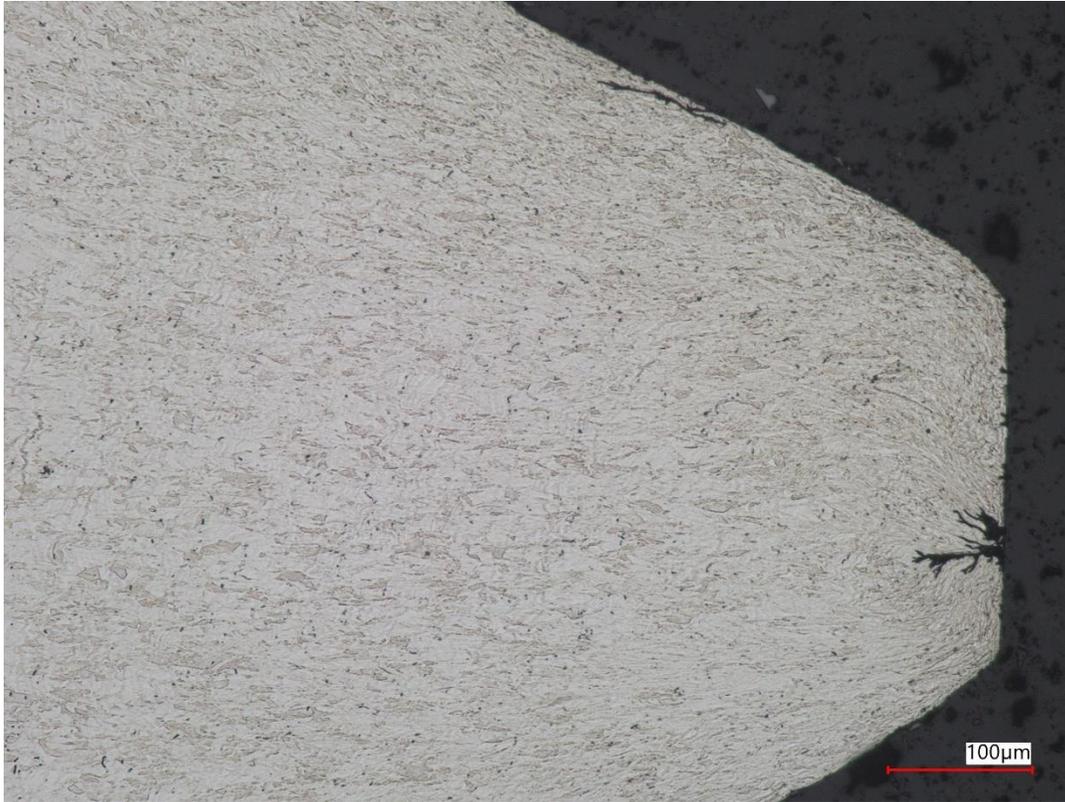
FIGURE 75. FOLDS OBSERVED AT THE CREST AND FLANK OF THREADS, BOLT R2

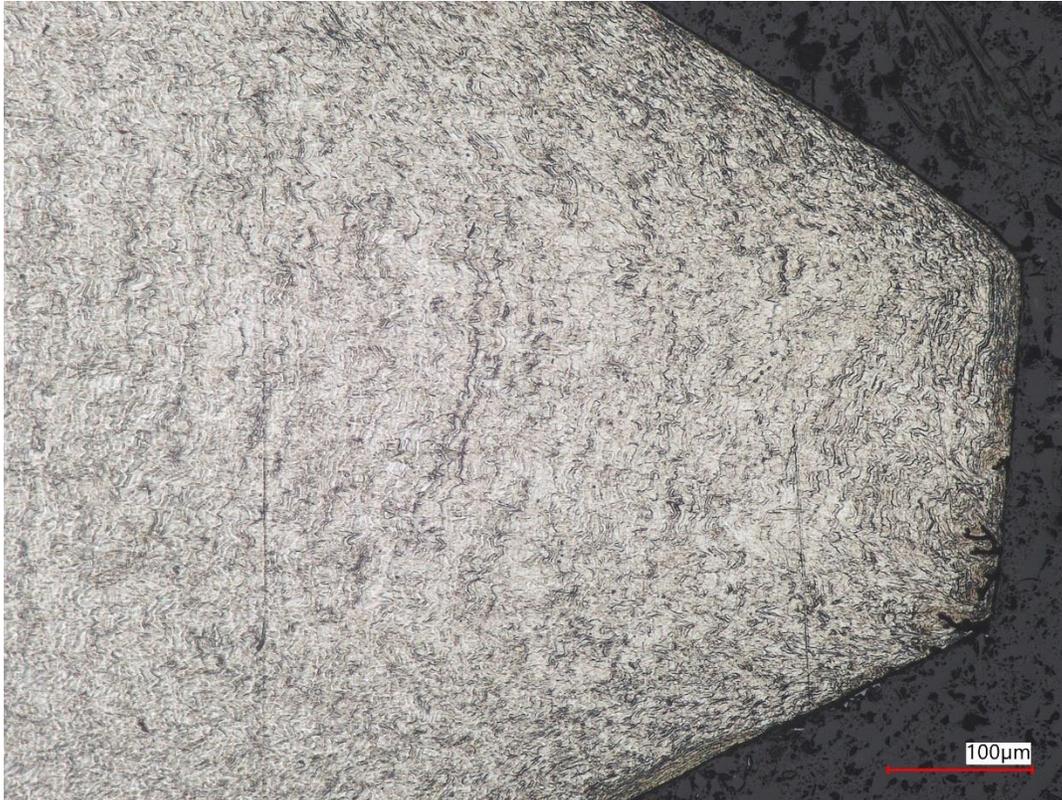
FIGURE 79. FOLDS OBSERVED AT THE CREST AND FLANK OF THREADS, BOLT R3
