Toronto Transit Commission

Scarborough Rapid Transit (SRT) Vehicle Accident Investigation Report

2023-09-28	A	Released	Marcel Silva, P.Eng. Glen Johnstone, P.Eng.	Nicholas Zeolla, P.E.	Sulaiman Janjua	Jarek Skonieczny, P.Eng.
Date	Rev.	Status	Prepared By	Checked By	Approved By	Approved By
HATCH

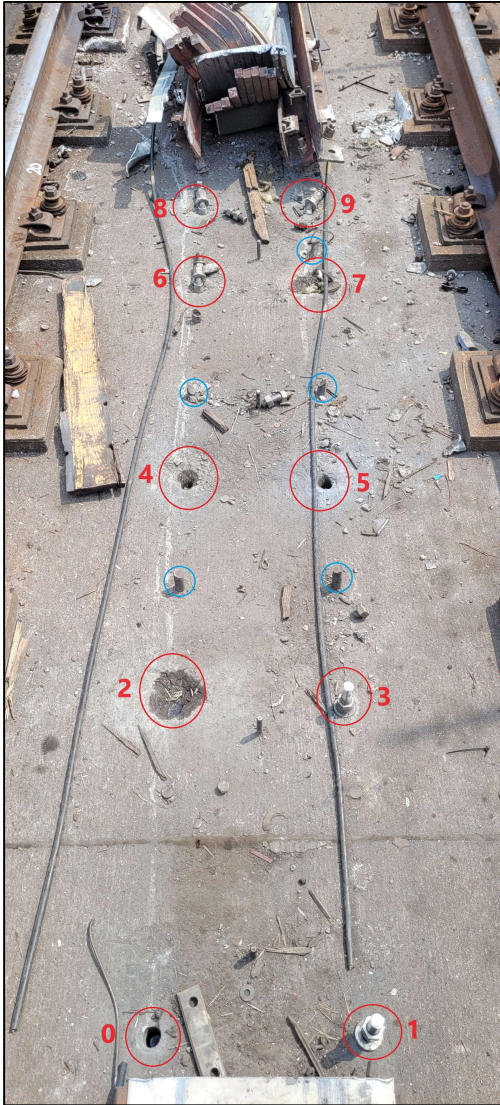
Figure 23 - Reaction Rail Section B Anchor Bolts

b) Reaction rail Section B anchor bolt fastener locations are identified by red circles in Figure 23 – numbered #0 through #9.

c) Anchor bolts #1, #3, #6, #8, and #9 were found in situ by TTC personnel immediately after the derailment. Anchor bolts #6, #8 and #9 were observed to be bent in the direction of train travel and the top portion of the anchor bolts were observed to be missing. Anchor bolts #1 and #3 were missing the top portion of bolt but were observed to be unbent below the shear face.

- d) Anchor bolts #0, #2, #4, #5, and #7 were observed to have been pulled out of their cored holes and remained fastened to the reaction rail section that was pushed under reaction rail Section C.

- e) Reaction rail anchor bolts #0 through #9 were observed to be mechanical set type fasteners. Anchor bolts #1 and #3 appeared to be stainless steel bolts. Anchor bolts #6, #8, and #9 appeared to be carbon steel bolts.

- f) Anchor bolts #0, #2, #4, #5, and #7 were observed not to be in the core holes and were presumed to be still fastened to the underside of the unseated reaction rail, hidden from view. As these anchor bolts were not visible to the Track Specialist, their material composition could not be ascertained.

- g) Blue circles in Figure 23 identify anchor bolts that were observed to have been saw cut and abandoned prior to the incident.
- h) The flat failure face of the lower portion of anchor bolts #1 and #3 were observed to be polished, and the edge of the failure face was hammered flat by cyclical contact with the upper portion of the bolt, as shown in Figure 24. The top portion of anchor bolts #1 and #3 were observed to be still fastened to the unseated reaction rail.

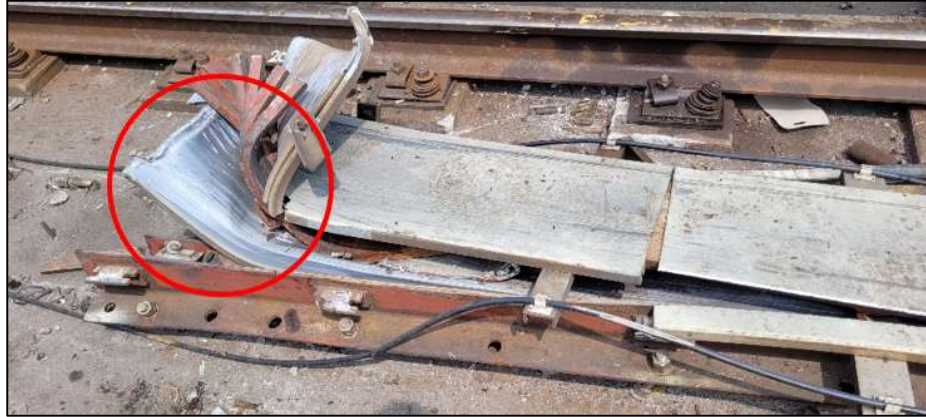
Figure 25 - Reaction Rail Section B

- i) Reaction rail Section B was observed to have been struck and unseated during the derailment. Reaction rail Section B was observed pushed under reaction rail Section C. The top cap of reaction rail Section B was dissimilar to other top cap sections in the immediate area as it was observed to be polished. Red outlined area in Figure 25 identifies the polished top cap of reaction rail Section B.

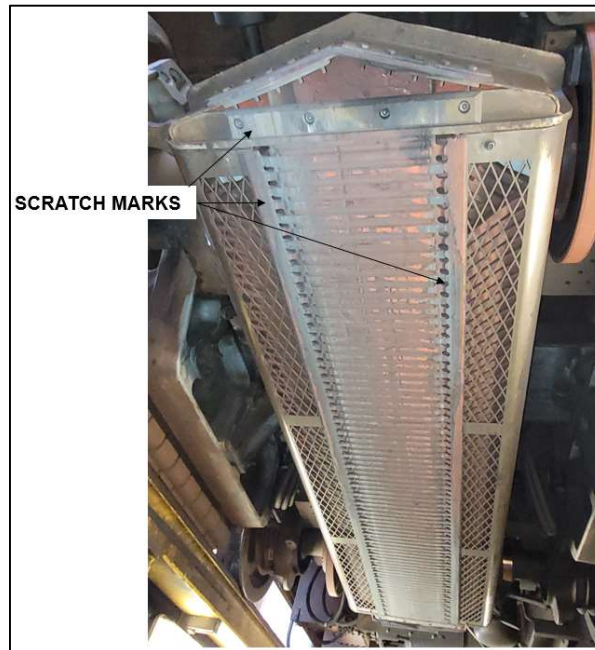
Figure 34 - Scratch Marks on Bottom of the LIM

Uniform scratch marks were found along the entire length of the LIM bottom (Figure 34). These marks appeared to be aged due to their discoloration and dirt build-up presence. This proved to be a common finding for all inspected trucks/LIMs and suggests the bottom of the LIMs have been frequently rubbing against the reaction rail top aluminum cap at various locations in the system.

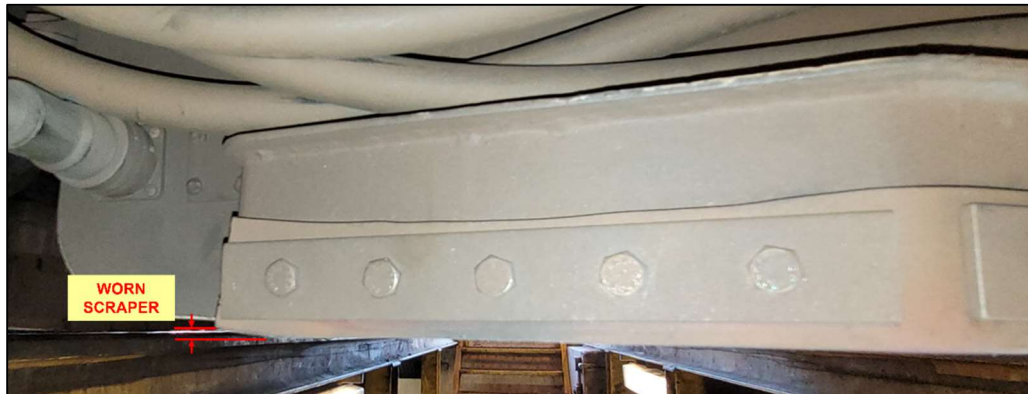
Figure 36 - Worn Scraper Blade

A slight wearing of the scraper blade tip was also observed, as shown in Figure 36.

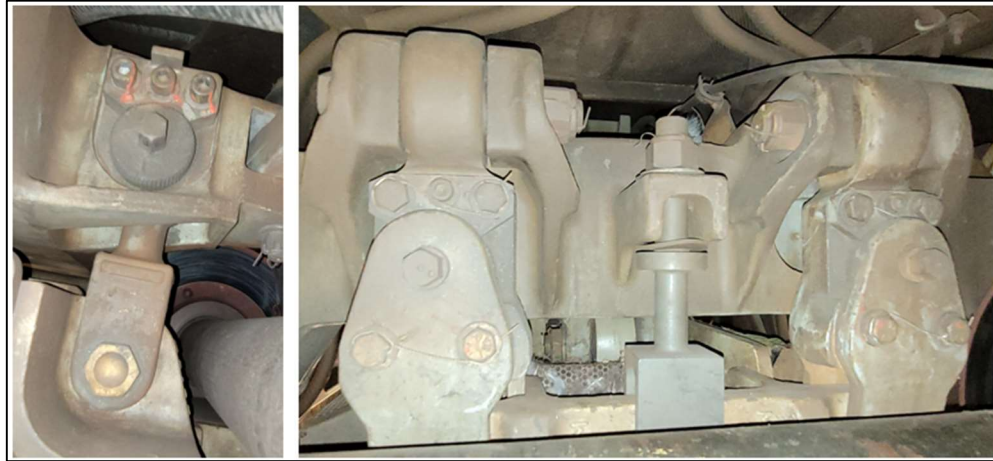
Figure 41 - Vertical Connection Links on Truck S/N 033

The vertical links attaching the LIM to the yoke assemblies and their connections were also physically inspected and found to be properly secured, as shown in Figure 41.

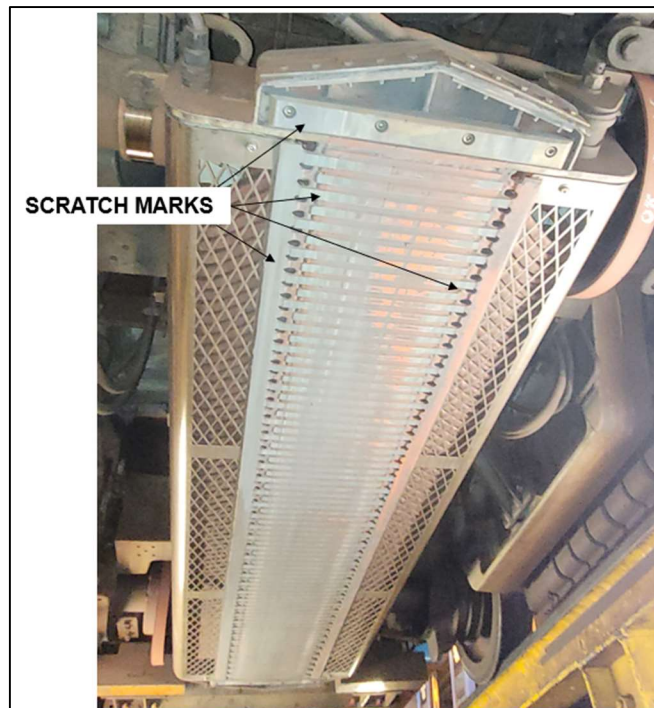
Figure 42 - Scratch Marks on Bottom of the LIM

Uniform scratch marks were found along the entire length of the LIM bottom, as shown in Figure 42, suggesting rubbing against the reaction rail top aluminum cap at various locations in the system. These marks appeared to be aged due to their discoloration and dirt build-up presence.

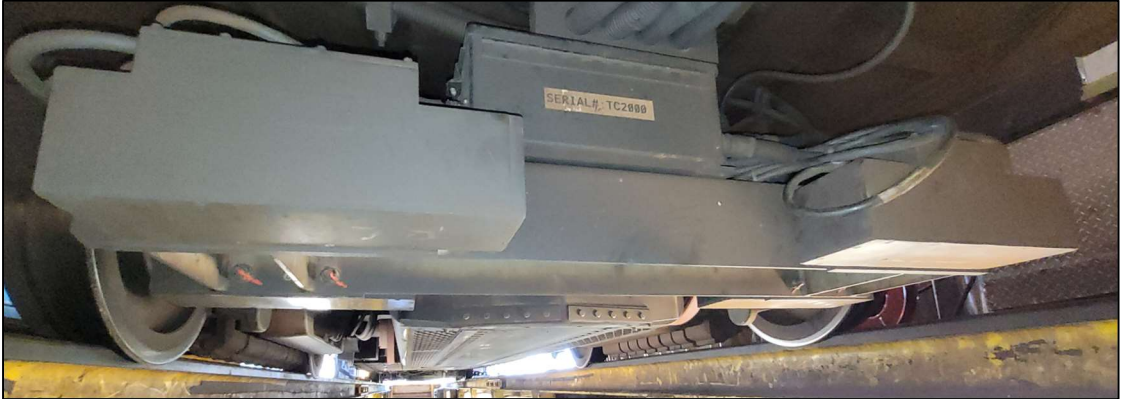
Figure 43 - ATC Antennas on Truck S/N 033

No major damages were found on the ATC antennas, as shown in Figure 43.

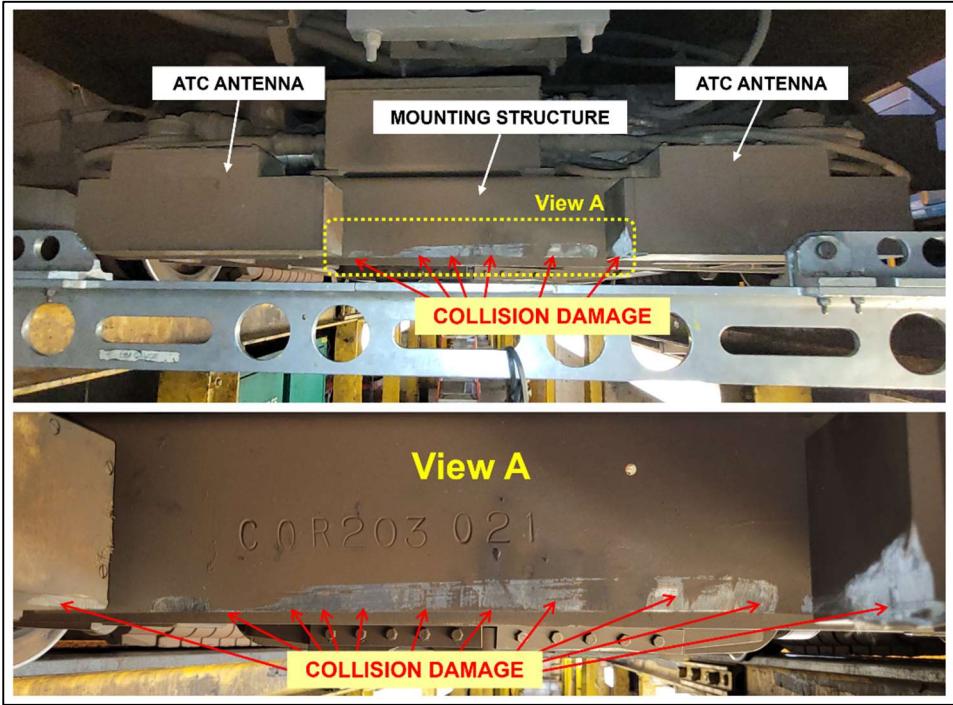
Figure 46 - ATC Antennas Damage on Truck S/N 048

Significant damage was found on the ATC antennas and its mounting structure, as shown in Figure 46, believed to be the result of a collision with a guideway obstruction.

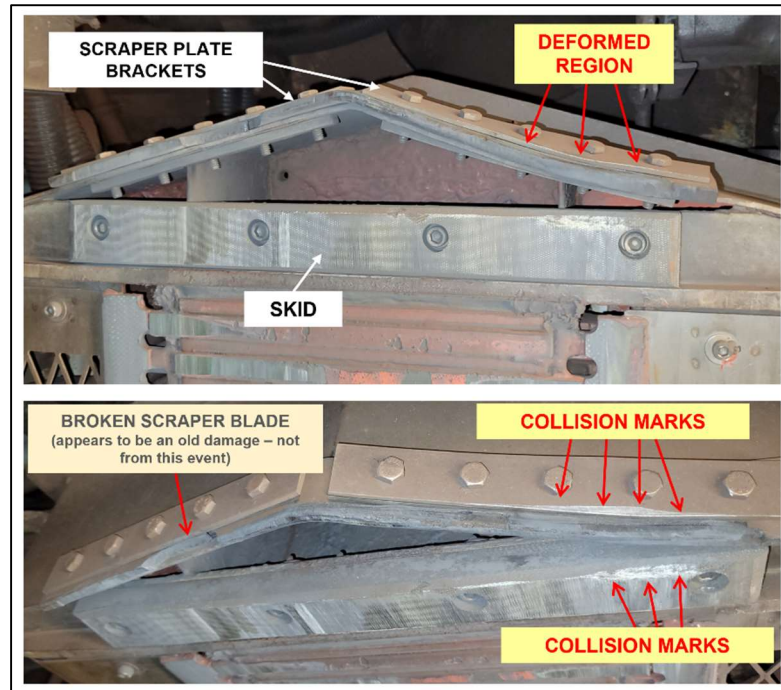
Figure 49 - Scraper Blades and Skid Damage on Truck S/N 048

The LIM scraper blades brackets were also deformed inwards, as shown in Figure 49. Fresh scratch marks were also found on the skid at the bottom of the LIM.

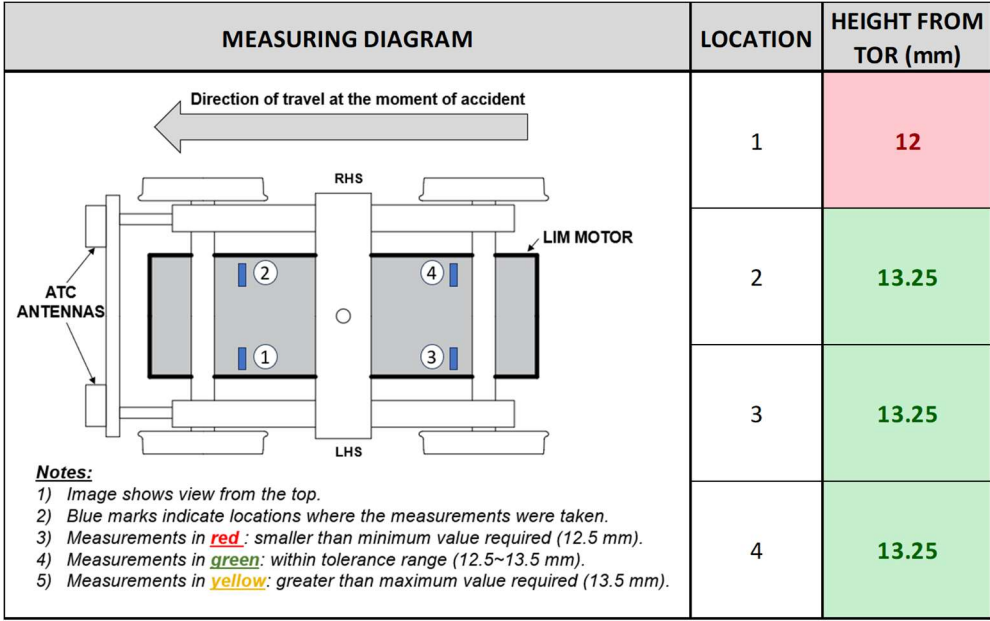
Figure 50 - LIM Height Measurement Results for Truck S/N 048

The LIM height with respect to the top of the running rails was measured using gauge number 127E-610-005 [9], depicted in Figure 10, and verified with a caliper. Results are given in Figure 50. One of the measurements was found to be outside of the specified range (0.5 mm smaller than the lower specification limit). The measurement directly opposite to it was 13.5 mm. Given the considerable damage to the ATC antennas and its mounting bridge, as well as scraper blades brackets, and how high the guideway obstruction collided with the truck (approximately 70 mm), the 0.5 mm LIM height tolerance violation is not believed to have been a contributing factor to the accident.

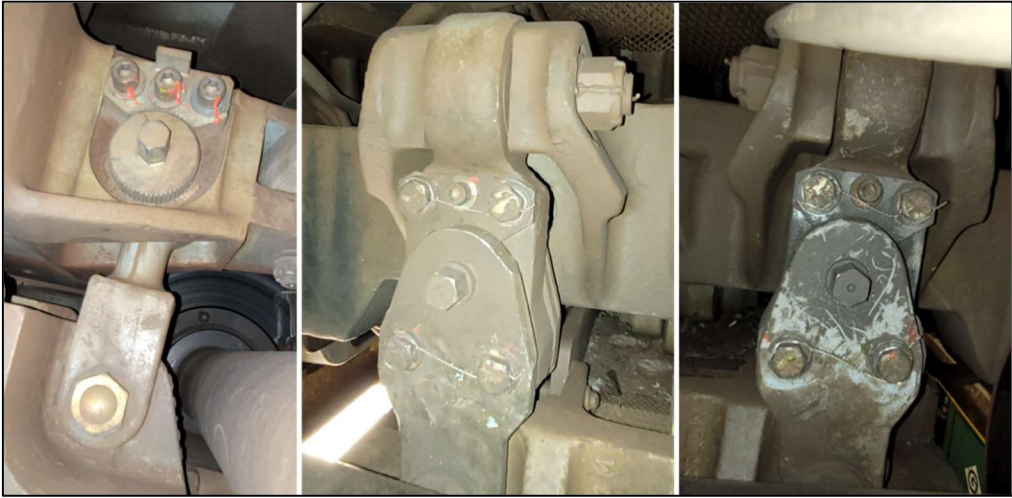
Figure 51 - Vertical Connection Links on Truck S/N 048

The vertical links attaching the LIM to the yoke assemblies and their connections were also physically inspected and found to be properly secured, as shown in Figure 51.

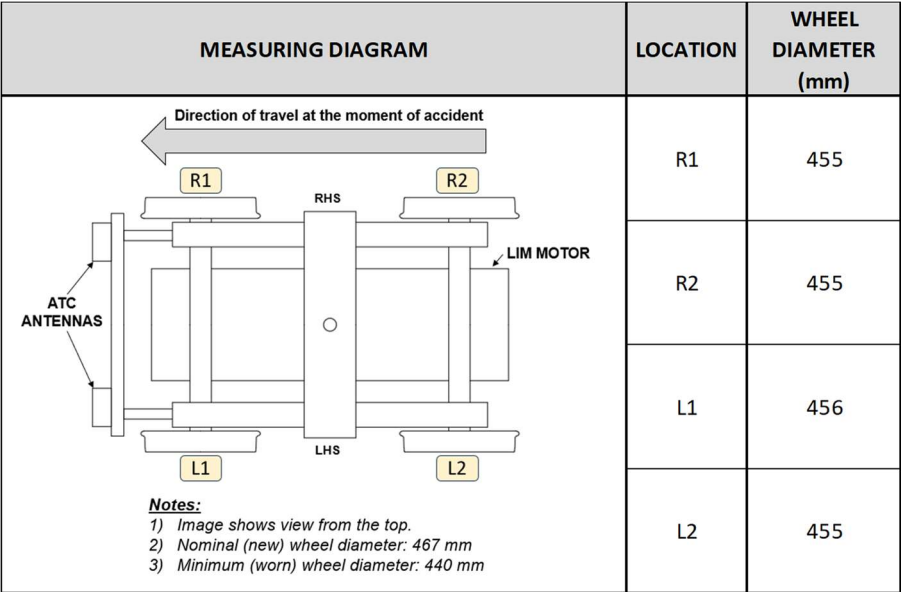
Figure 53 - Wheel Diameter Measurement Results on Truck S/N 048

For completeness, wheel diameters were also measured and found to be above the minimum wheel diameter (> 440 mm). Results are shown in Figure 53.

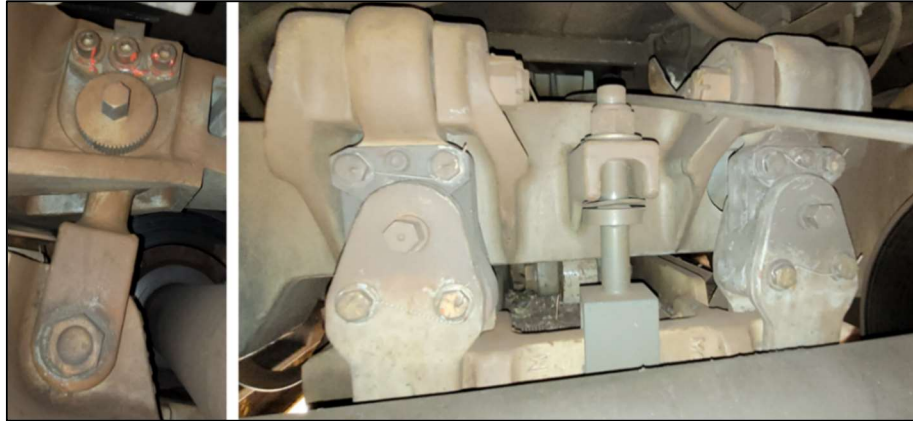
Figure 56 - Vertical Connection Links on Truck S/N 028

The vertical links attaching the LIM to the yoke assemblies and their connections were also physically inspected and found to be properly secured, as shown in Figure 56.

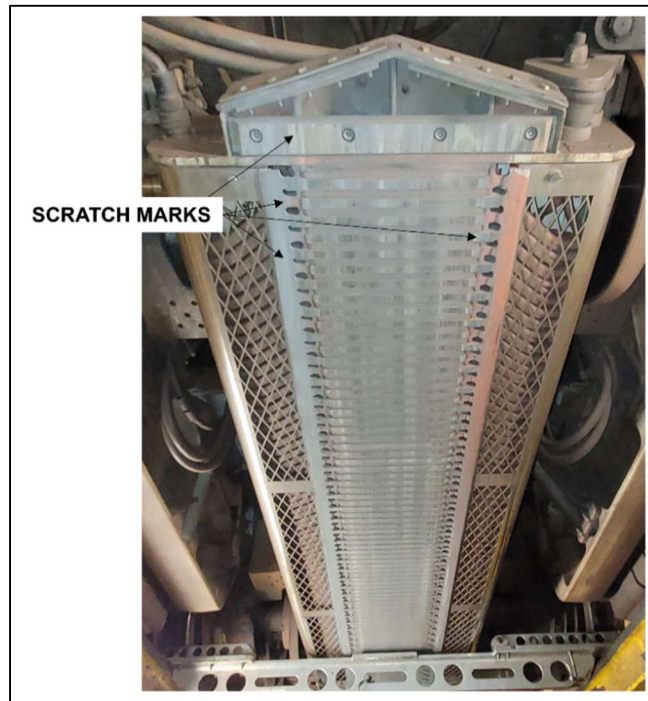
Figure 57 - Scratch Marks on Bottom of the LIM

Uniform scratch marks were found along the entire length of the LIM bottom, as shown in Figure 57, suggesting rubbing against the reaction rail top aluminum cap at various locations in the system. These marks appeared to be aged due to their discoloration and dirt build-up presence.

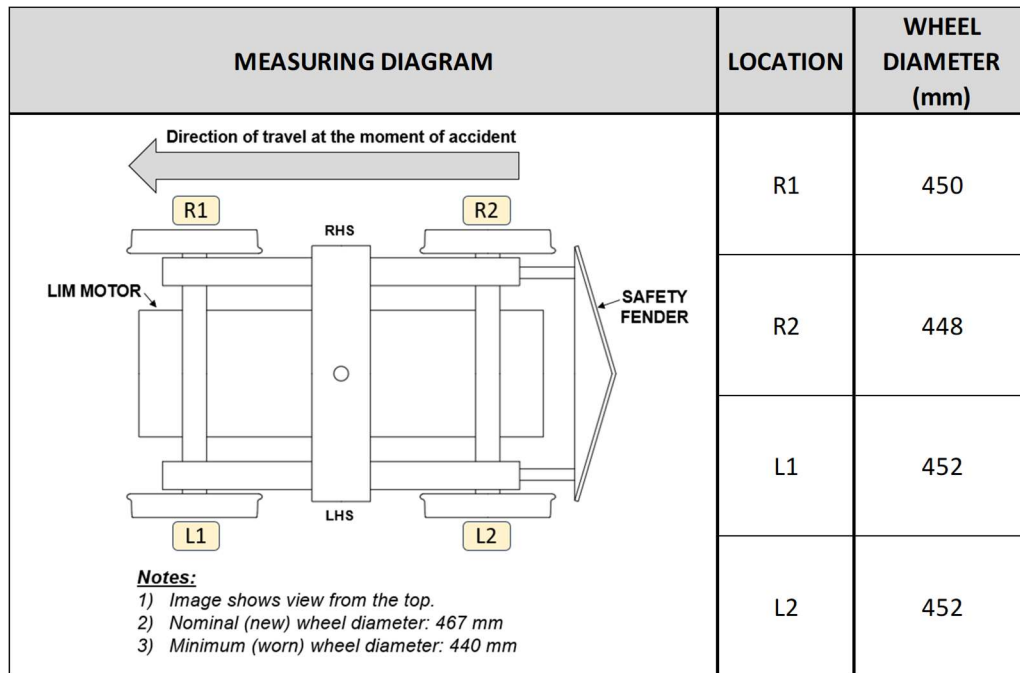
Figure 59 - Wheel Diameter Measurement Results on Truck S/N 028

For completeness, wheel diameters were also measured and found to be above the minimum wheel diameter (> 440 mm). Results are shown in Figure 59.

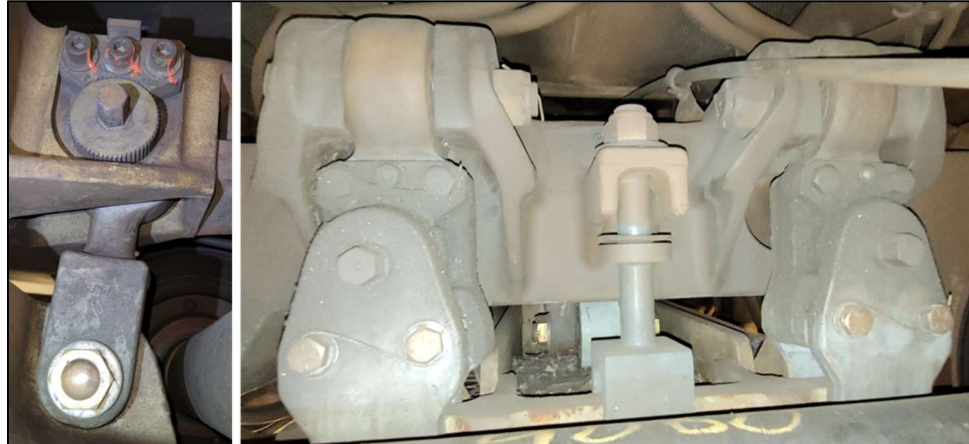
Figure 62 - Vertical Connection Links on Truck S/N 005

The vertical links attaching the LIM to the yoke assemblies and their connections were also physically inspected and found to be properly secured, as shown in Figure 62.

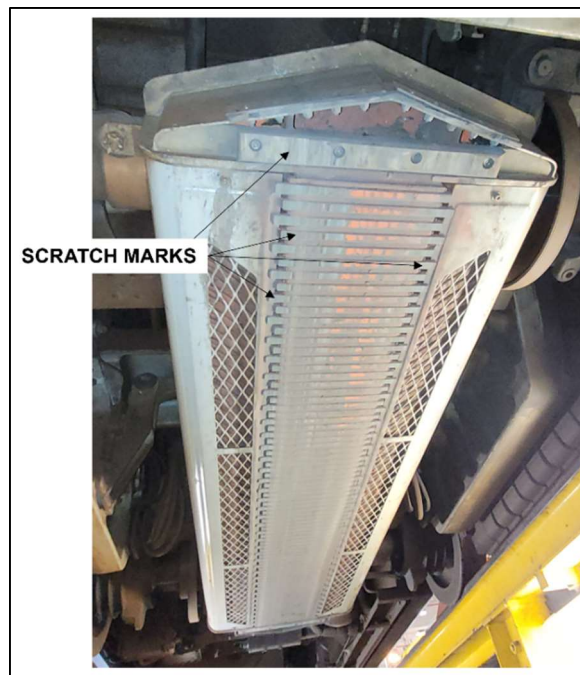
Figure 63 - Scratch Marks on Bottom of the LIM

Uniform scratch marks were found along the entire length of the LIM bottom, as shown in Figure 63, suggesting rubbing against the reaction rail top aluminum cap at various locations in the system. These marks appeared to be aged due to their discoloration and dirt build-up presence.

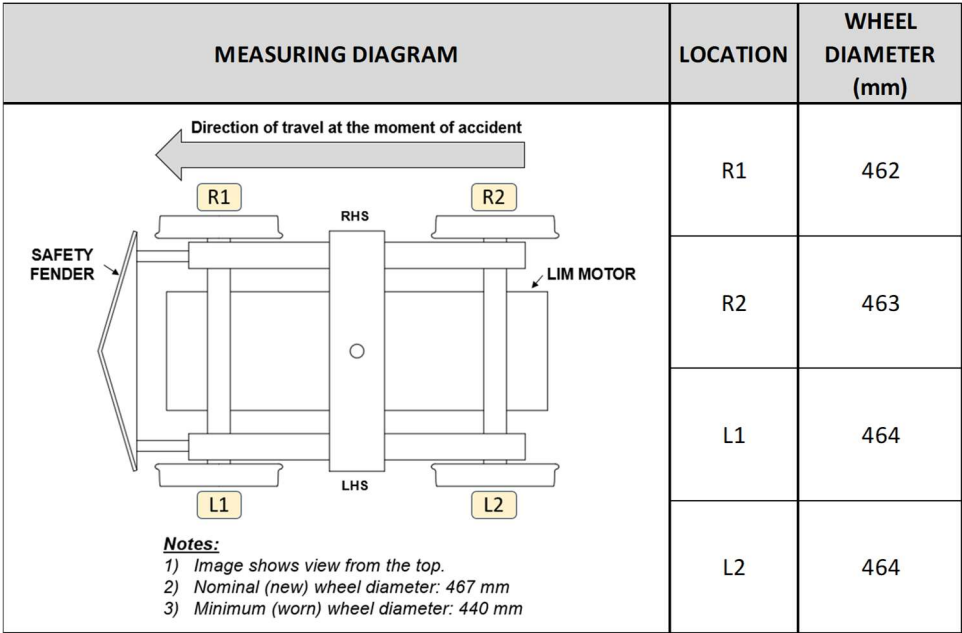
Figure 65 - Wheel Diameter Measurement Results on Truck S/N 005

For completeness, wheel diameters were also measured and found to be above the minimum wheel diameter (> 440 mm). Results are shown in Figure 65.

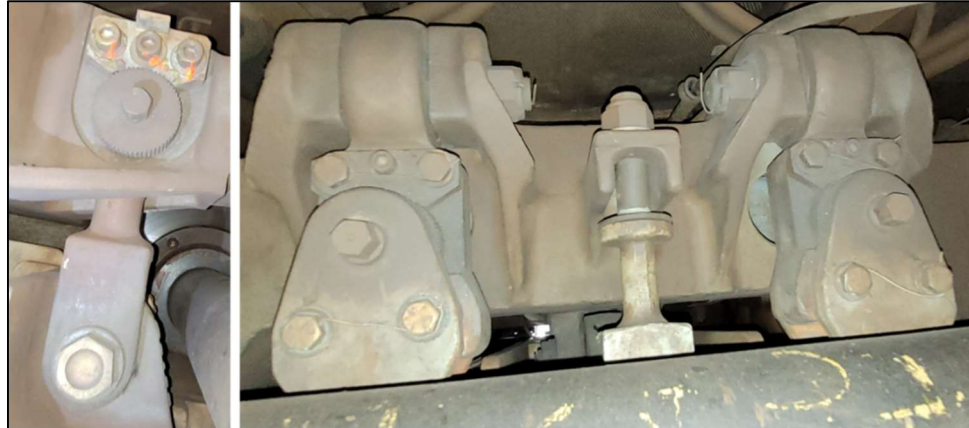
Figure 68 - Vertical Connection Links on Truck S/N 019

The vertical links attaching the LIM to the yoke assemblies and their connections were also physically inspected and found to be properly secured, as shown in Figure 68.

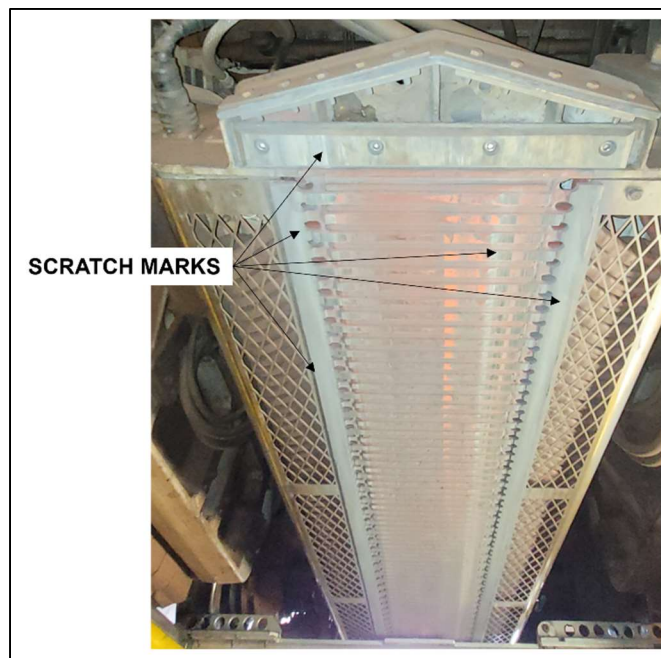
Figure 69 - Scratch Marks on Bottom of the LIM

Uniform scratch marks were found along the entire length of the LIM bottom, as shown in Figure 69, suggesting rubbing against the reaction rail top aluminum cap at various locations in the system. These marks appeared to be aged due to their discoloration and dirt build-up presence.

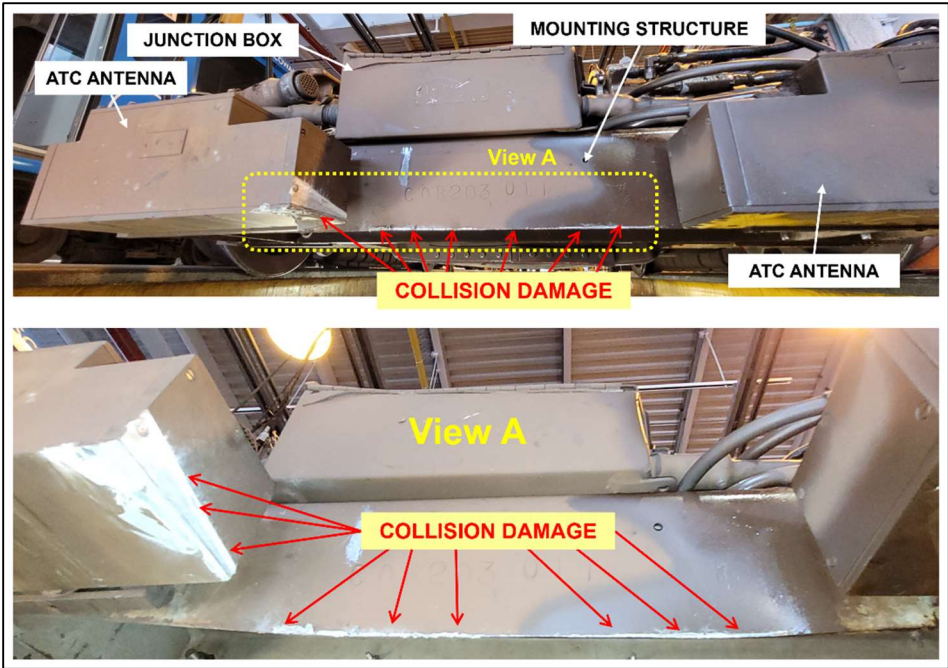
Figure 75 - ATC Antennas Damage on Truck S/N 027

Significant damage was confirmed on the ATC antennas and its mounting structure, as shown in Figure 75, believed to be the result of a collision with a guideway obstruction.

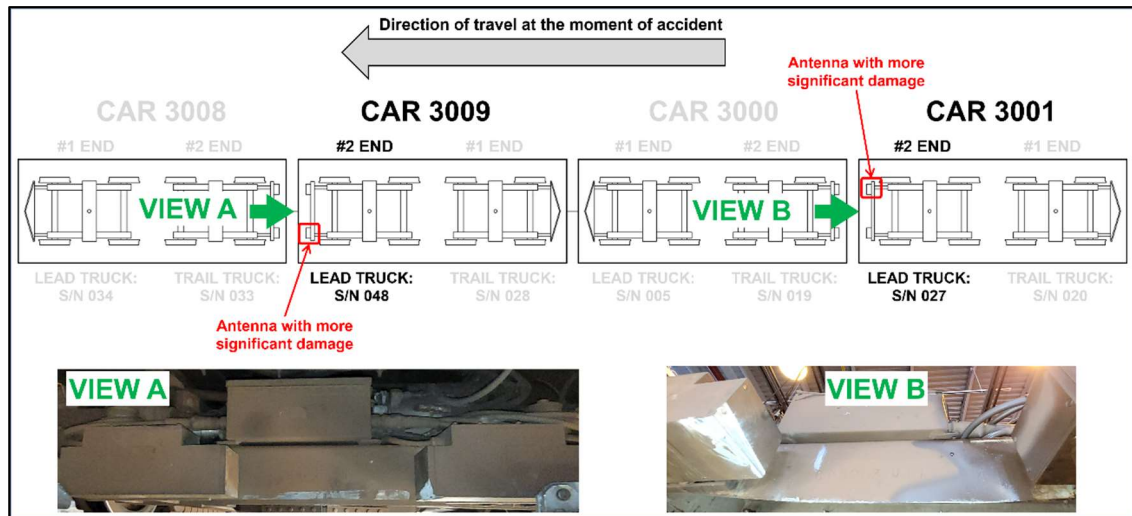
Figure 76 - ATC Antennas Damage: Truck S/N 048 vs Truck S/N 027

The highest damage mark was observed approximately 70 mm above the top of the running rails. The damage was very similar to the one found on Truck S/N 048 (Car 3009). The more pronounced difference between the damage on these two trucks is that on Truck S/N 027 (Car 3001) the right-side (facing direction of travel) antenna experienced more severe damage, whereas the left-side (facing direction of travel) antenna was more significantly damaged on Truck S/N 048 (Car 3009). See Figure 76.

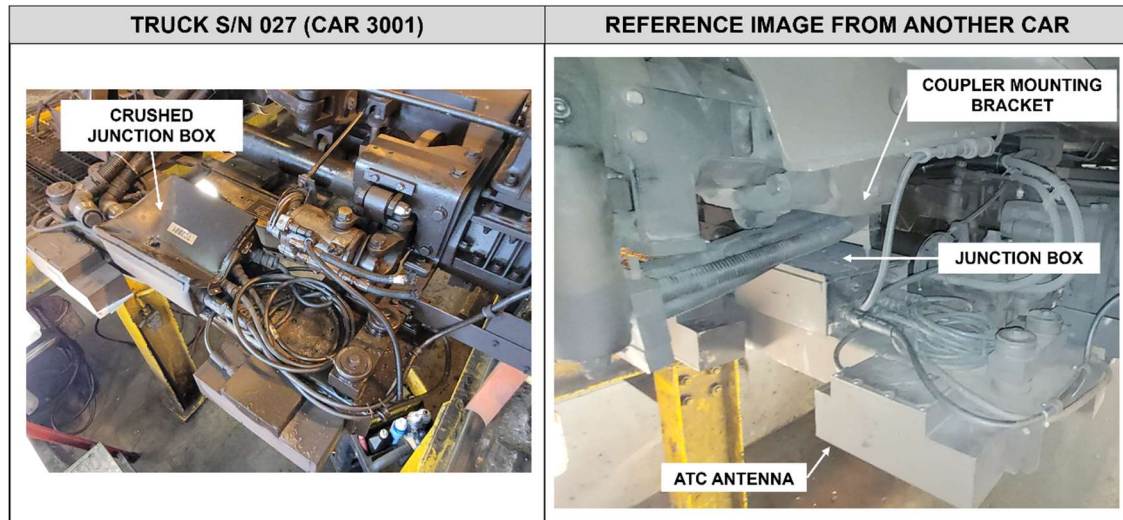
Figure 79 - Crushed ATC Junction Box on Truck S/N 027

The junction box just above the ATC antennas was also found to be significantly deformed, suggesting it was crushed from the top (Figure 79). The shape and location of the deformation suggest an impact with the vehicle's coupler mounting bracket when the train struck the guideway obstruction and pitched forward.

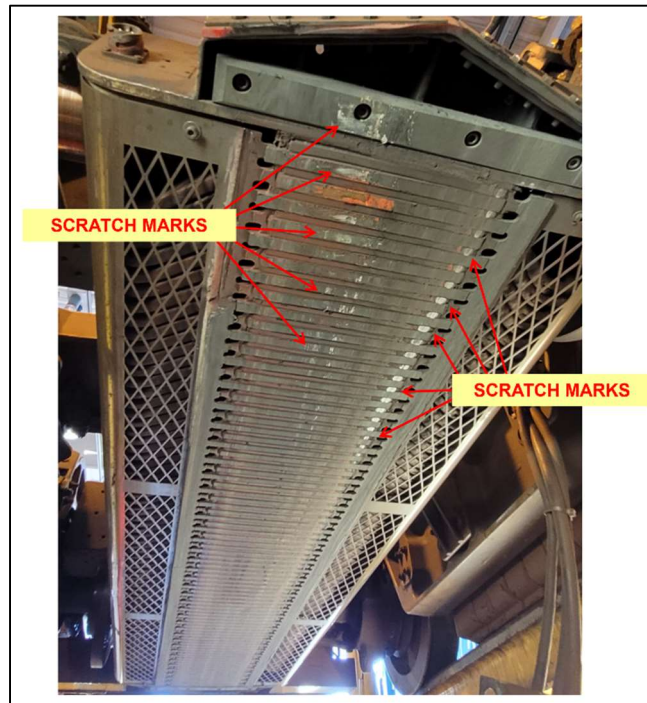
Figure 81 - LIM Bottom Damage on Truck S/N 027

In addition to the usual scratch marks commonly observed at the bottom of the LIM, deeper marks were also found, suggesting a more substantial scraping of the LIM bottom occurred (Figure 81).

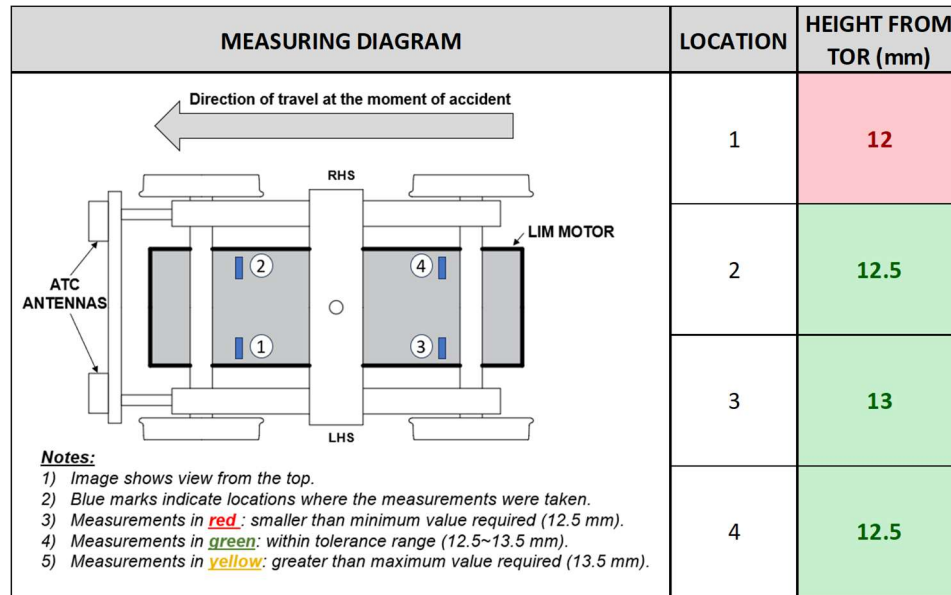
Figure 82 - LIM Height Measurement Results for Truck S/N 027

The LIM height with respect to the top of the running rails was measured using gauge number 127E-610-005 [9], depicted in Figure 10, and verified with a caliper. Results are given in Figure 82. One of the measurements was found to be outside of the specified range (0.5 mm smaller than the lower specification limit). The measurement directly opposite to it was 12.5 mm. Given the considerable damage to the ATC antennas and its mounting bridge and how high the guideway obstruction collided with the truck (approximately 70 mm), the 0.5 mm LIM height tolerance violation is not believed to have been a contributing factor to the accident.

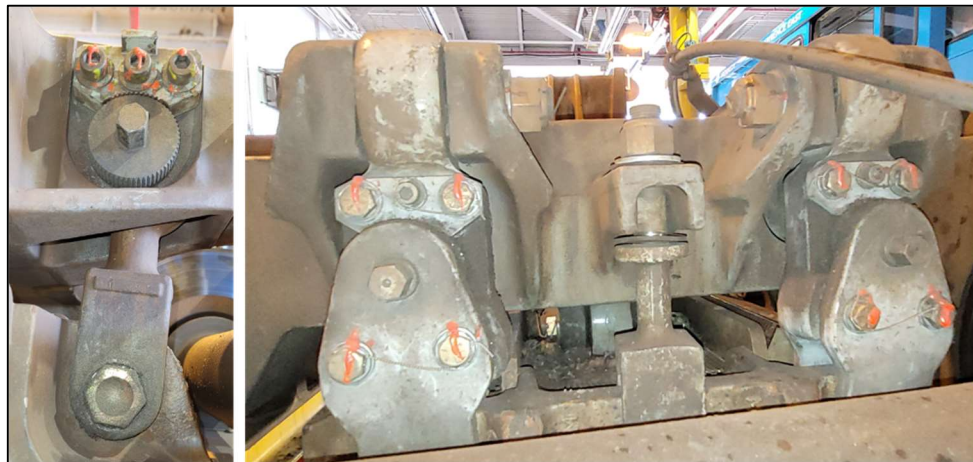
Figure 83 - Vertical Connection Links on Truck S/N 027

The vertical links attaching the LIM to the yoke assemblies and their connections were also physically inspected and found to be properly secured, as shown in Figure 83.

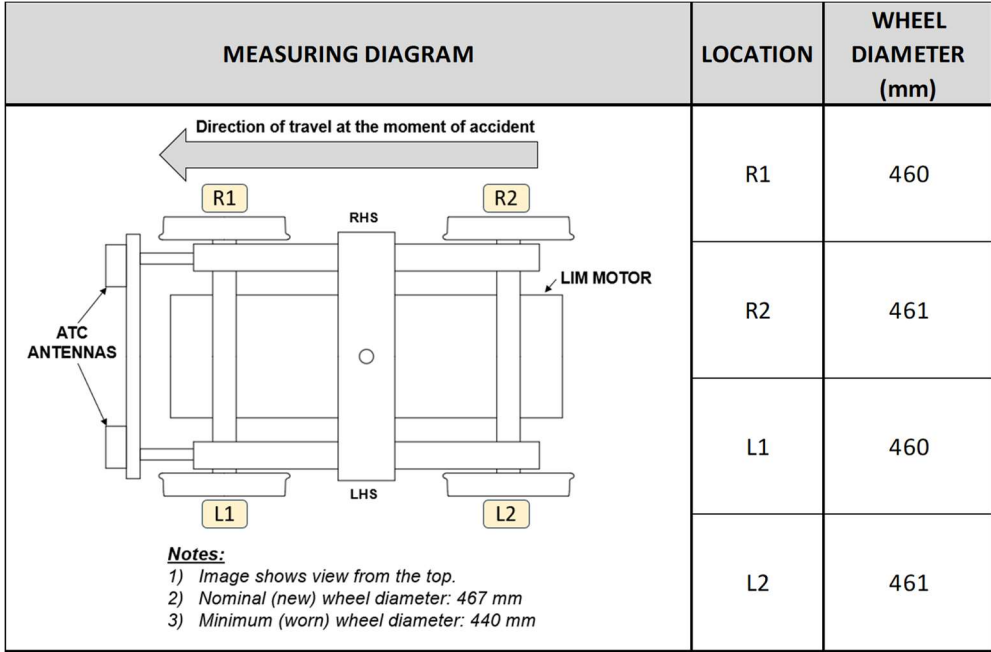
Figure 84 - Wheel Diameter Measurement Results on Truck S/N 027

For completeness, wheel diameters were also measured and found to be above the minimum wheel diameter (> 440 mm). Results are shown in Figure 84.

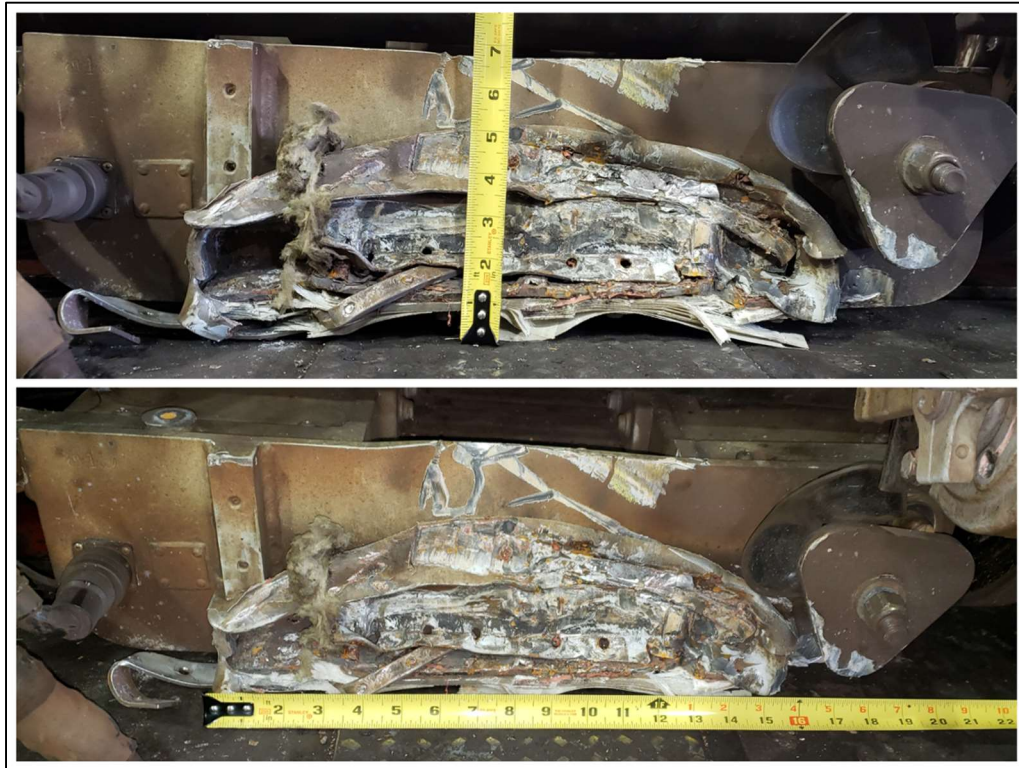
Figure 86 - LIM Damage on Truck S/N 020

Extensive crushing damage was found on the front face of the LIM, as shown in Figure 86, confirming a front collision with a guideway obstruction occurred.

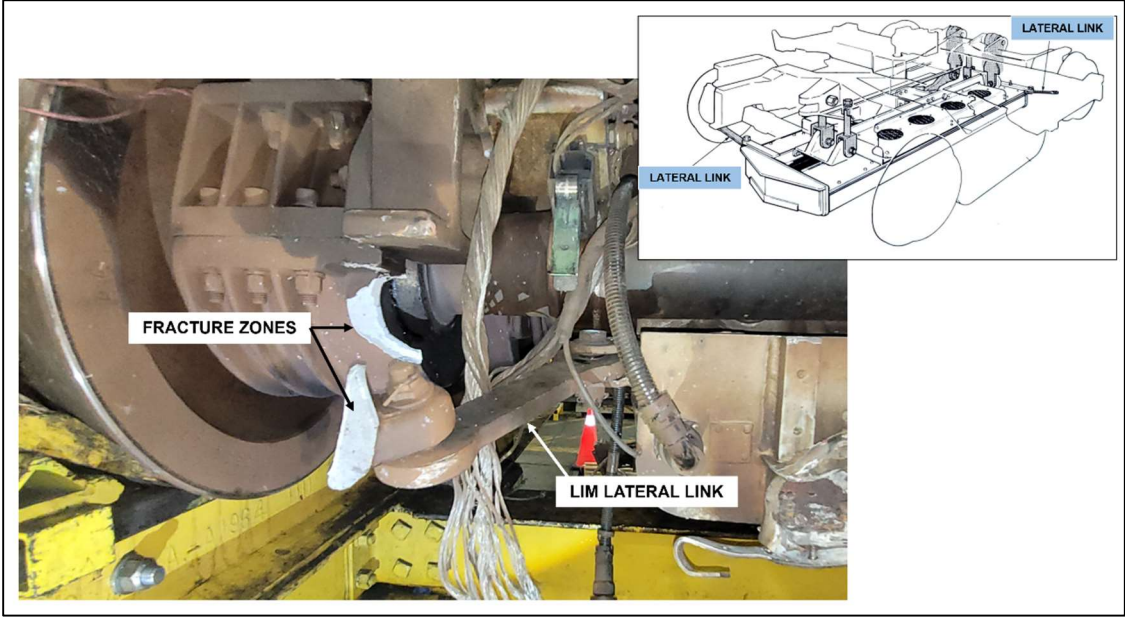
Figure 90 - Fractured Journal Box (LIM Lateral Link Attachment)

One of the LIM lateral link attachments to the journal box was fractured as a result of the collision, as shown in Figure 90. The LIM thrust link connections were also damaged (Figure 91).
