TORONTO TRANSIT COMMISSION REPORT NO.

SUBJECT: YORKDALE FATALITY OF SEPTEMBER 14, 2012 -
FINAL INVESTIGATION REPORT

YORKDALE FATALITY INVESTIGATION REPORT

Spadina Line, Southbound Track at
277+54
Toronto Transit Commission

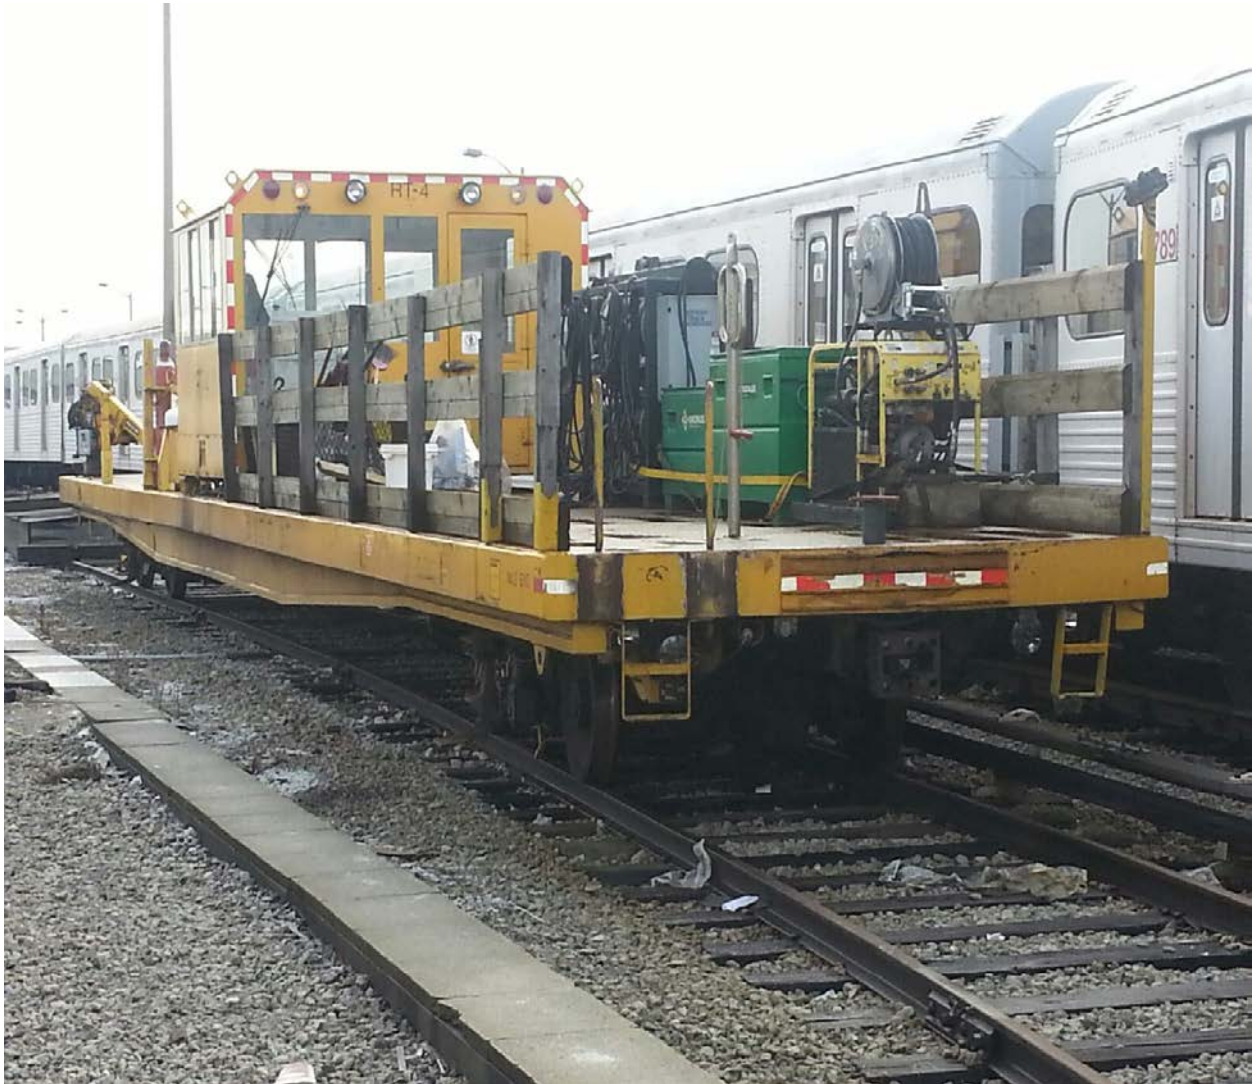
Figure 1

RT-4 Work Car

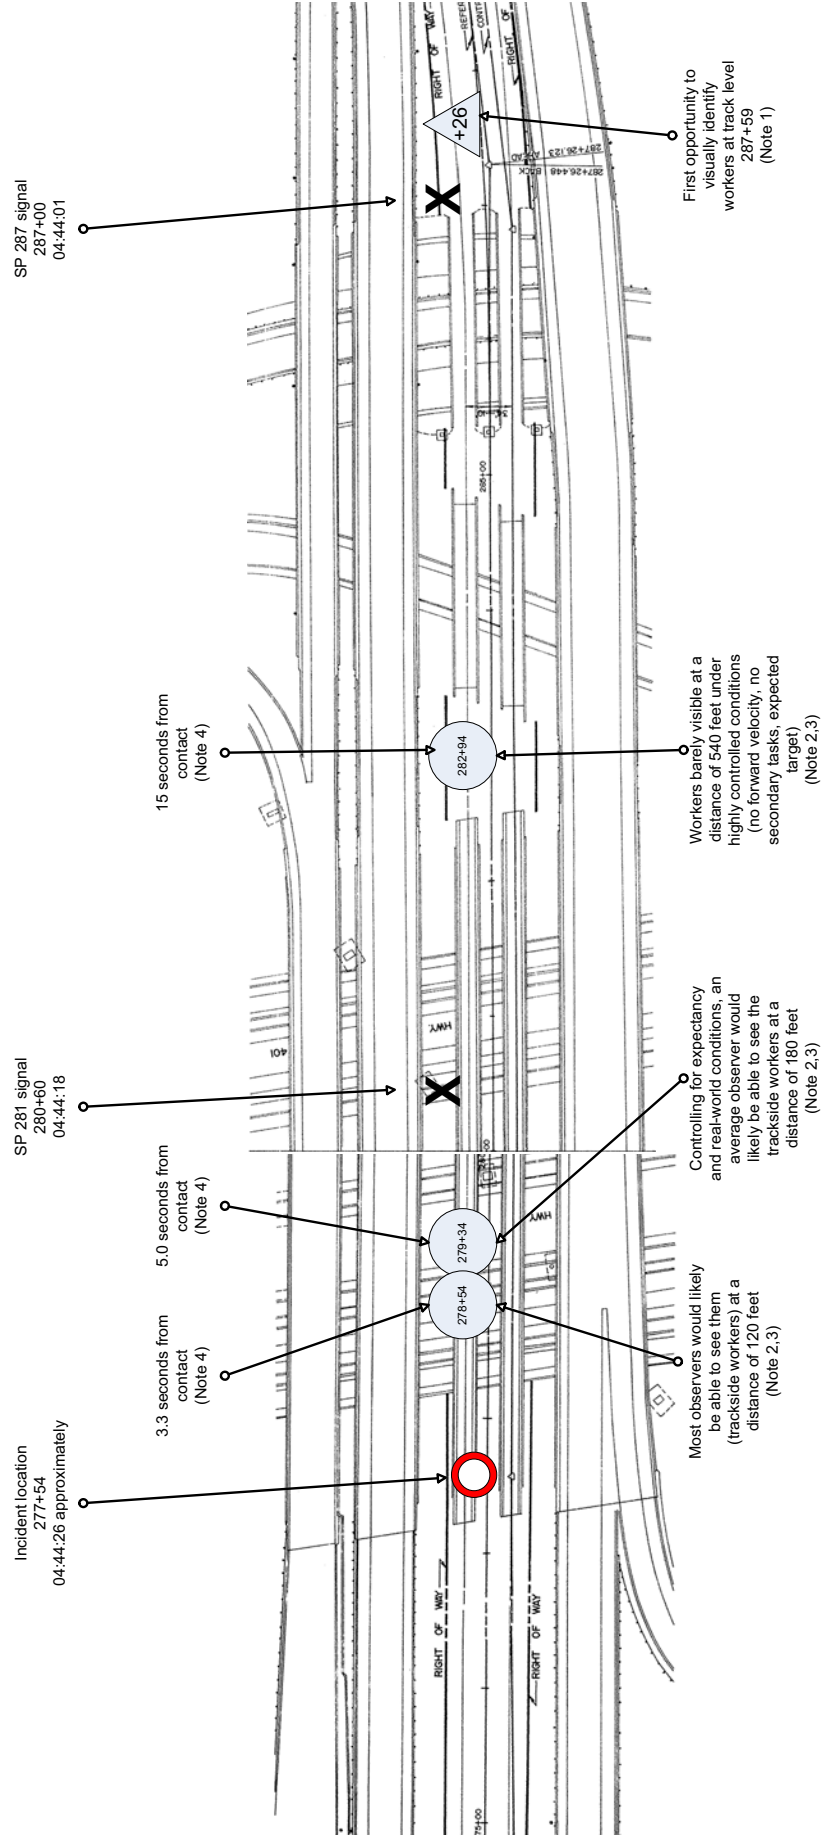
Figure 3

images were recorded from the immediate site of the contact back in one second intervals. Again, due to difficulties in accessing track level, the Team was only able to collect photos to a point 17 seconds before contact, plus one more at the limit of the work car Operator's line of sight. Two sets of images were taken, one with the existing headlights and another with a test LED lamp system. On November 23, 2012 ME issued a report with recommendations to TTC management (PR #24885 Progress Report #3). A report from Human Factors North was delivered on November 27th, 2012 which analyzes the results of the site visit including visibility distances from the perspective of RT-4. (See Figure 3)

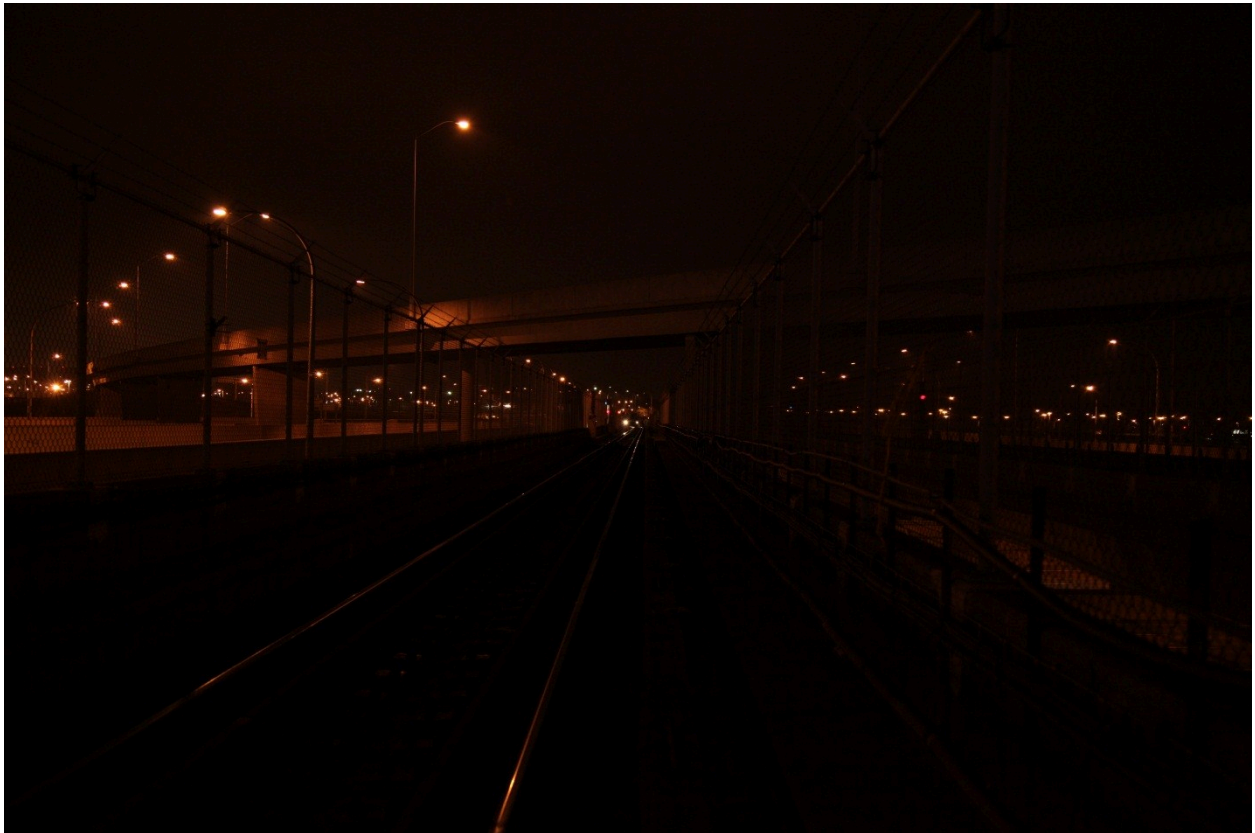
Figure 4

**Workers' Perspective of RT-4 at Maximum Line of Sight –
Original Headlights**

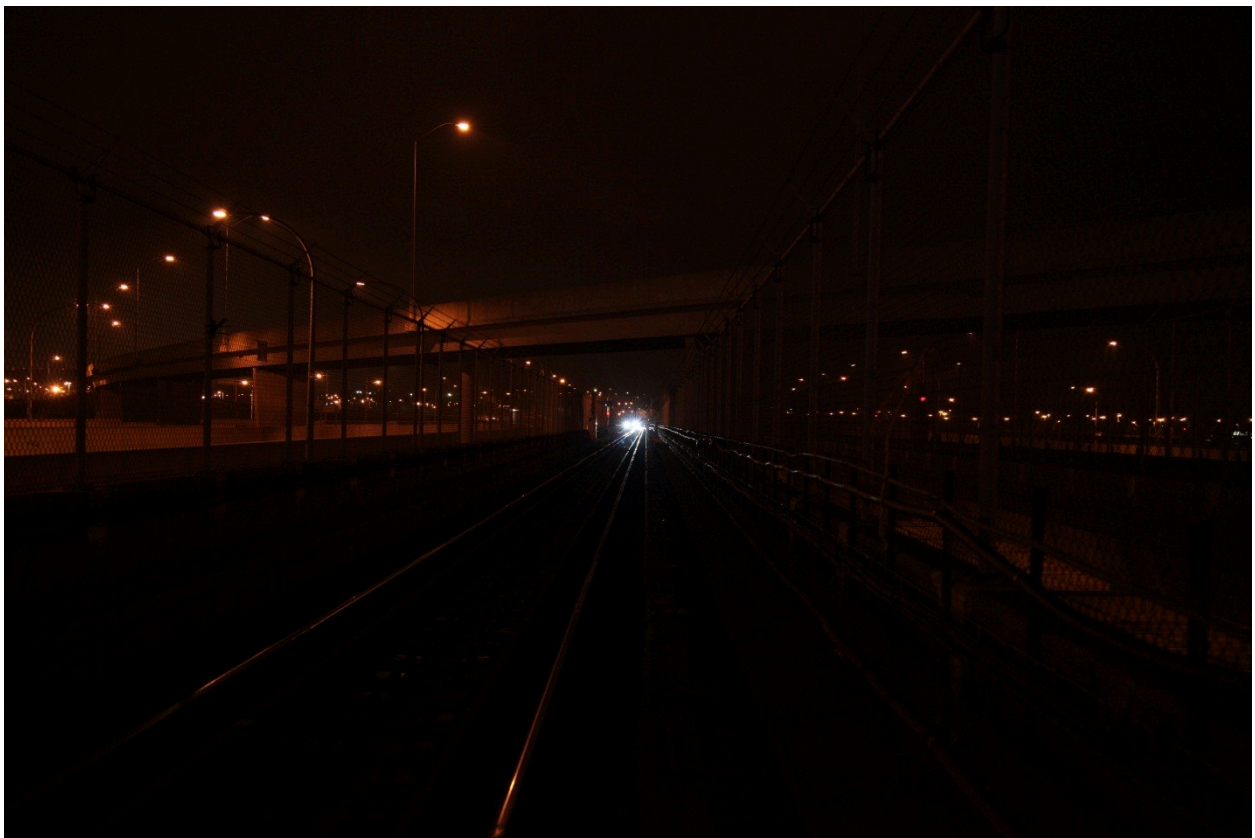
Figure 5

**Workers' Perspective of RT-4 at Maximum Line of Sight –
LED Headlights**

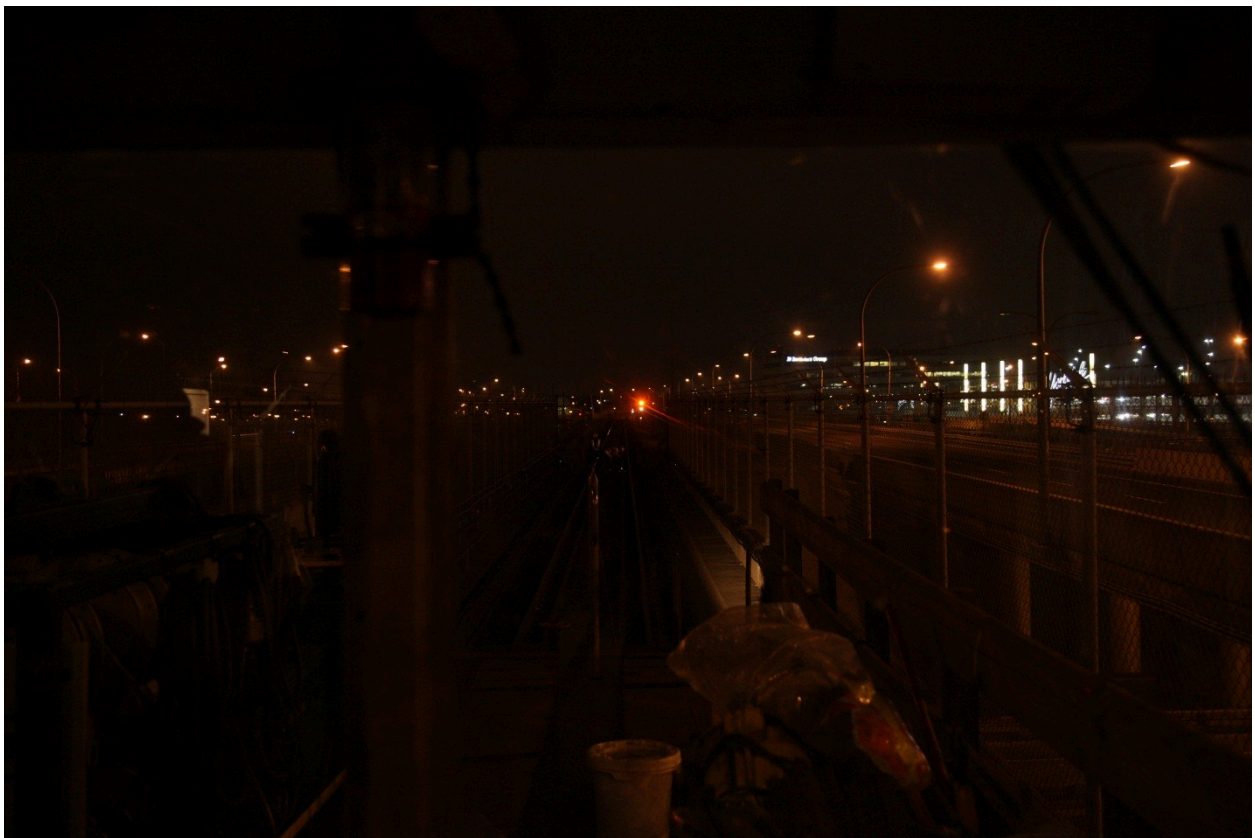
**Operators Perspective from RT-4 at Last Chance to Stop Safely –
Original Headlights**

Given the condition of the headlights, the central question in this barrier analysis is *“Could the work car Operator see the workers in time to stop?”* Human Factors North report #2 responds directly to this question. The workers become ever more visible after the threshold of visibility at 540 feet. Adjusting for factors such as expectancy, and variations in visual acuity, the average person could see the workers at about 180 feet. At 40 km/h the measured distance for emergency braking for RT-4 was 114 feet. Accounting for reaction time, this is approximately the final moment to assure a safe stop. Figure 6 shows the Operator’s perspective at this distance. The Team judges that a professional work car

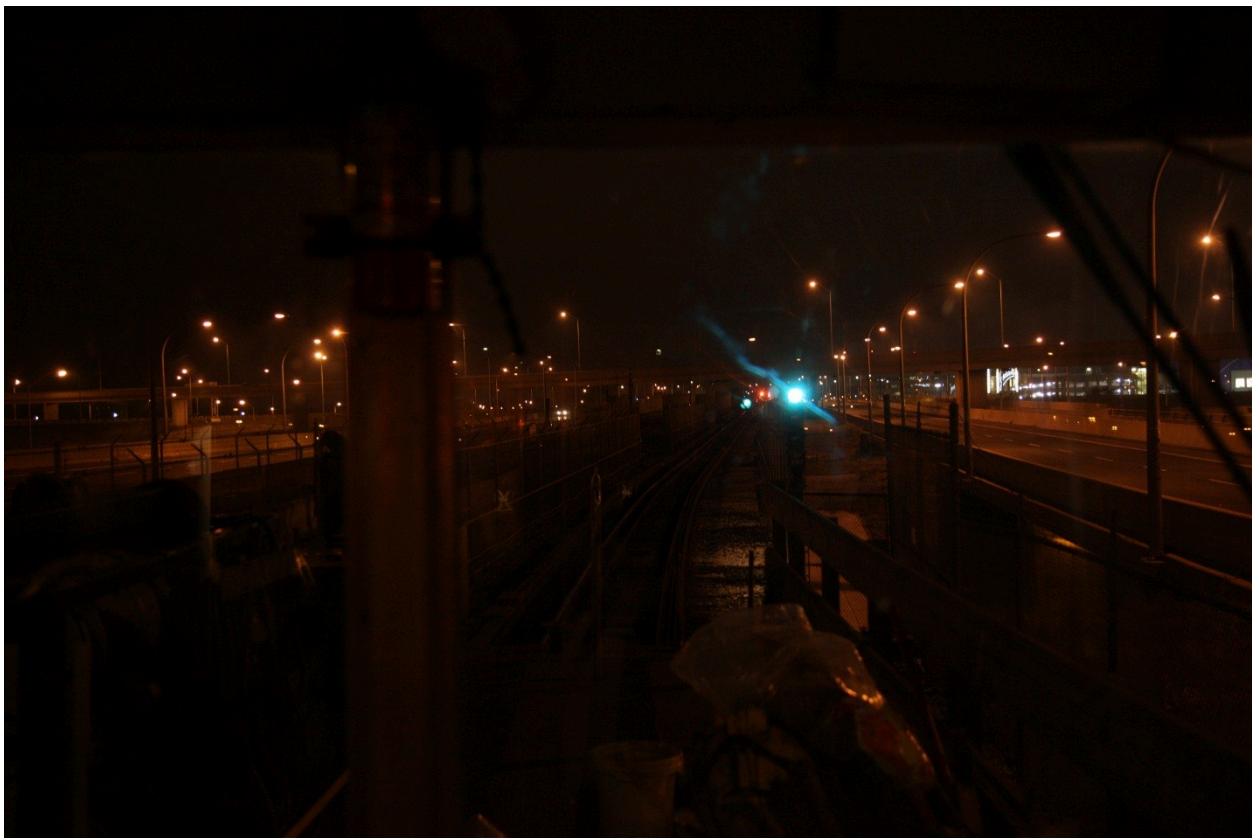
Figure 7

**Operators Perspective from RT-4 at Maximum Line of Sight –
Original Headlights**

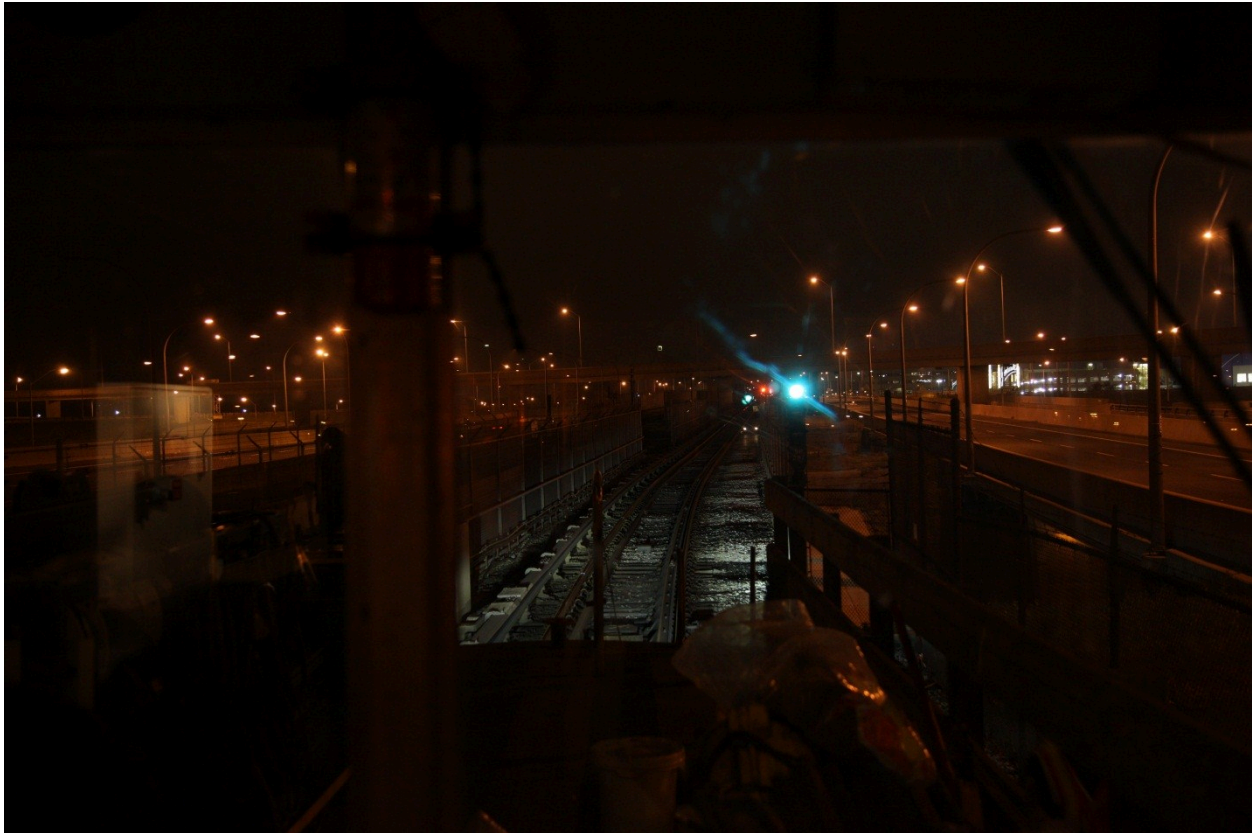
Figure 8

**Operators Perspective from RT-4 at Maximum Line of Sight –
LED Headlights**

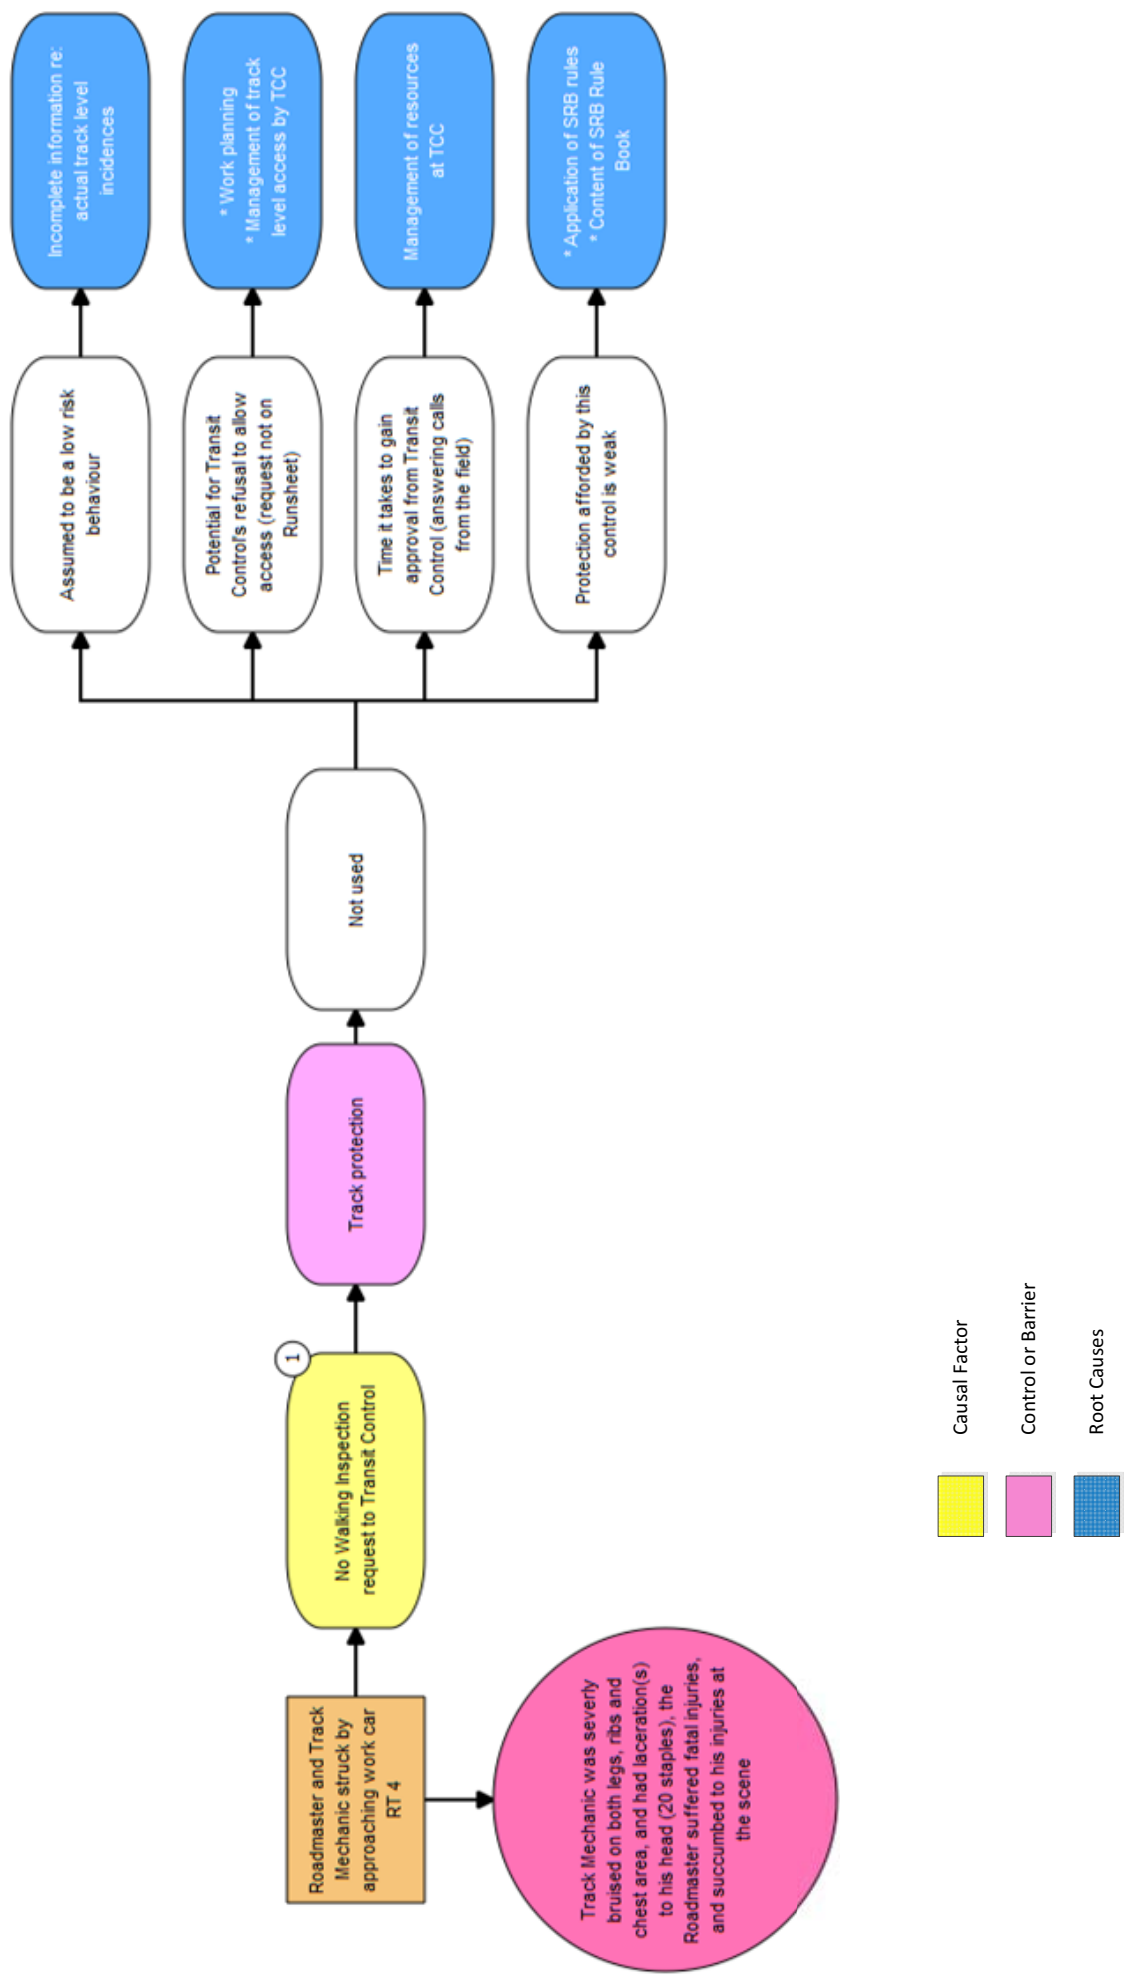
Short duration access to unprotected track is a fact of life in the culture of non-revenue maintenance. Among the possible reasons for this behaviour are two direct root causes and two underlying root causes (See Appendix C and Figure 9 page 27):

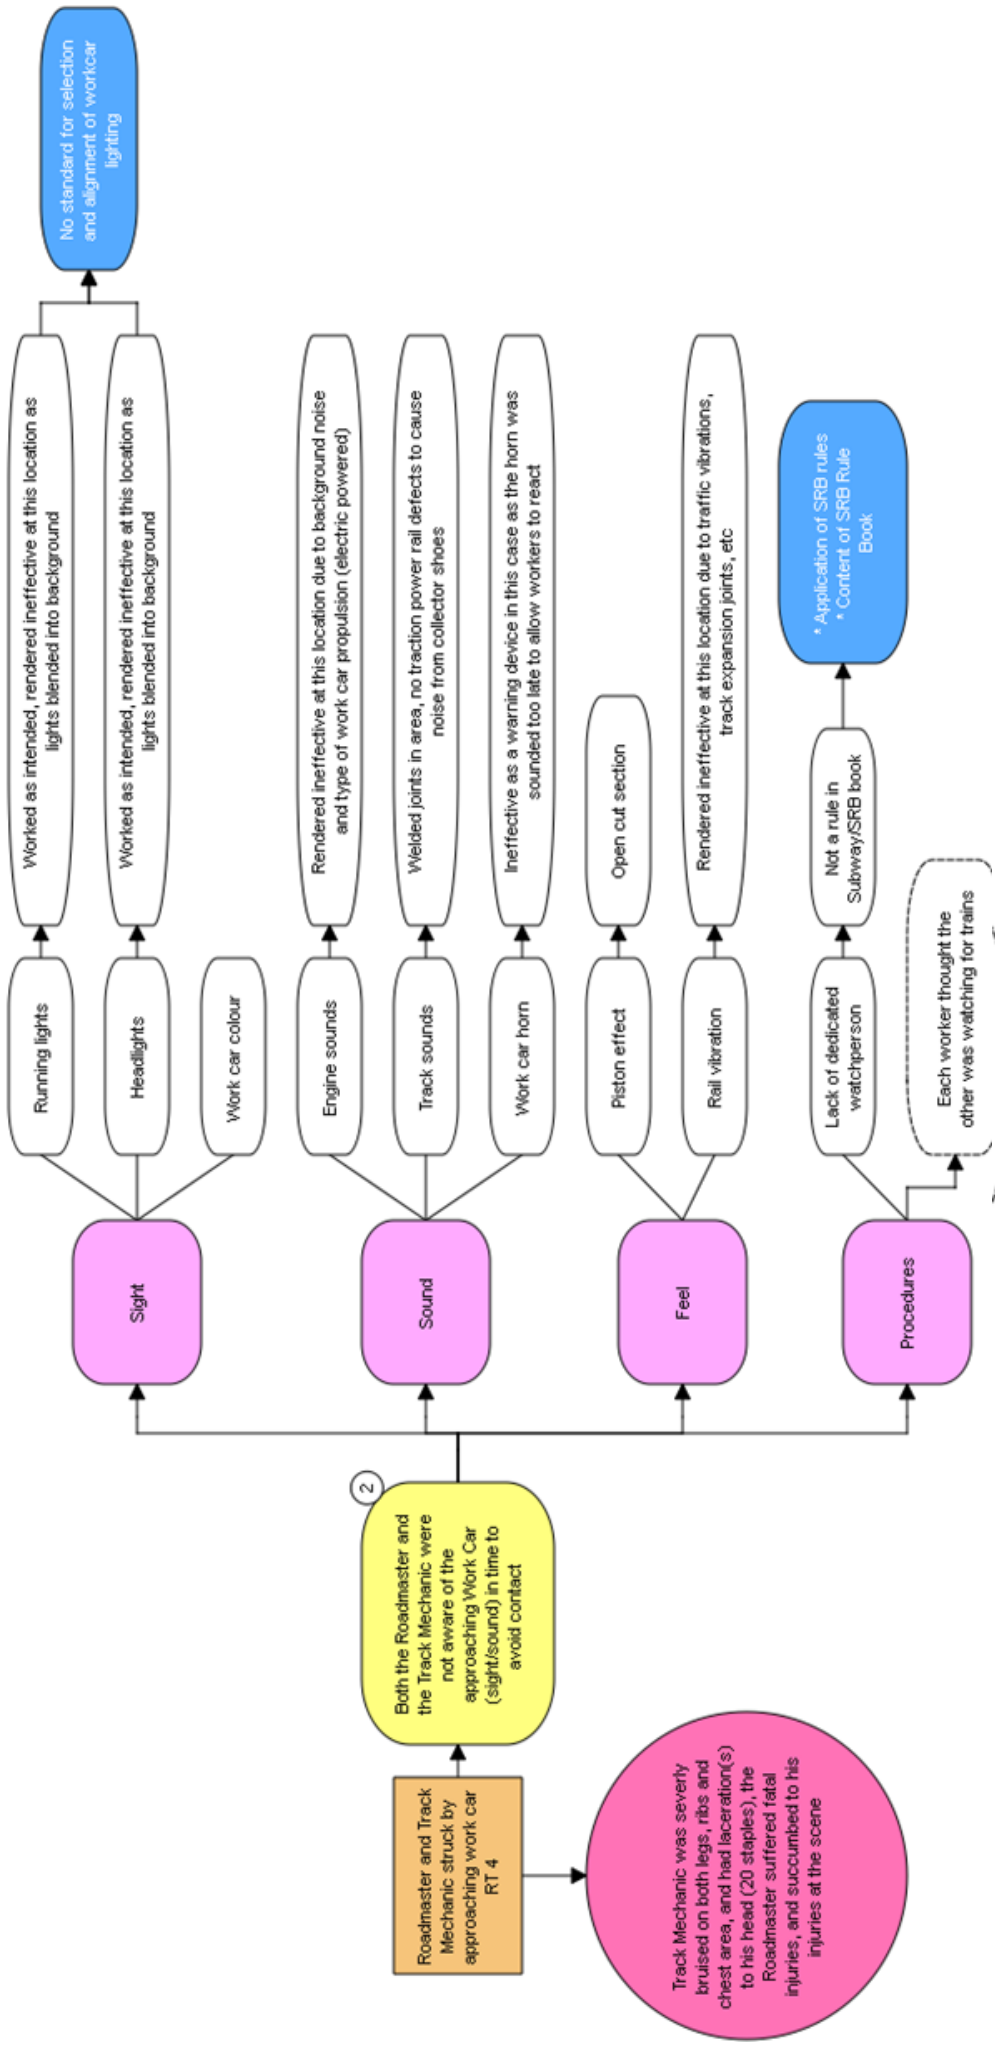
Figure 10

The Events and Conditions Sequence analysis found that failure to detect the approaching work car was a causal factor. The specific safety barriers that failed include sensory cues of sight, sound and feeling as well as the procedural failure of the lack of a dedicated watchperson. There were two direct root causes identified and one underlying issue (See Appendix C and Figure #10, Page 32):

The DCOO implement the recommendations in Rail Cars and Shops Problem Report 24885.

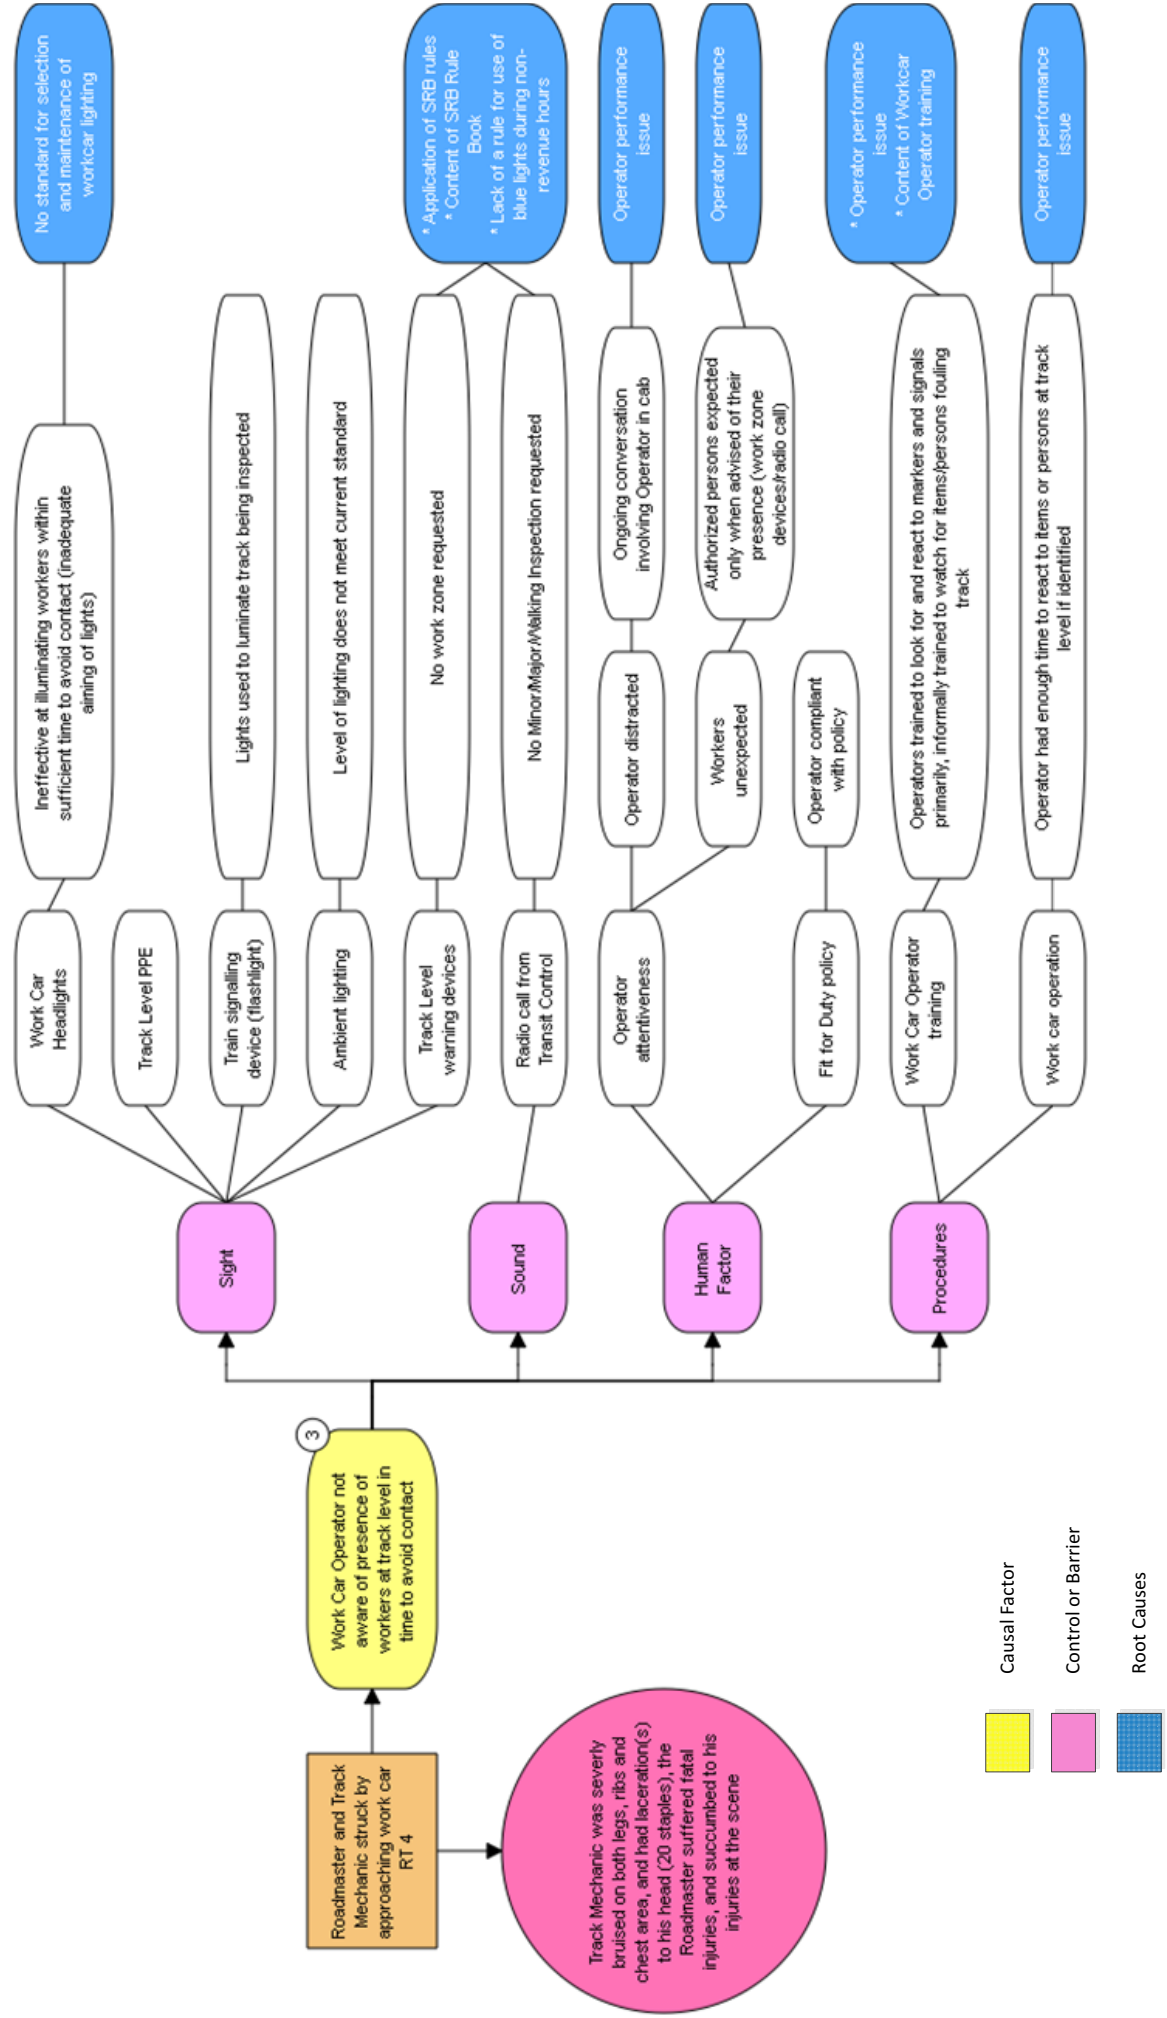
Figure 11

7. The Operator’s inattentiveness is explained by his conversation with the other occupants of the work car cab, aggravated by the unexpected presence of the track crew. There is no expectation that the other workers in the cab assist as lookouts for the Operator. There is guidance regarding distractions from co-workers while operating work cars, in the Training Department’s Work Car Operator Initial Resource Book, Section D2-3. The Operator’s performance is seen to be a root cause given that he stated “it looked like there was something there” at no less than 700 feet from the incident site, but maintained an average speed of 40 km/h and did not look directly ahead to see what it was, until much too late.

The procedural barrier failed in that the Operator was using the signal and wayside marker system for guidance with insufficient attention to the potential for people or objects foul of the rail. The subway is a closed system but not an impermeable one. In addition to track workers, Operators should expect occasionally to find items such as fallen trees, trespassers and animals foul of the rail. This aspect of training and operations is a contributing factor to the incident.

There is a need for a program to improve work car Operator attentiveness.
