TORONTO TRANSIT COMMISSION REPORT NO.

SUBJECT: SUBWAY STATION APPEARANCE IMPROVEMENT UPDATE

Subway Station Appearance Improvement Update

Commission Meeting – August 26 2009

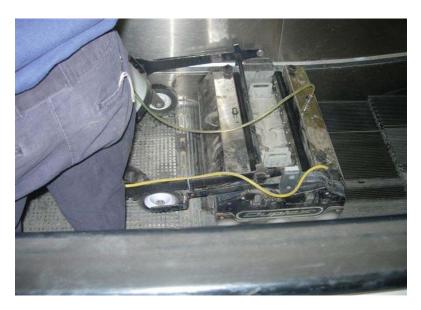
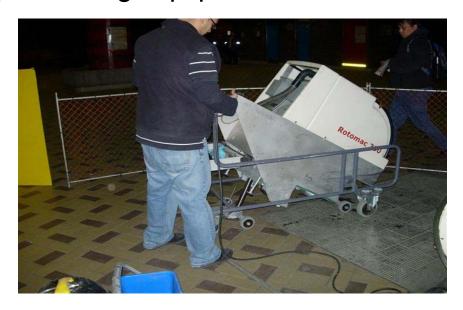
• Electric Powered Escalator Step Cleaning Equipment

- Steam Clean Floor and Comb Plates
- Lock Out/ Tag Out Escalator for Scaffolding for Ceiling & Wall Cleaning
- Graffiti Removal from Steps and Handrails

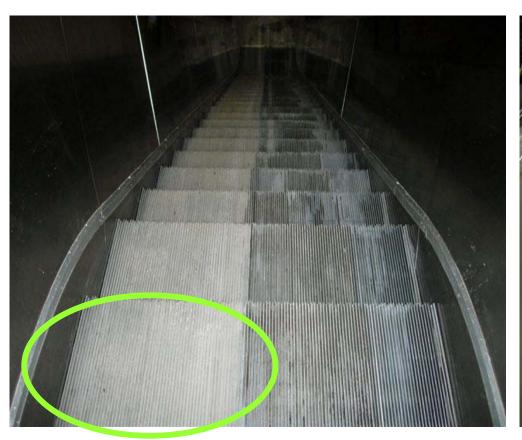
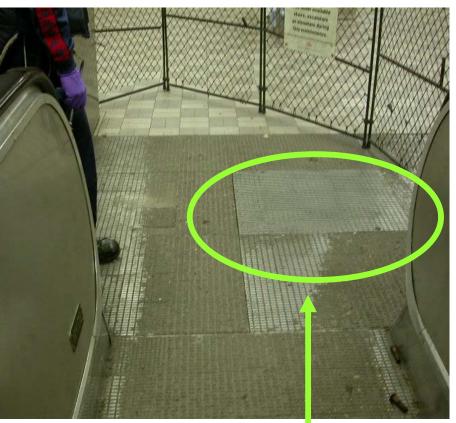
Escalator Cleaning Crew

Cleaned ½ Step

Cleaned Plate

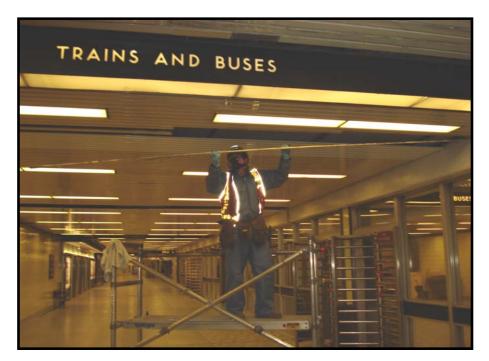
Missing Ceiling Slats

- Removal 70 Projects
- Reinstallation 55 Projects
- Ceiling Slats are Being Reinstalled as Projects are Completed

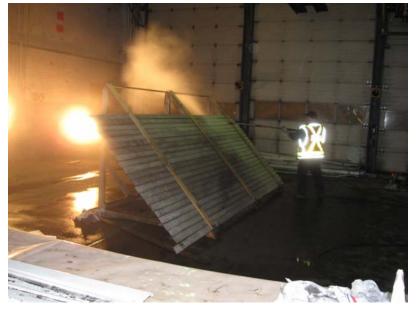
Power Wash Cleaning System
Prior To Reinstallation Tested In
August 2009

- Power Washed at Storage Location With Floor Drain
- Wrapped in Plastic and Delivered to Subway Station
- Installed Clean

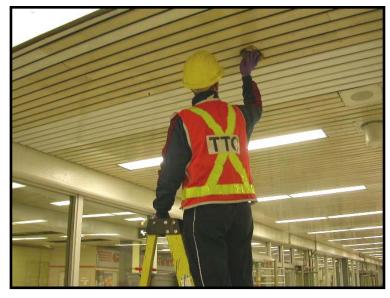
- Crew Not Required for Vacation / Sick Relief
- Schedule Prepared Based on Ceiling Area Per Station
- Crew Can Clean Ceilings in Approximately 20 Stations Per Year
