INDEPENDENT REVIEW

REPORT SRT LINE 3 INCIDENT

SYSTRA Canada Reference: 23038-GART-0001_D

Toronto Transit Commission (TTC)

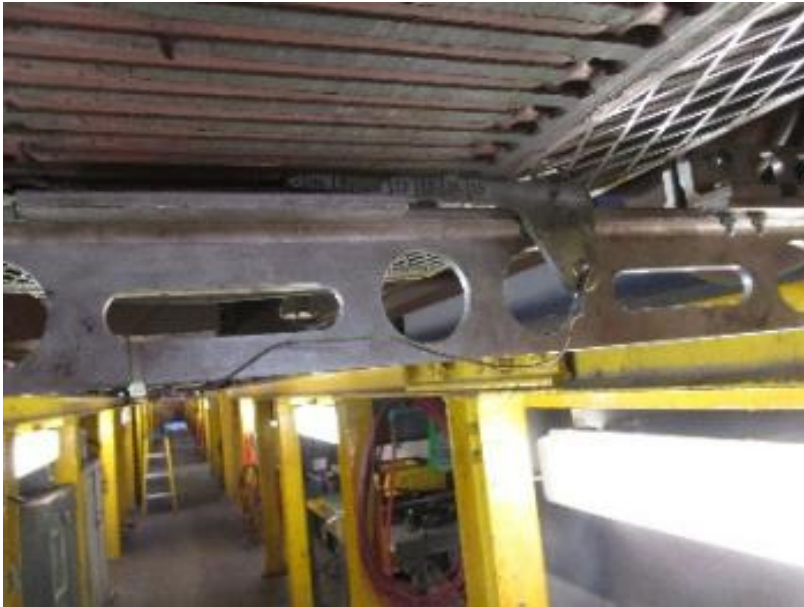
Figure 4: Adjustment method on LIM

The control and adjustment for the LIM on the rolling stock is done with a ruler and a measuring wedge every 32 days, see Figure 4 and Track and Structure uses a composite ruler to inspect the height of the reaction rail whenever a work order is generated, see Figure 5.

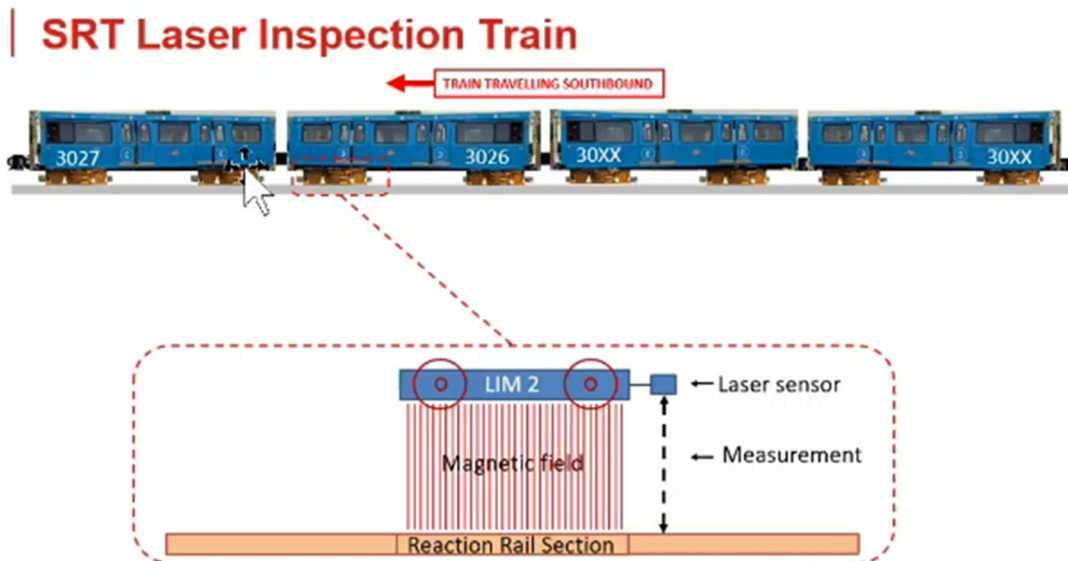
Figure 6: Position of the laser device

Additionally, RC&S instated specialized testing to detect high spots on the reaction rail to mitigate an increasing reporting of damages to the LIM. The first iteration of this test used a sacrificial block in front of the LIM to mark the reaction rail whenever it was higher than the defined threshold. This method was proven inefficient as the block would wear down on the first few occurrences and therefore would not be able to detect further high spots. The methodology was modified to use laser distance sensor mounted near the LIM.

The position of the laser distance sensor is shown in the figure below:

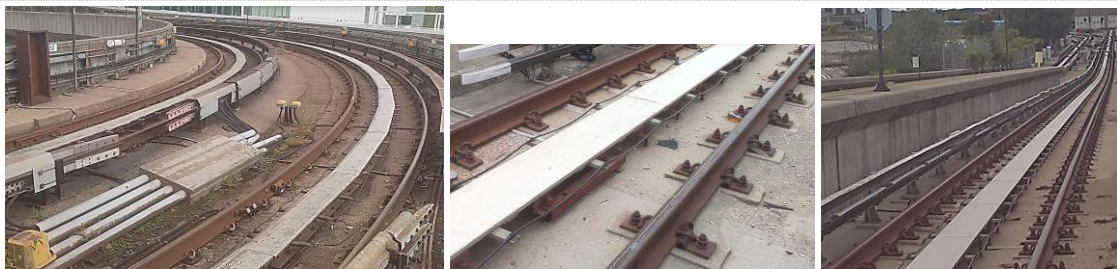
1. Kennedy Station

- Track visual observation of the installed track components (rails, fasteners, platform, etc)
- Special focus on the reaction rail alignment and its fastening condition

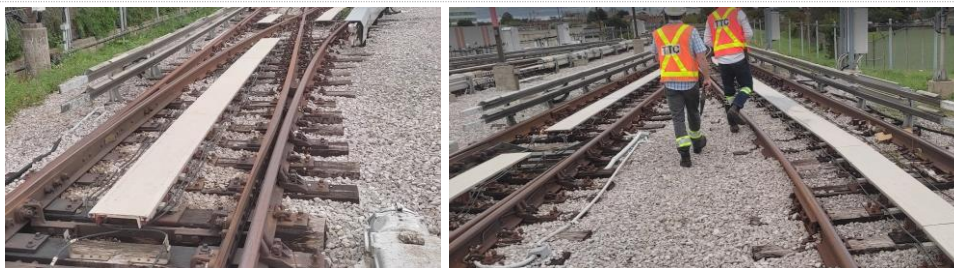
- Yard visual observation of the installed track components (turnouts, rails, fasteners, platform, etc)

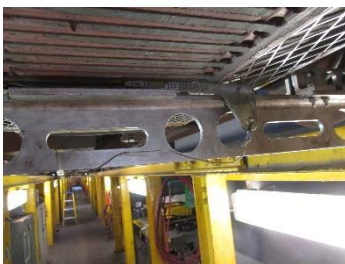
Photo n°3

- The control and adjustment for the rolling stock is done with a ruler and a measuring wedge (photo n°3) and the control and adjustment at track level is done with a rolling stock equipped with laser sighting at the front (running every 2 to 3 months), then the control and adjustment is done with a composite ruler (photo n°4)
