Work Car Hydraulic Leak Incidents Update

Date: December 3, 2024

Subway Work Car Hydraulic Fluid Leak Investigation Report

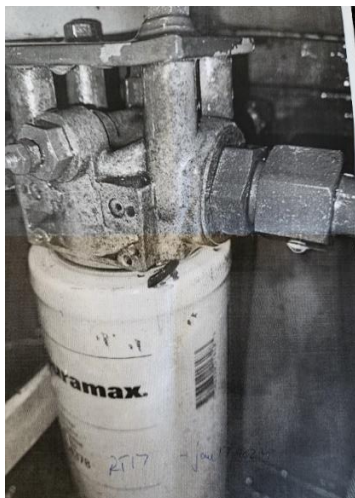
Five years of SMS maintenance records do not provide any evidence of hydraulic filter replacements for RT17. Hatch believes the filter and O-ring components may have been due for replacement, lacking any evidence to the contrary.

Figure 2 - RT17 View of hydraulic filter mounted with failed O-ring

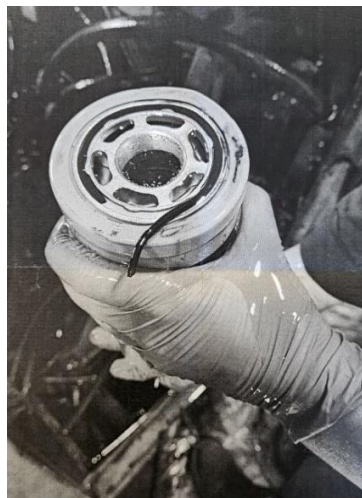
Figure 3 - RT17 Close-up view of failed hydraulic filter O-ring

The review of TTC's maintenance records for RT17 suggest the filter and failed O-ring components may have been past their service life. TTC maintenance personnel typically mark the installation date on the filter, but this practice alone, without updating the service history in a record keeping system, can lead to missing required component maintenance. TTC maintenance reporting practices also require improvement, as the level of information in the SMS maintenance work order system did not always provide sufficient detail to determine when filters are due for replacement (i.e., part numbers for old filters and replacement filters).

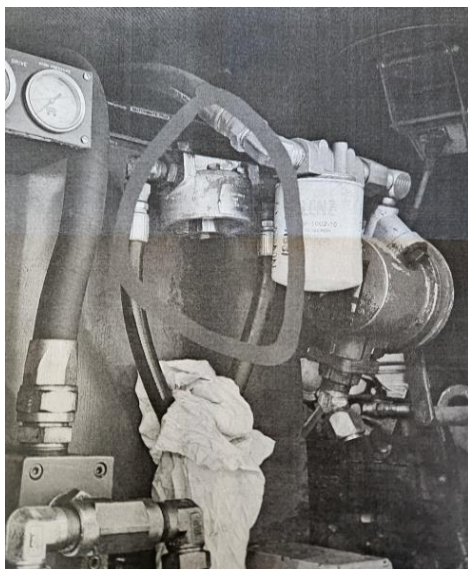
A faulty hydraulic filter O-ring was cited as the root cause of the hydraulic fluid leak. Evidence of the described faulty filter with defective O-ring was not available at the time of Hatch's onsite visit. However, a picture of the filter mounting housing that was taken at the time of the repair was provided. Faulty filter inventory and/or improper installation during replacement were identified as the potential causes for the O-ring failure. TTC personnel explained that the entire filter assembly (filter and filter mounting housing) was replaced by a new filter assembly after the failure due to the obsolescence of the original filter type.

Figure 4 - RT7 Hydraulic Filter Mounting Housing, Original Configuration. Failed Filter Removed

Five years of SMS maintenance records (see Figure 6 below) do not provide any evidence of hydraulic filter replacements for RT7. The O-rings used in the filter assembly likely hardened and fractured due to use beyond their service life, given the O-rings are composed of rubber. The interval and procedure for the inspection and maintenance of the filters is unclear or not specified by TTC or the Original Equipment Manufacturer (OEM) of the work cars.

A review of TTC's maintenance records suggests the O-rings used in the filter assembly may have failed due to suspected use beyond their service life. TTC should develop maintenance requirements for the filters based on the lifecycle of the components, including inspection and service intervals as well as maintenance procedures.

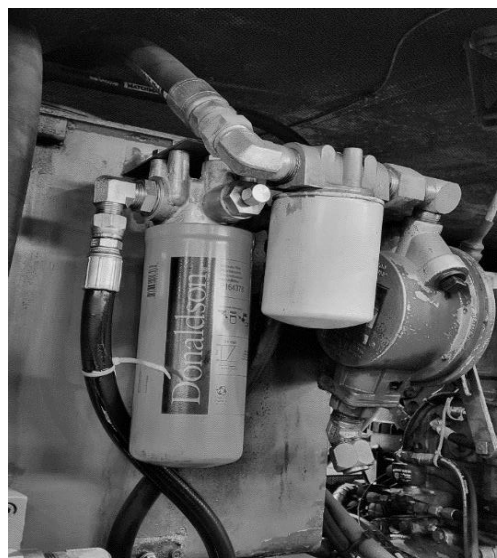
Figure 5 - RT7 Hydraulic Filter and Filter Mounting Housing, New Configuration (Current)

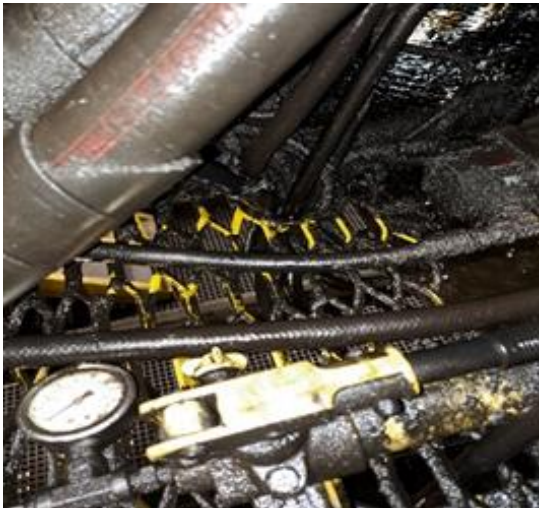
The 100L to 140L approximation includes the hydraulic fluid that saturated the pump room (see Figure 9 below) and coated the RT56 carbody underframe (see Figure 10 below). Cut-outs in the center and left side of the pump room floor area enabled hydraulic fluid to seep through the side sills.

Figure 9 - Overhead view of engine room

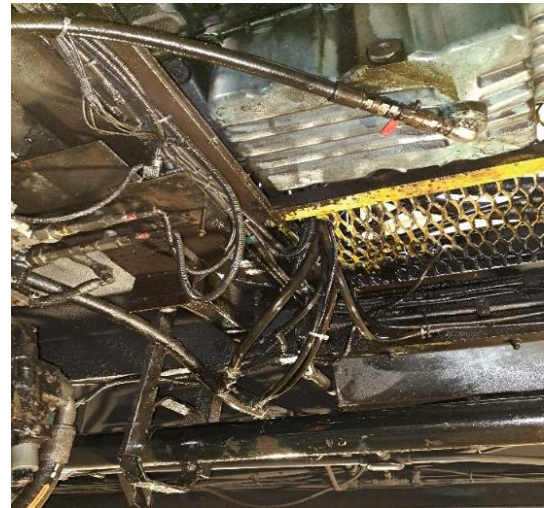
Figure 10 - View of engine room from undercar

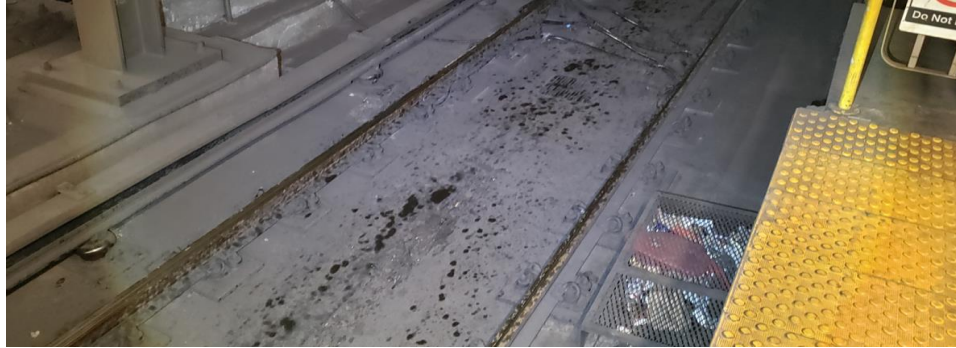
transferred to the tracks. RT56 continued to leak hydraulic fluid while pushed south on the northbound tracks from Spadina to Museum station and then when pulled from Museum to Bay Lower and then East to Greenwood Yard, creating slippery rail conditions.

Figure 11 - Hydraulic fluid leaked on rails and track bed at Sherbourne station

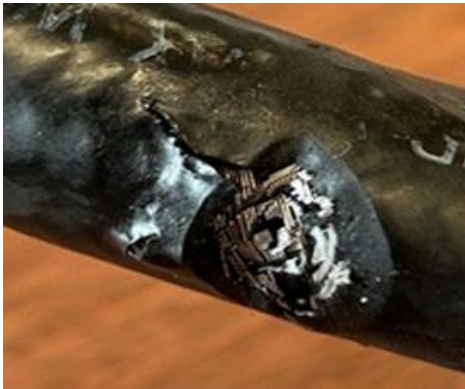
An investigation of TTC's May 13, 2024 spill incident determined an abraded hose routed tightly against the chamfered edge of a steel ring in the floor grate was the failure mechanism that caused the hydraulic fluid leak. Over years of service, the motion of the hose against the ring caused wear and visible abrasions on the hose. The continued abrasion of the hose exposed the wire mesh which created a sharp edge on the ring and eventually caused the hose to fail, enabling hydraulic fluid to leak from the hose.

Figure 12 - Abrasion on the hose

After examining the failed hose pictured in Figure 12, Geoffrey Philipsen, a Senior Product Application Engineer for a hydraulic hose supplier, confirmed the observed abrasions were the failure mechanism that caused the spill incident. The hose and ring were then sent to Acuren Testing Laboratories (formally Cambridge) in Oakville for visual, microscopic, and scanning electron microscope examination.

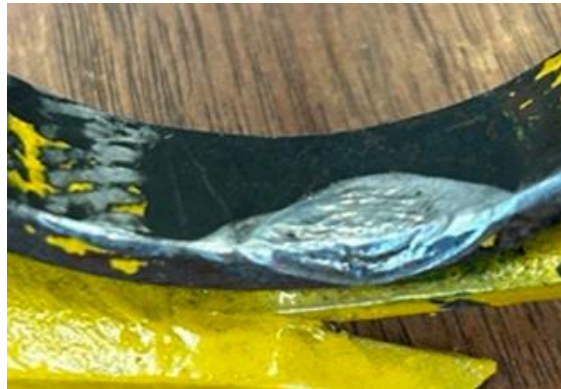
Figure 13 - Wear on the ring

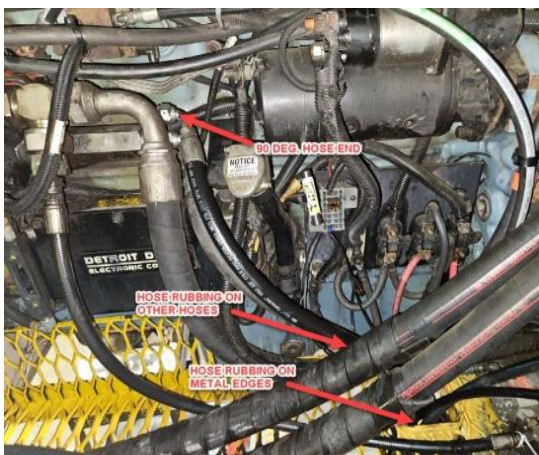
Over the years, TTC millwrights adapted the routing to address issues with the workcar OEM's hose arrangement. The TTC routing scheme pictured in Figure 15 below used a 90-degree fitting instead of the work car OEM's 45-degree fitting, is shorter in length, and avoids the engine. However, TTC's routing scheme created a sharp hose angle at the exit point of the circular steel floor ring, which led to the abrasion discussed in Section 2.5.5.1 that eventually wore through the hose.

Figure 15 - RT56 TTC hose routing in May

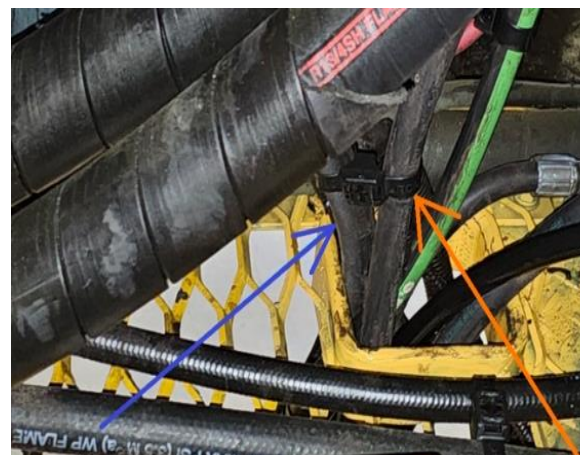
TTC maintenance personnel are still working to develop an optimal routing scheme and floor grate opening. As an interim repair measure, the original circular ring was cut out and replaced with a larger rectangular shape (see Figure 16) after the May 13 incident. Now, the hoses are bound together (orange arrow) to reduce the angle (indicated by the blue arrow) at the exit point to reduce the risk of similar failures. However, it is noted that the hoses are still in contact against the steel ring and are still subject to abrasion through movement.

Figure 16 - RT56 hoses as of June 6

In accordance with Hatch's recommendation to improve configuration control, identified equipment issues should be reviewed for disposition, and if necessary appropriate TTC staff should review and approve any design changes for incorporation. Further, the implementation of changes should be confirmed by quality assurance resources.

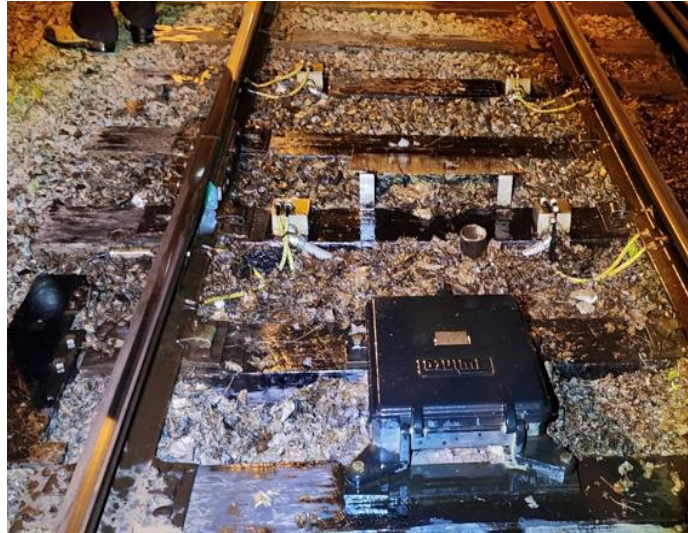
Figure 17 - RT84 Spill NB Eglinton on May 15

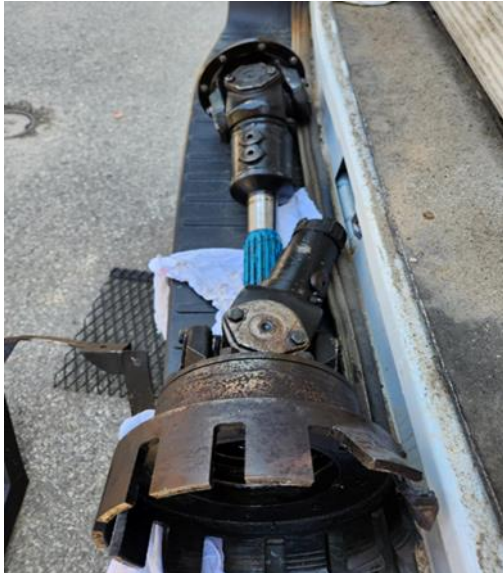
The hydraulic fluid spill was caused by a series of events. First the excessively worn driveshaft clutch plates seized and disintegrated, enabling the driveshaft to rotate freely unconstrained. The flailing driveshaft then hit the housing cage, causing the housing cage to impinge on a hydraulic hose at the fitting area. The force of the impact severed the hose from its fitting, causing the evacuation of hydraulic fluid onto the rail bed.

The RT84 SMS maintenance records for the past 12 years include 3 vacuum clutch replacements (11 April 2019, 01 Feb. 2017 and 02 April 2012). Though, the clutch component is expected to last a lot longer. The clutch units should be regularly inspected, given TTC has replaced 3 clutches in a 12-year period for the RT84 work car.

Figure 18 - RT84 clutch housing with broken driveshaft

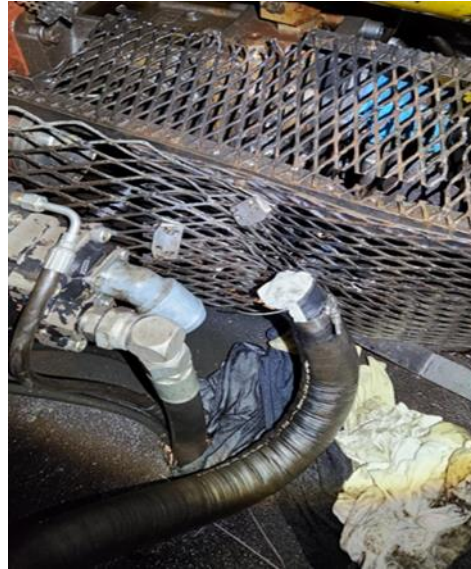
Figure 19 - RT84 severed hydraulic hose

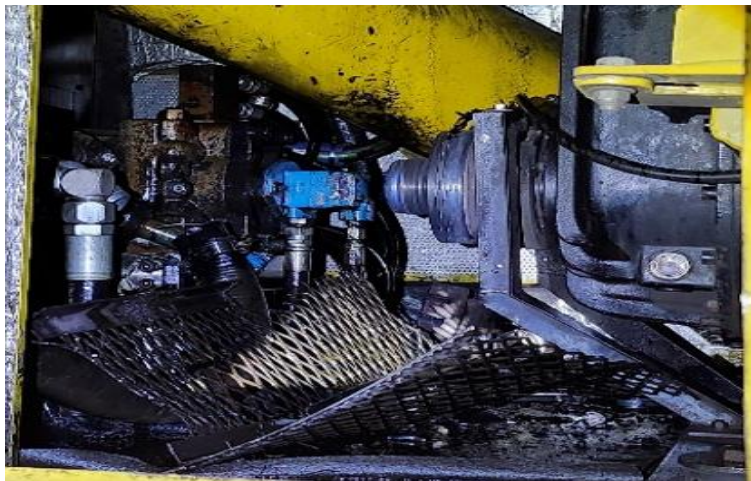
Figure 20 - RT84 engine compartment with broken drive shaft and damaged shaft guard

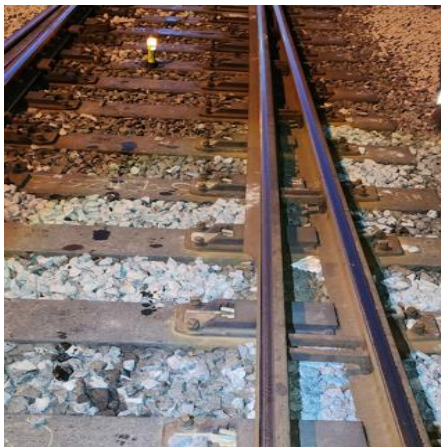
Figure 21 - RT41 Hydraulic fluid spill at work site (see track bed)

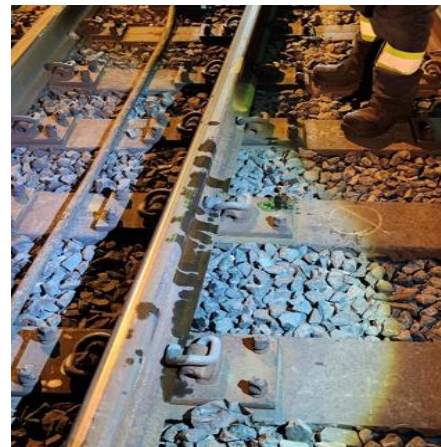
Figure 22 - RT41 Hydraulic fluid spill at work site (see running rails)

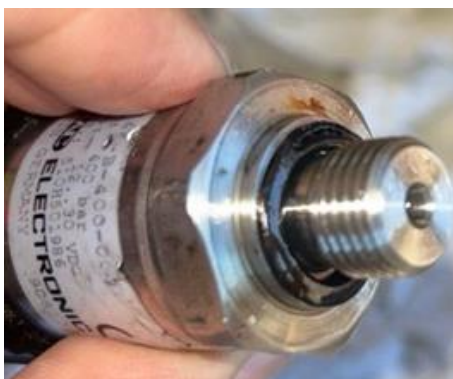
A failed O-ring underneath the pressure sensor was identified as the root cause of the hydraulic fluid leak. The removal of the O-ring from the pressure sensor revealed the O-ring was excessively compressed and fractured along one edge.

Figure 23 - RT41 Pressure Sensor with O-ring

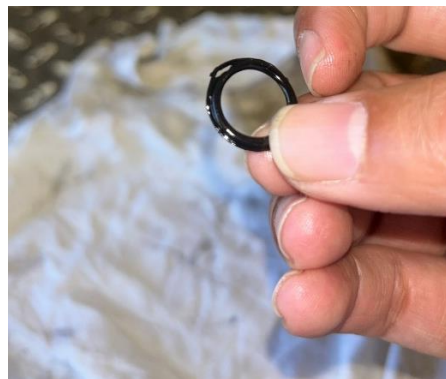
Figure 24 - RT41 Failed O-ring

The pressure sensors and FKM rubber O-rings come as an assembly from Hydac, located in Germany. TTC advised the last recorded maintenance for this assembly was in 2015 when a major overhaul/re-build activity was undertaken. Over 9 years, the O-ring could have hardened over time, becoming more brittle, resulting in a minor leak.

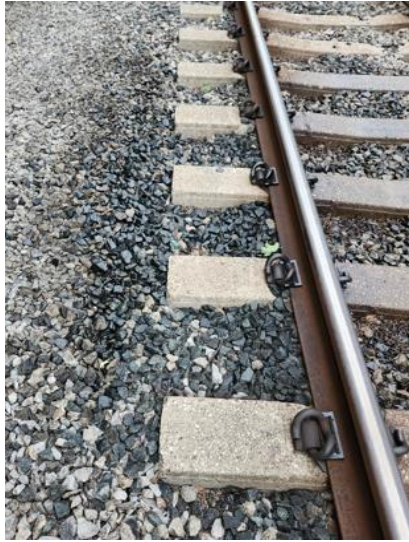
Figure 26 - RT18 spill area

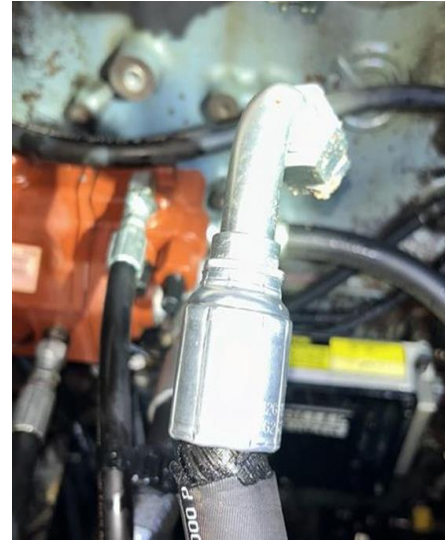
Figure 27 - RT18 failed hose

The hydraulic hose failure was caused by the use of an incorrect fitting and improper hose rating type. TTC personnel told Hatch that staff observed “weeping of a hydraulic hose” on May 22nd and May 23rd during a fleet inspection and requested a replacement hose. A 5000 PSI rated hose was used for the assembly of the replacement hose, instead of the required 3000 PSI rated hose due to the lack of material availability. The Shop used the available one-piece fittings on the 5000 PSI hose, which requires two-piece fittings. The replacement hose failed on May 26th shortly after the May 24th installation on RT18. The original hose from May 23 was not available for further analysis at the time of Hatch’s visit.

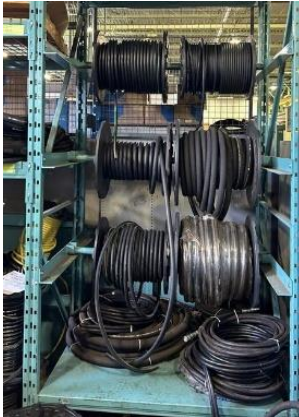
Hatch also observed a general disorganization of the work area and materials, including a lack of clear identification of the hoses and fittings in the storage area of the shop floor. Note: An audit was not performed to confirm the validity of Hatch’s findings regarding the condition of the work area and materials.

Figure 28 - Hose storage area

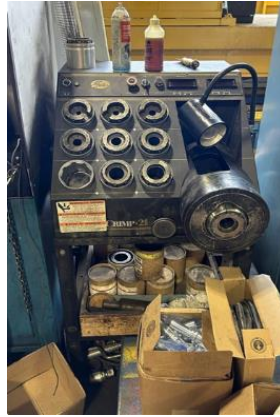
Figure 29 - Fittings area

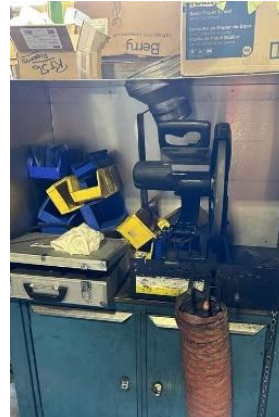
Figure 30 - Hose assembly area

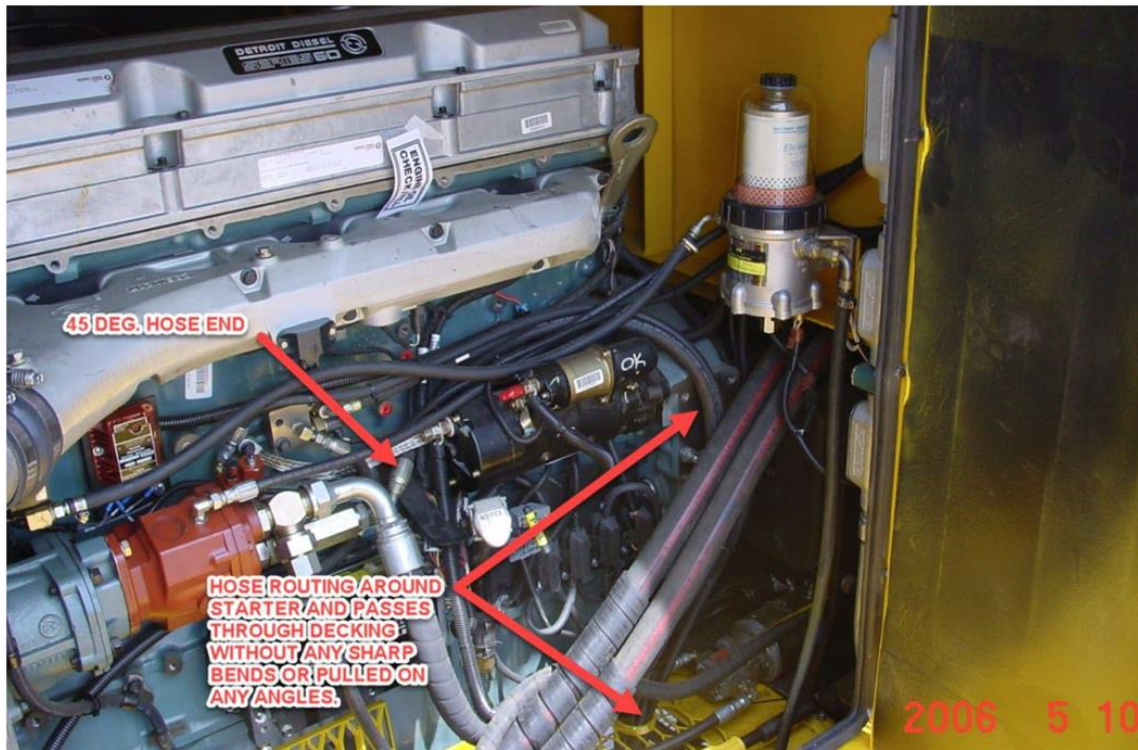
Acuren received a black hydraulic hose showed damages on the body and leaking after being in service. The hose was used in a work car that was in a tunnel at the time of incident. The outside temperature was likely to be 9 – 10 °C. Acuren was asked to conduct a failure analysis examination to determine the cause of the incident. Figure 1 shows the hose during the service.

FIGURE 1. THE HOSE IMAGE IN SERVICE

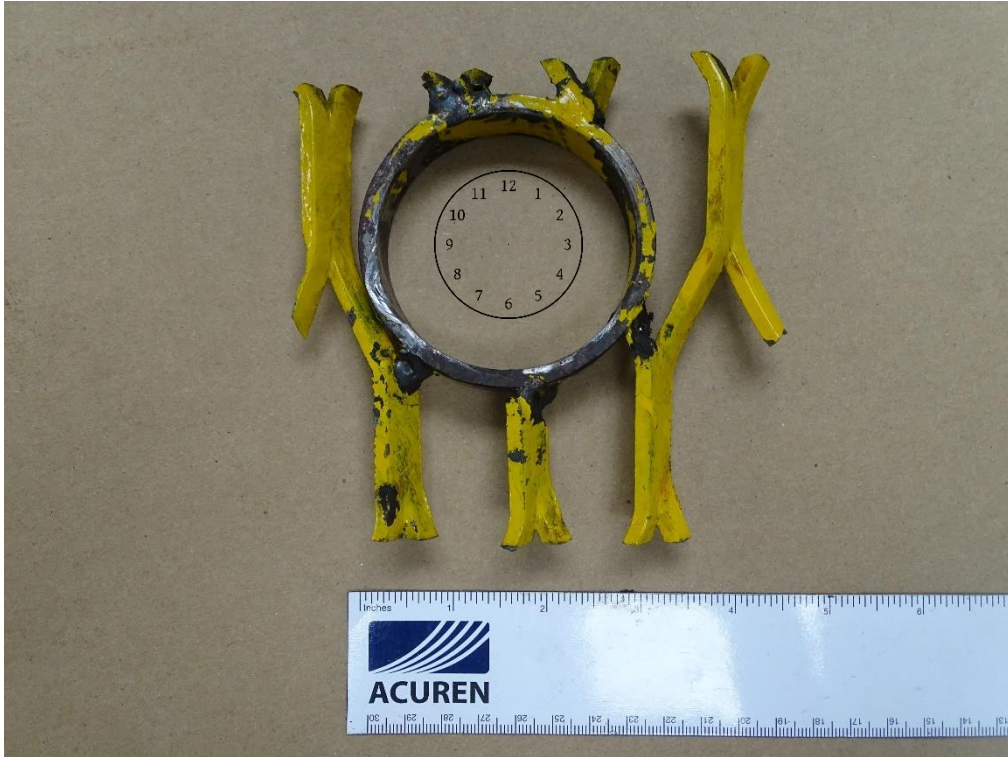
- i) To facilitate communication, the clock position was used to describe the ring as shown in Figure 11.
- ii) Deformation was observed at the edge of the ring at about 8 o'clock. In addition, evidence of rubbing was evident on the inner surface of the ring at the same position, Figure 12.
- iii) Similar shiny rubbed areas were observed on the edge and inner surface of the ring at 10 and 11 o'clock positions, Figure 13.
- iv) The metal ring exhibited rubbing at the edge and inner surface at about 4 and 5 o'clock,

FIGURE 11. THE RING RECEIVED ALONG WITH THE HOSE

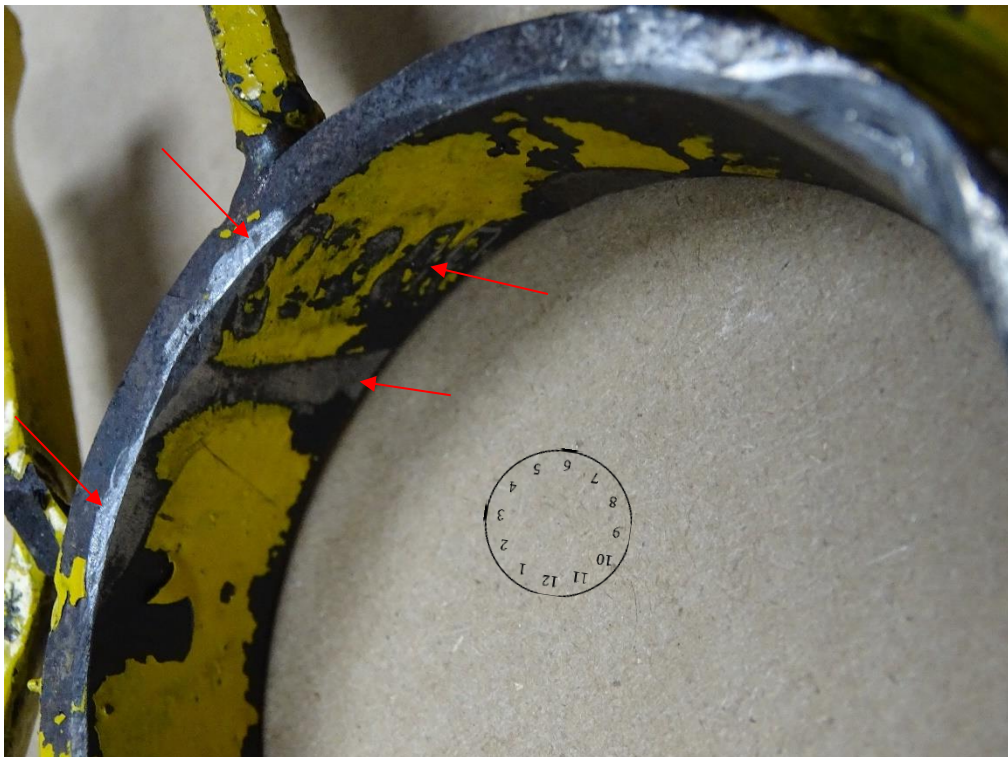
FIGURE 14. EVIDENCE OF RUBBING AT 4 AND 5 O'CLOCK

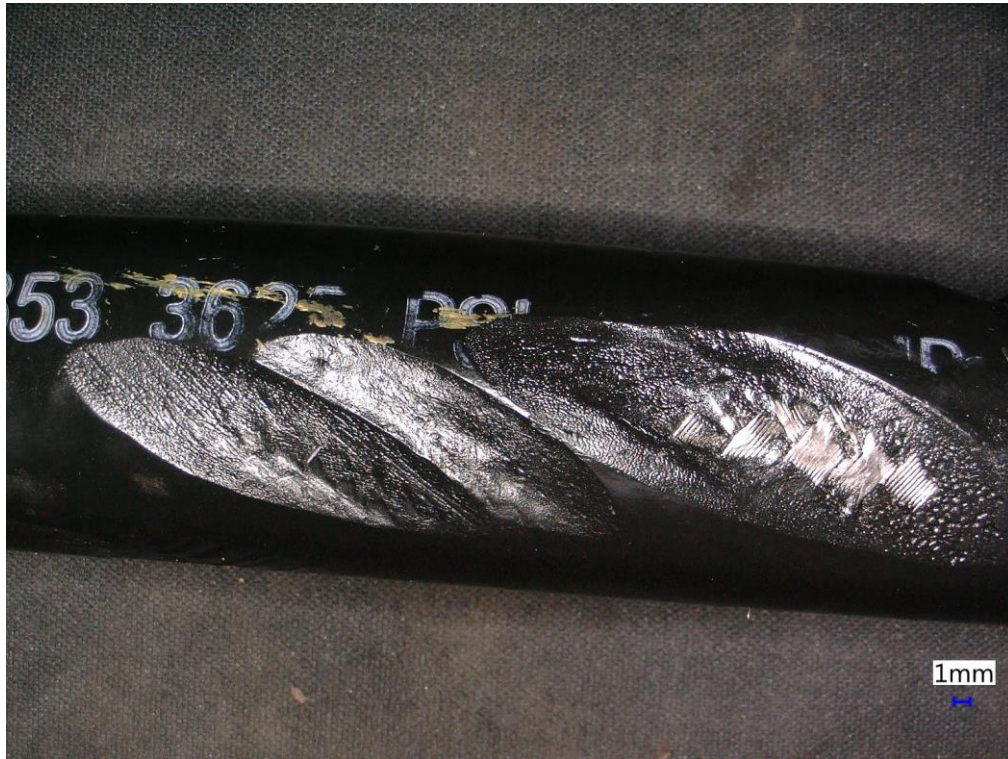
FIGURE 15. AREA 1 AND 2 UNDER 10X MAGNIFICATION

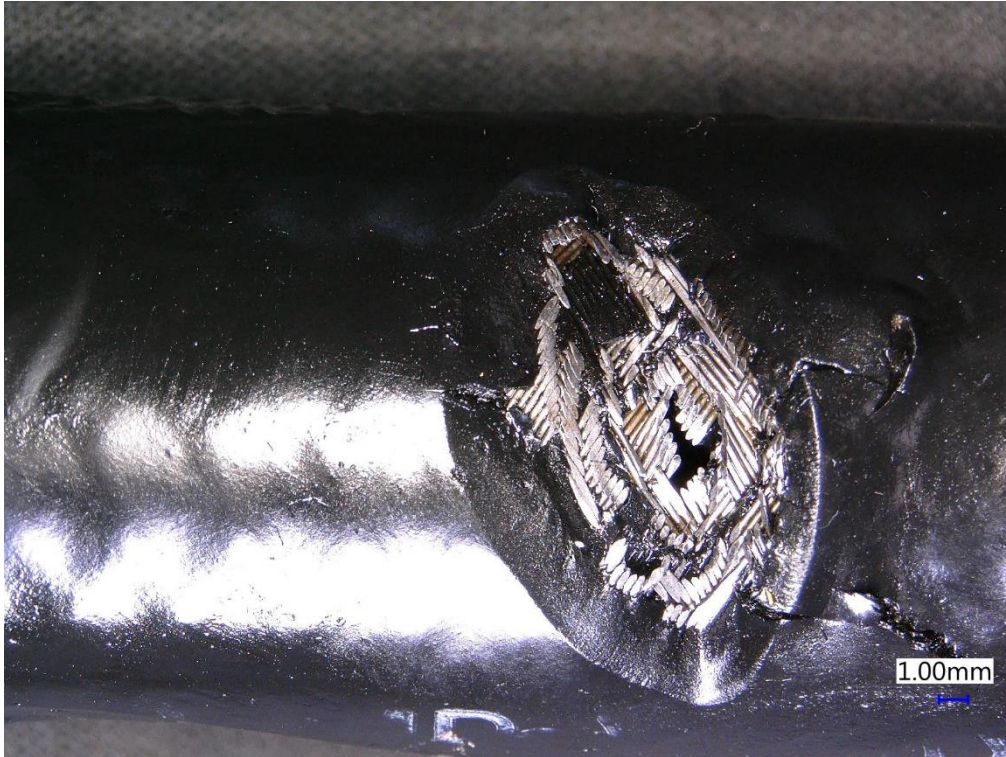
FIGURE 19. A GENERAL IMAGE OF AREA 3

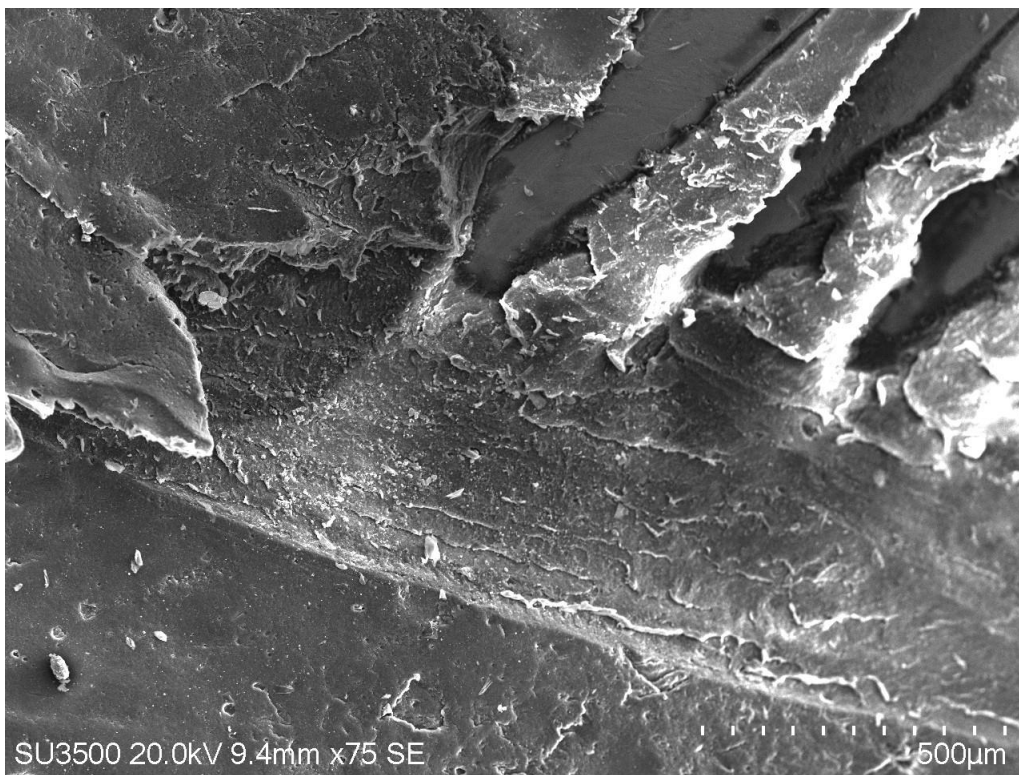
- ii) Figure 27 shows another example of worn flat wire strands in the reinforcement layer within the damaged area 2. Higher magnification examination showed scratches, indentations and gouging on the surface, indicating the progression of wear in this area, Figure 28, Figure 29, and Figure 30. The appearance of polymeric cover in the damaged area indicated rubbing/wear, Figure 31. Figure 32 shows the border between the worn cover and the cover outside of the area 2 (intact cover).

FIGURE 31. APPEARANCE OF PLASTIC COVER IN THE DAMAGED AREA 2

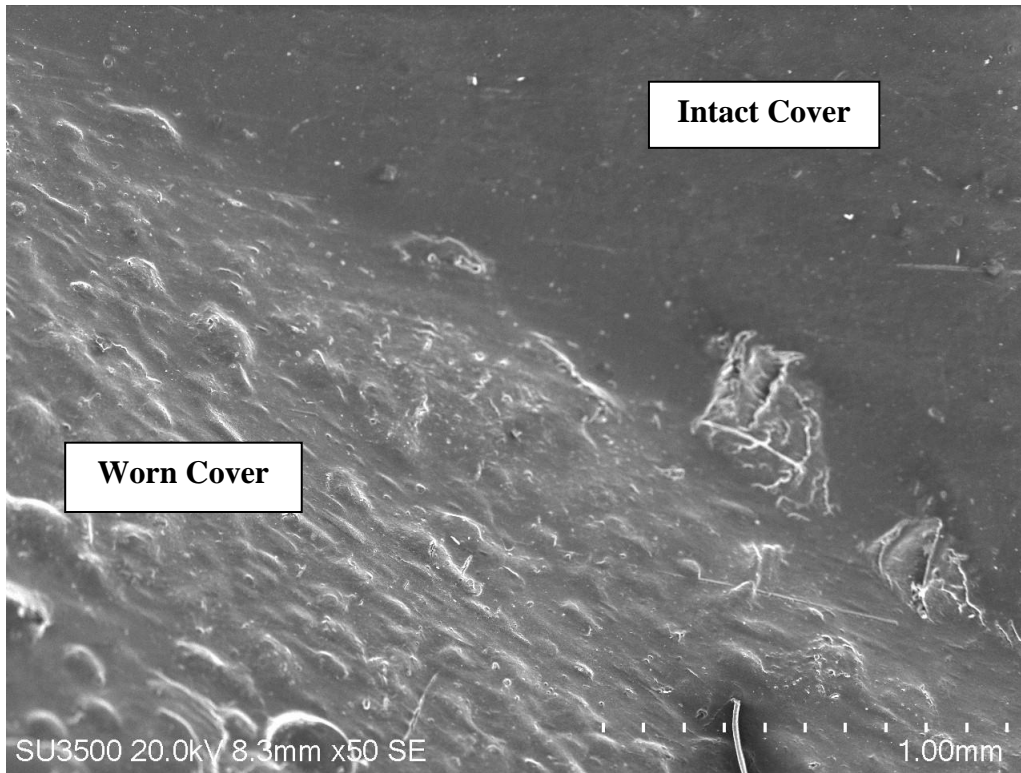
FIGURE 32. BORDER OF WORN COVER AND INTACT

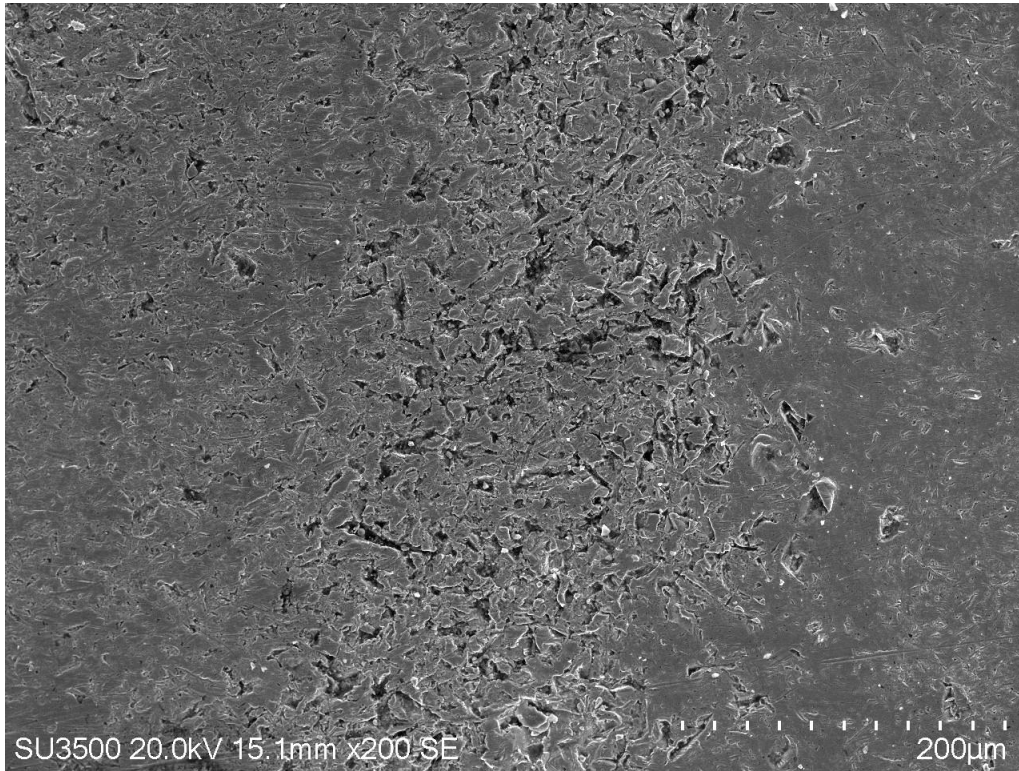
- vi) Figure 42 and Figure 43 show another example of broken wire strands, exhibiting wear marks on the flat tip.
- vii) The damaged area observed on the inner surface of the ring at 8 o'clock was also examined using SEM, Figure 44. The results showed scratch marks, indentation/impact marks, suggesting the presence of wear marks on the inner surface of ring, Figure 45, Figure 46, and Figure 47. The wear characteristics resembled those observed on the worn wire strands within the reinforcement layer of the hydraulic hose.

FIGURE 44. INNER SURFACE OF THE METALLIC RING AT 8 O'CLOCK

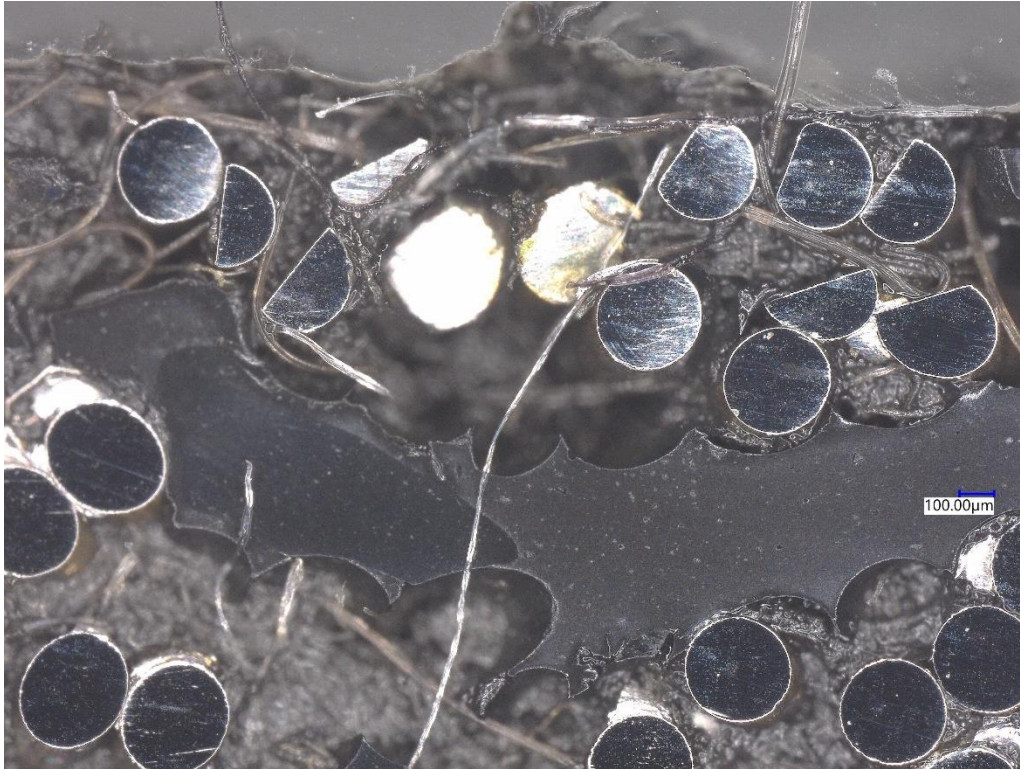
FIGURE 49. SHAPE OF THE WIRE STRANDS WITHIN THE DAMAGED AREA

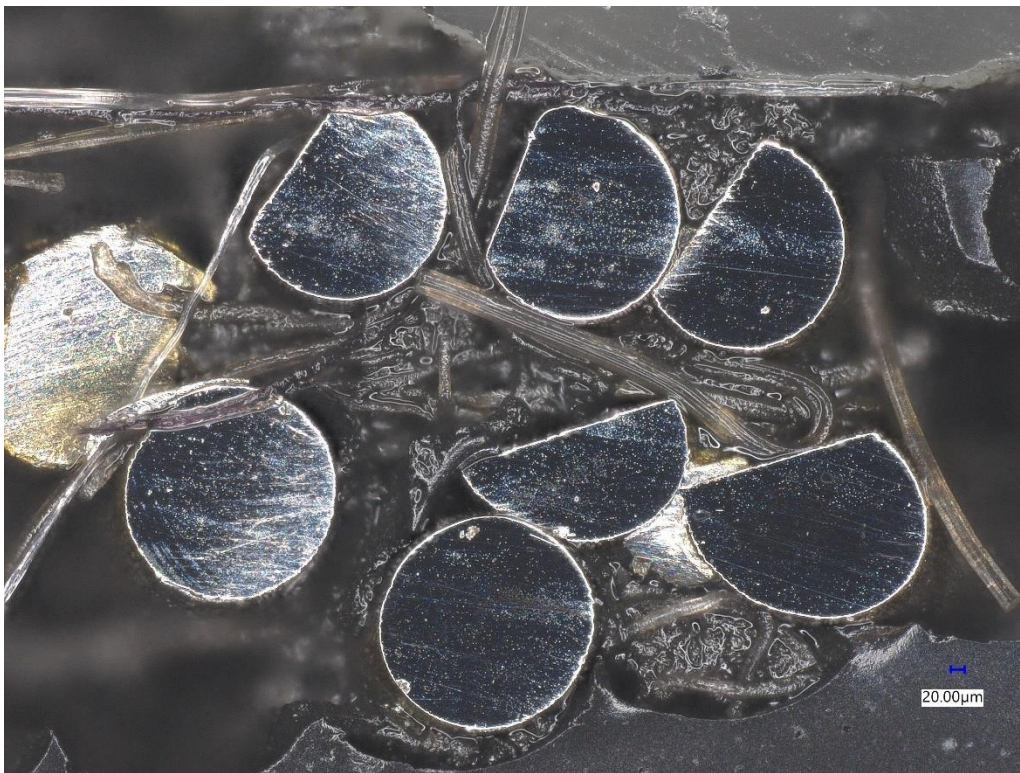
- i) Figure 48 presents a general image of the prepared cross-sectional metallographic sample in as polished condition. The cross-section shows two layers of black coating and a reinforcement layer (metallic wire strands) situated between them. The outer surface coating was thinner or totally removed in the damaged area resulted in exposure of the wire strands.
- ii) Closer view of the reinforcement layer within the damaged area is presented in Figure 49 and Figure 50. The wire strands exhibited a round cross-section. However, the shape of several wire strands, particularly those situated closer to the outer surface of the hose was compromised. The wire strands that were compromised exhibited a flattened edge when viewed in cross-section.
- iii) Examination after etching revealed tempered martensite structure in the wire strands, Figure 51 and Figure 52.

Metallographic examination exhibited a round cross-section for most of the wire strands within the reinforcement layer. However, the shape of several wire strands was compromised within a damaged area, especially those closer to the outer surface and exposed. These wire strands exhibited a flat edge in their cross-section that caused by continued wear process during the service.

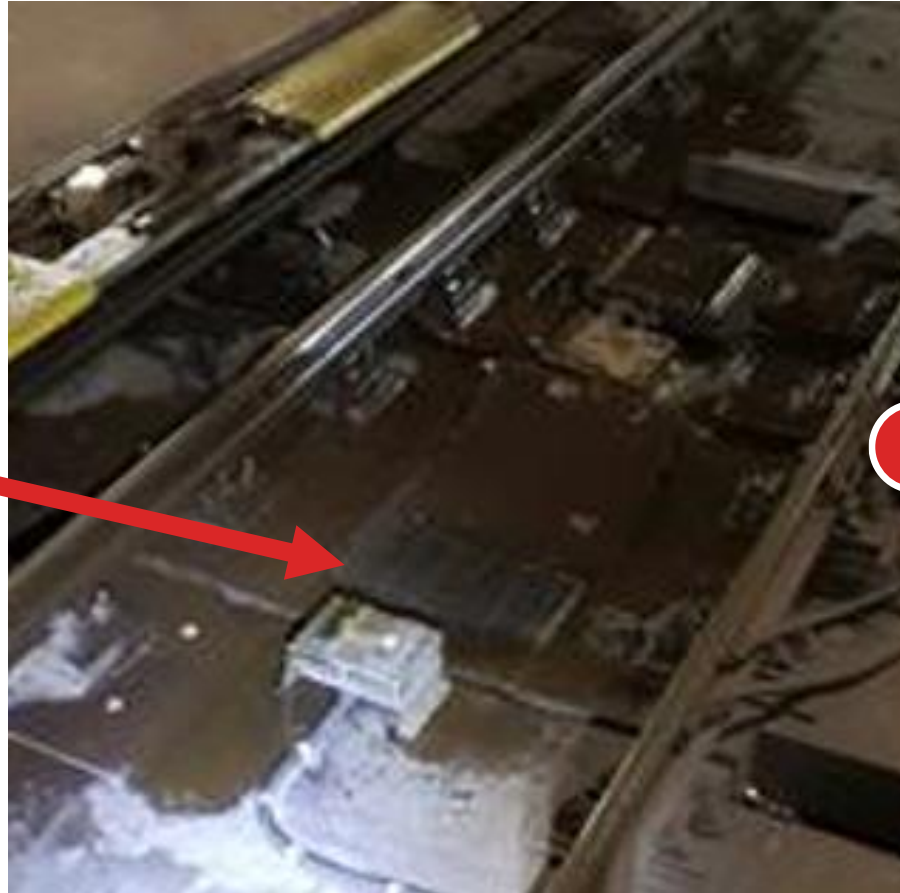
Leak thought to be only 5L at the time.

Through analysis it is estimated up to 140L was leaked at this location, with most having gone into the catch basin under this grate.

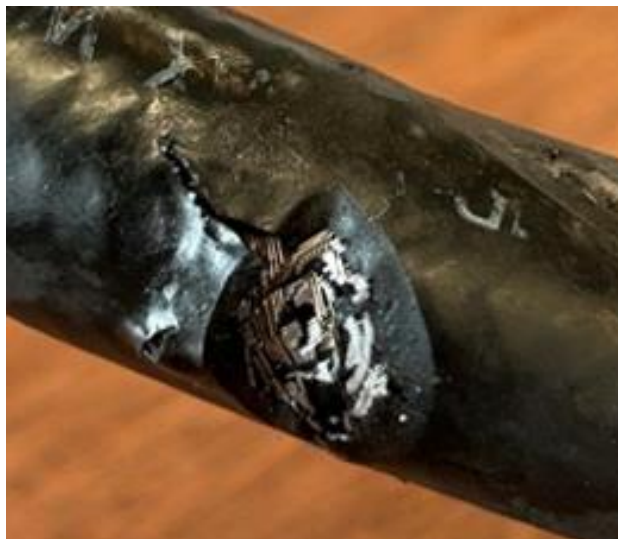
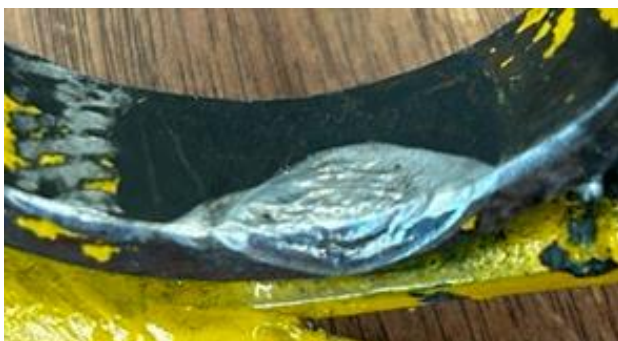
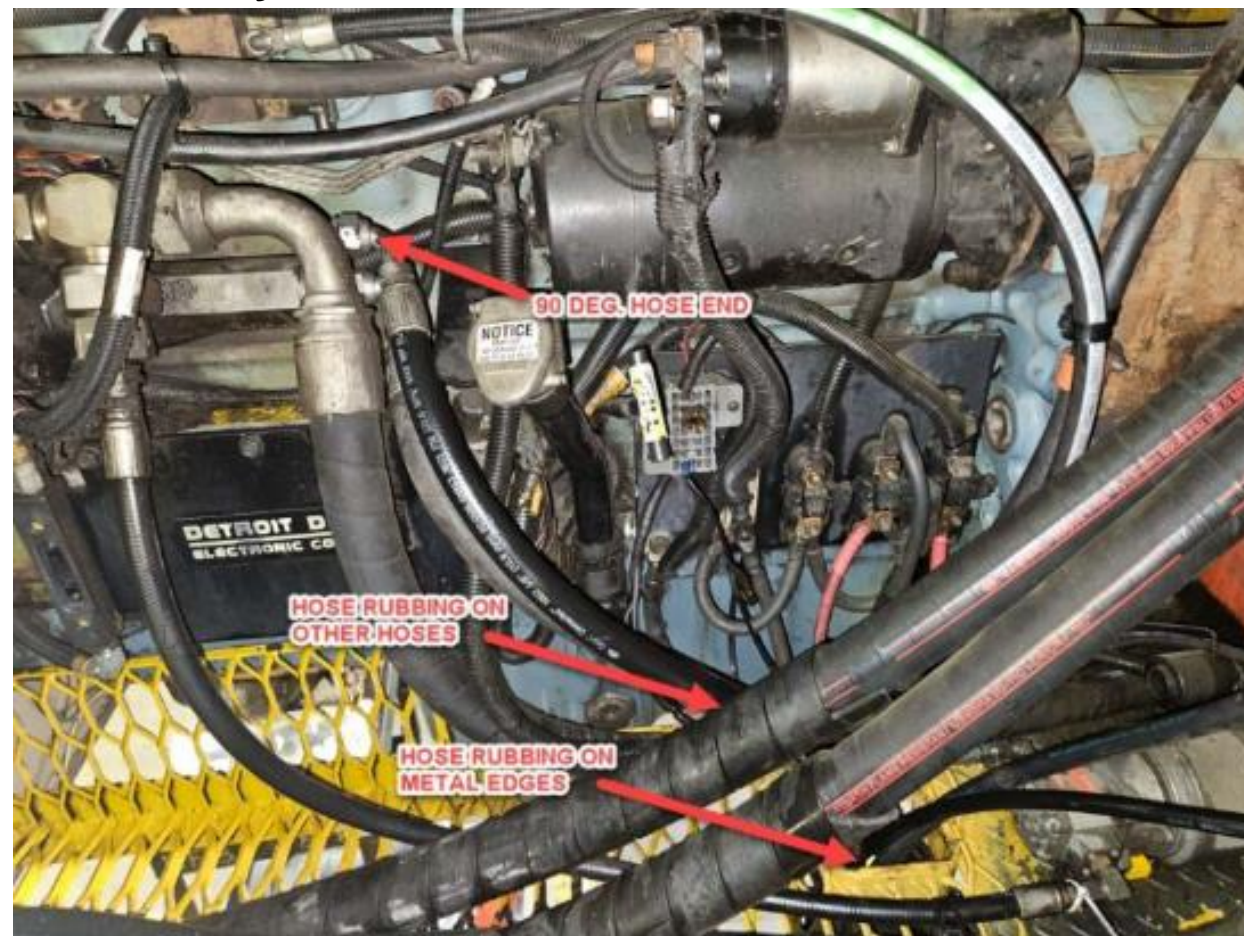
Source of the leak traced to abraded and failed hose routed tightly through and against sharp edge of ring in floor grate.

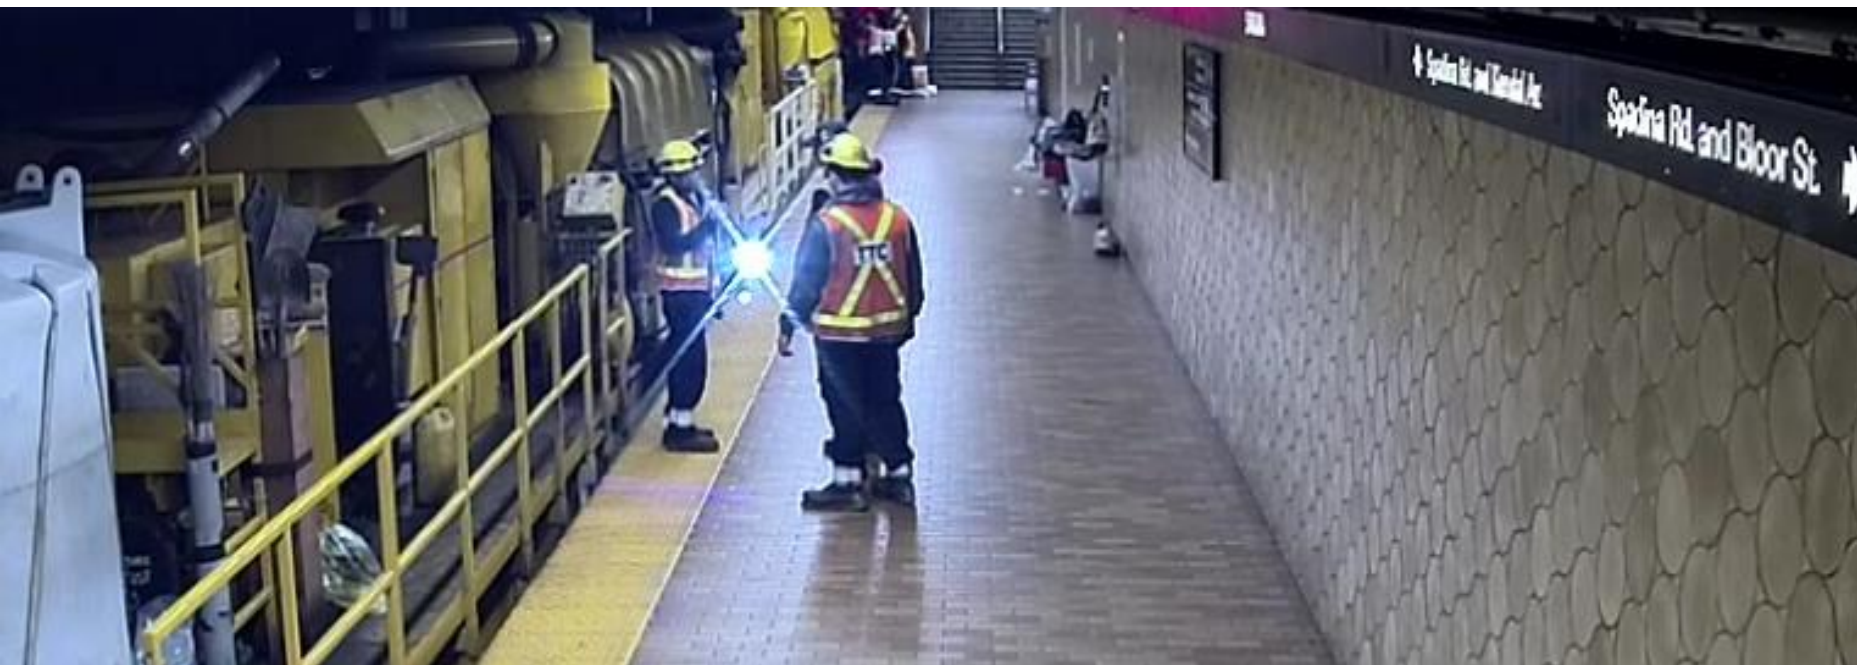
In the meantime, hydraulic fluid continued to flow through breached hose at approx. 150mL per minute (per calculation given hole size) at this new location, as observed later at track level between the running rails after the coupled work cars were moved off from this location.

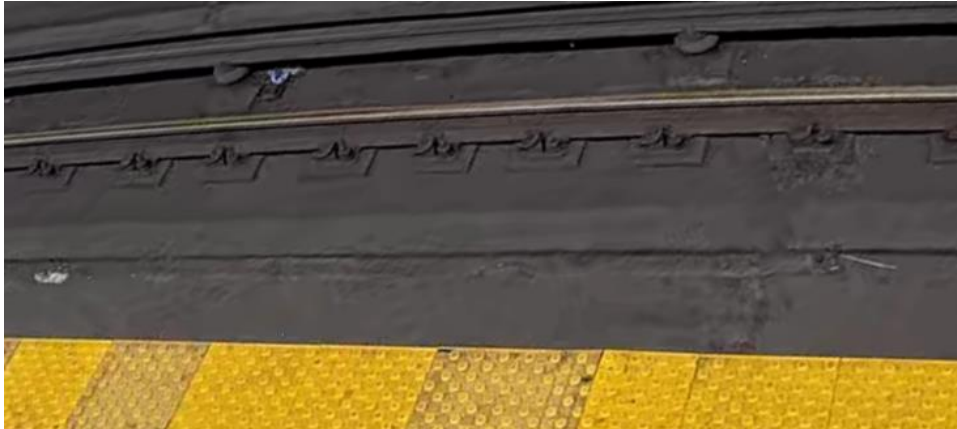
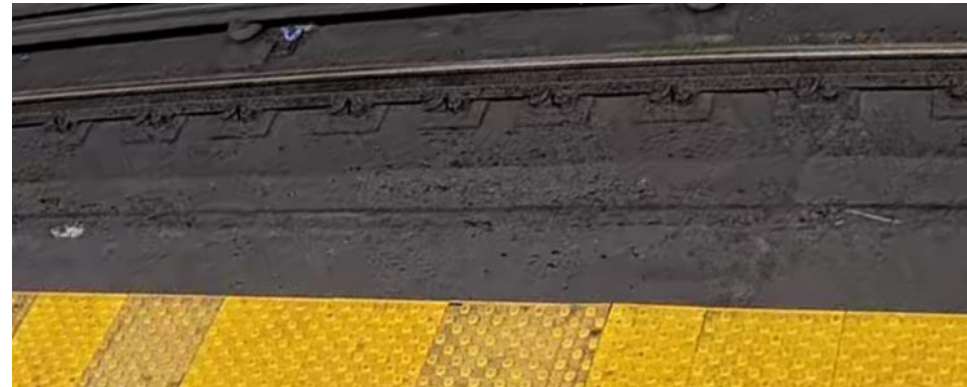
Hydraulic fluid splatter on rails causing E28's "signal violation due to positional uncertainty".

Investigation reveals the hydraulic fluid coating the underside and side sills of RT-56 (because of the initial hose breach/leak under pressure at Spadina) was shaking loose and splattering due to the movement of the coupled RTs as they made their way to first Museum and then on to Greenwood at 25 km/h once they were under TCC control past Museum Station.

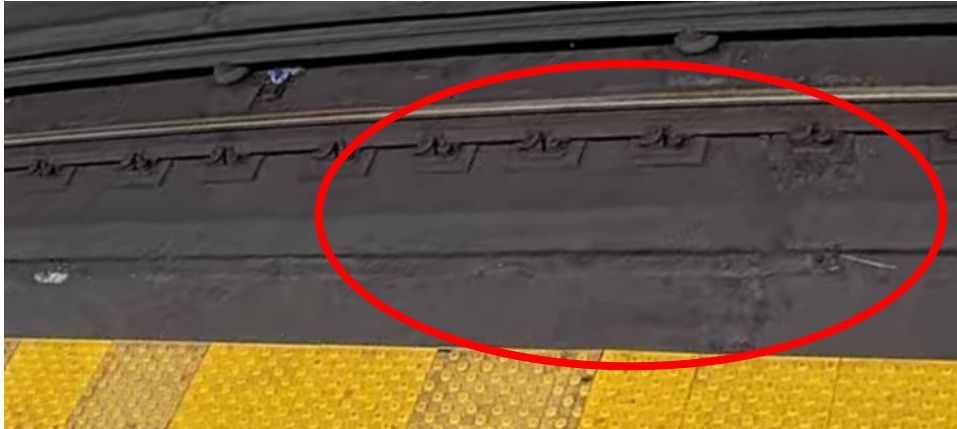
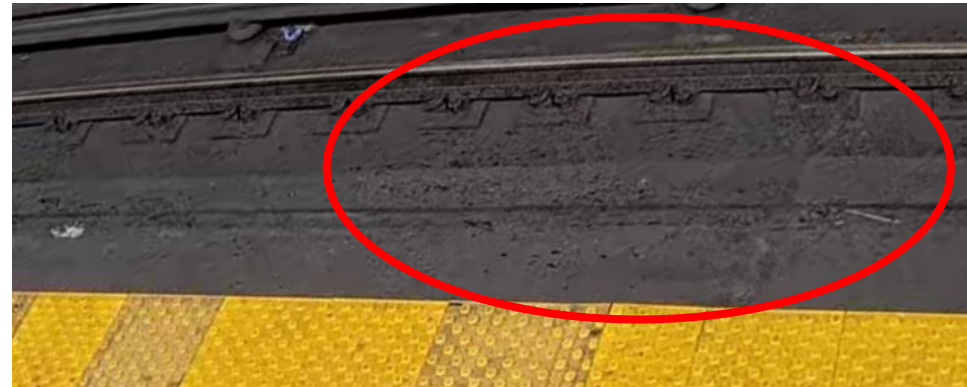
Hydraulic fluid splatter on rails causing E28's "signal violation due to positional uncertainty".
