Work Car Hydraulic Leak Incidents Update

Date: December 3, 2024

Subway Work Car Hydraulic Fluid Leak Investigation Report

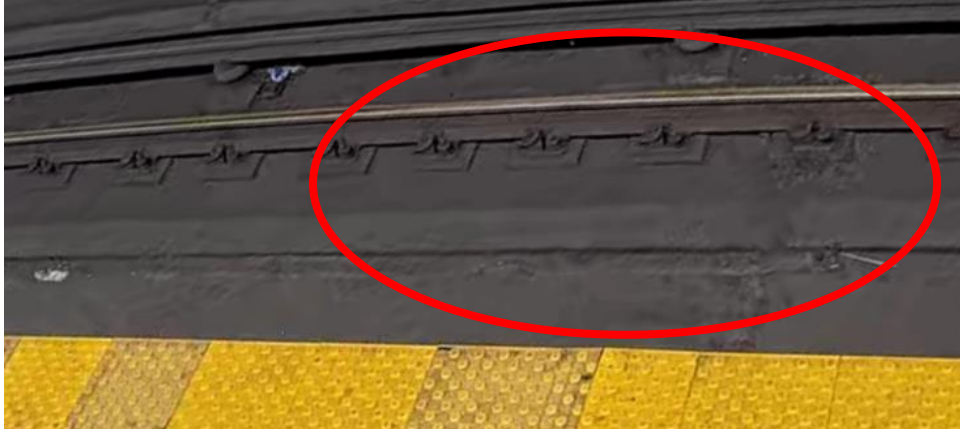
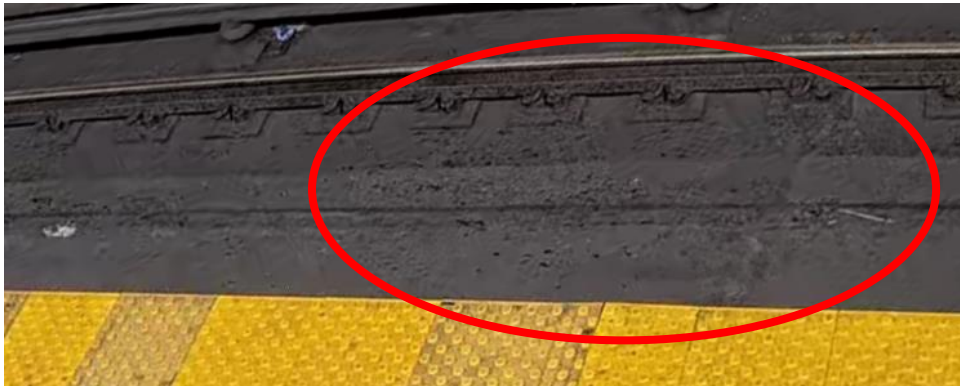
Hydraulic fluid splatter on rails causing E28's "signal violation due to positional uncertainty".

Investigation reveals the hydraulic fluid coating the underside and side sills of RT-56 (because of the initial hose breach/leak under pressure at Spadina) was shaking loose and splattering due to the movement of the coupled RTs as they made their way to first Museum and then on to Greenwood at 25 km/h once they were under TCC control past Museum Station.

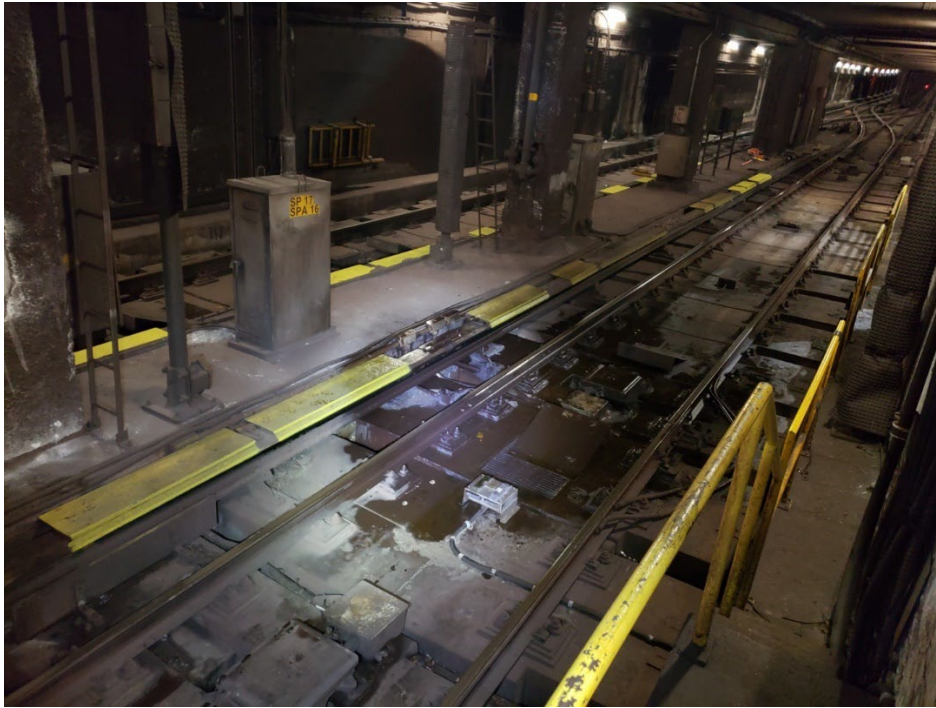
FIGURE 1

The most significant hydraulic leak reviewed in terms of disruption to service occurred on the morning of May 13, 2024 when RT-56 (a vacuum work car) was performing work on the northbound track at Spadina Station. The crew operating RT-56 had noticed abnormal noises coming from the work car and activated an emergency stop button to shut down the motors on the work car. The crew then discovered that a hydraulic hose had failed and sprayed hydraulic fluid on the work car and surrounding track area, as shown in [Figure 1](#).

Spadina Northbound Track Location of Initial Hydraulic Hose Failure
