Service Impacts Due to Hydraulic Spills

Summary of Recent Events

May 16, 2024

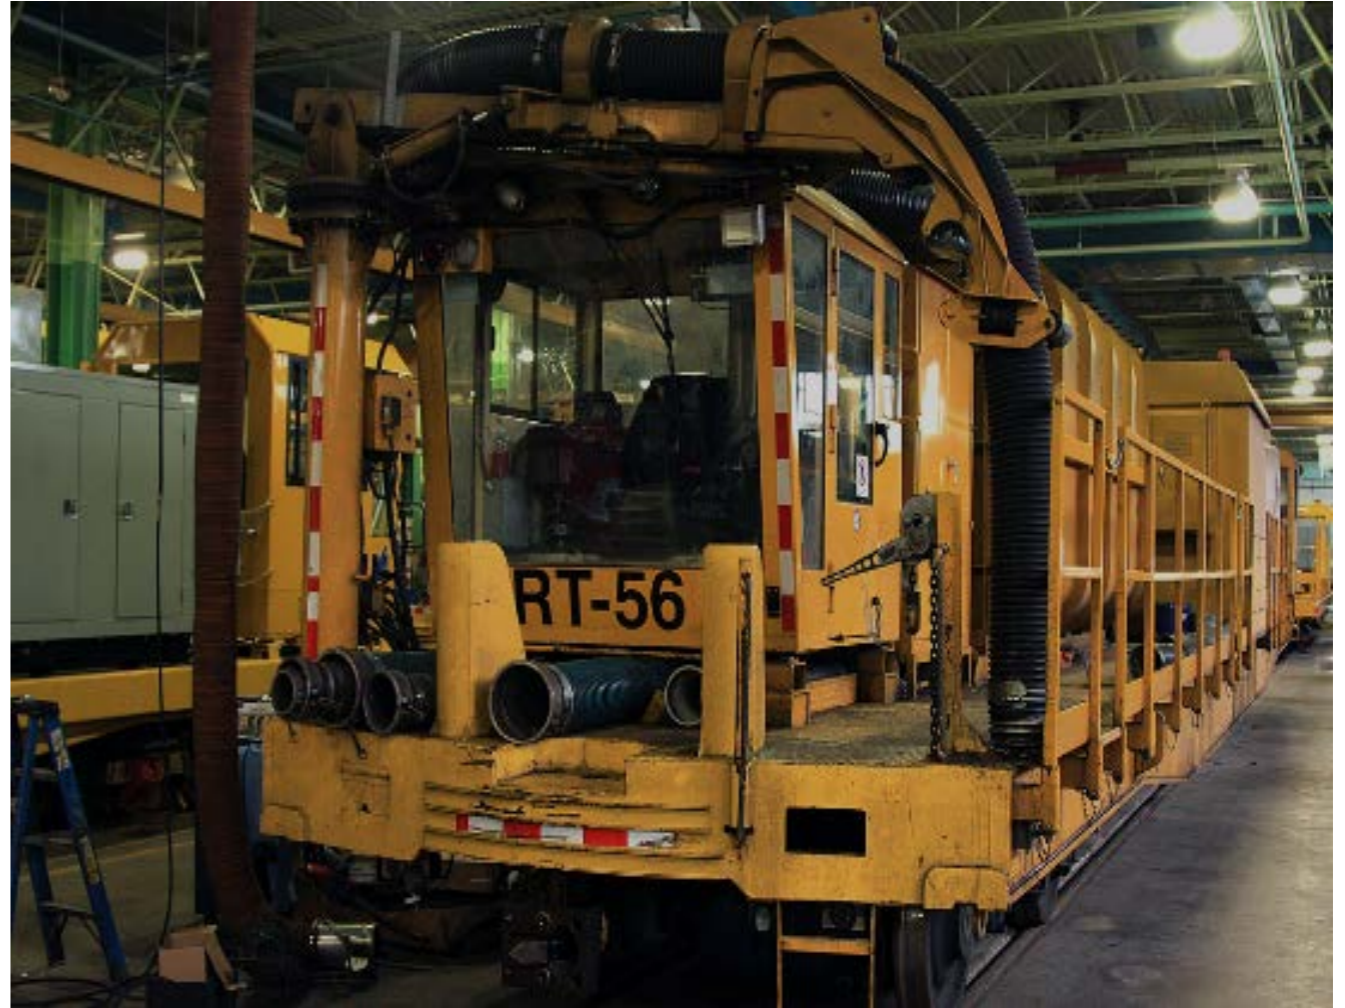
RT-56: Vacuum Work Car

- **9 a.m.** - TCC contacts Track for investigation
- **9:01 a.m.** - Final report of wheel slide at Donlands
- **9:45 a.m.** - Report of hydraulic leak on RT56 at Greenwood Yard
