Toronto Transit Commission

Scarborough Rapid Transit (SRT) Vehicle Accident Investigation Report

2023-09-28	A	Released	Marcel Silva, P.Eng. Glen Johnstone, P.Eng.	Nicholas Zeolla, P.E.	Sulaiman Janjua	Jarek Skonieczny, P.Eng.
Date	Rev.	Status	Prepared By	Checked By	Approved By	Approved By
HATCH

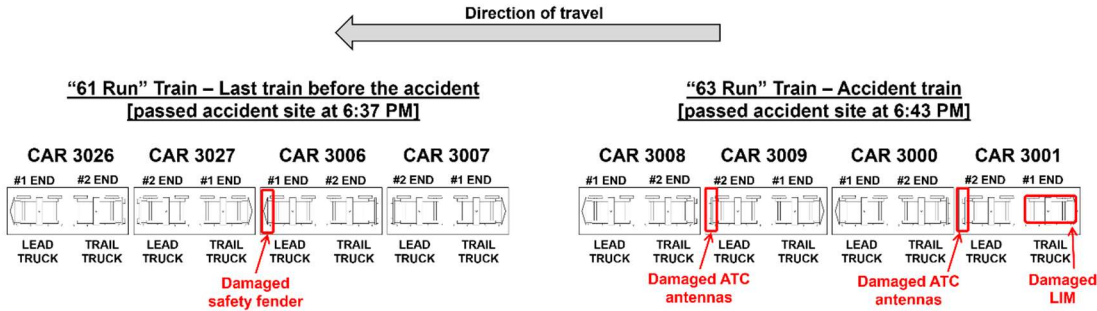
Figure 1 - Location of Damaged Trucks

1. Hatch did not find any evidence of conventional mechanisms associated with wheel/rail interaction that typically lead to derailments: no flanging marks on the rails due to truck hunting, no rail rollover, no track panel shift, no severe wheel flanging marks on the rails. Therefore, the primary event was a collision with a track infrastructure obstruction that subsequently led to the truck being lifted from the rails and displaced to the wayside (secondary event). In other words, the accident was not a conventional derailment but rather a collision.
2. Hatch found evidence of collision damage associated with a guideway obstruction on four trucks of the inspected cars (“63 Run” and “61 Run” trains), as shown in Figure 1. The damage caused by the collision on all four trucks were very similar, strongly suggesting that they were all struck by the same object.

- 3. Hatch did not find any evidence of improper LIM heights that could potentially have caused an interference with the reaction rail or to lift it in any way that would cause a collision.
- 4. Hatch did not find any evidence suggesting the vehicles had caused or contributed in any manner to the accident on July 24, 2023.

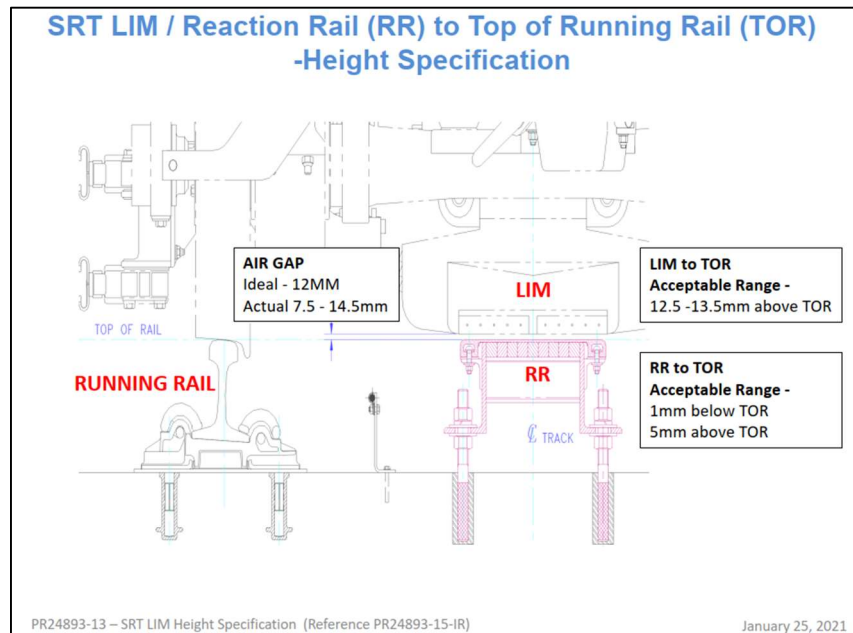
Figure 9 - TTC's LIM Height Specifications [4]

Per TTC's latest procedure [4], depicted in Figure 9, the LIM height with respect to the top of the running rails must be within 12.5 mm and 13.5 mm. This acceptable range is used during maintenance interventions at the carhouse to set the LIM height for all cars. Along with the reaction rail height tolerance (-1/+5 mm with respect to TOR), the resulting operational air gap range is between 7.5 mm and 14.5 mm.

3. Although TTC's latest LIM height specification requires the LIM height to be set between 12.5 and 13.5 mm, as shown in Figure 9 [4], the Standard Inspection Check Sheet [11] used to record the measurements still references the OEM's original tolerances (11 +1/+0 mm). This inconsistency may lead to errors if the technicians performing the adjustment are not properly trained. In addition, the inspection sheets, as currently formatted, do not require the technician to record key elements associated with the LIM height, such as the measured height value found during the inspection as well as new height after adjustment (if required). TTC is recommended to revise the Standard Inspection Check Sheet [11] to correct the discrepancy described above and allow the inspected heights to be adequately recorded.

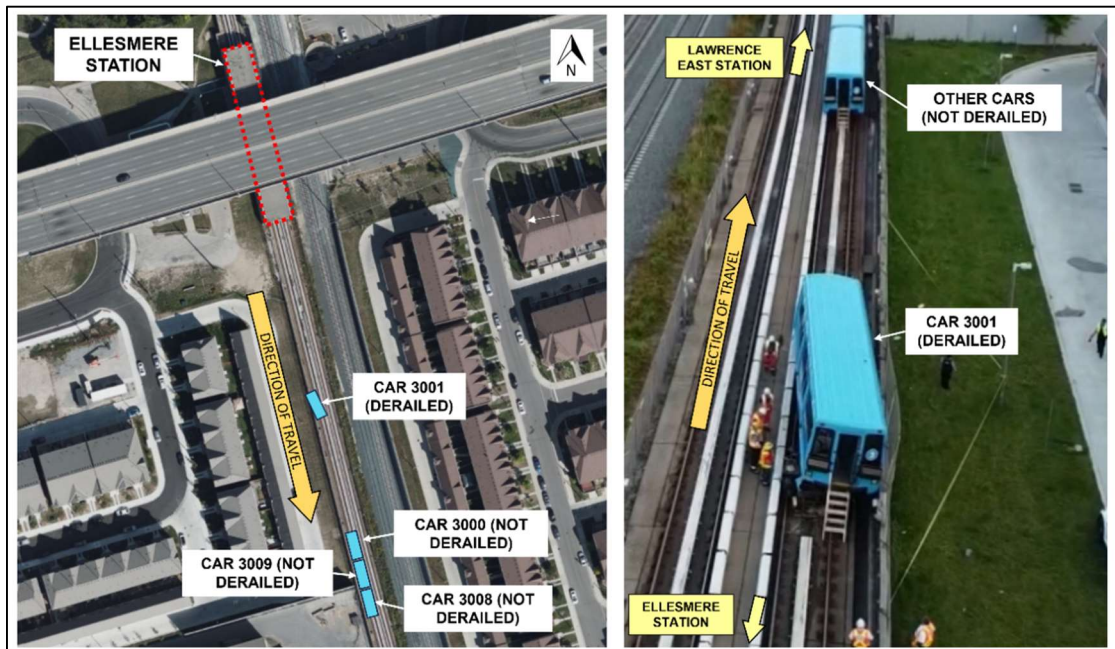
Figure 16 - Accident scene

Surveillance footage from Ellesmere Station shows the consist accelerating out of the station when the last trailing car of the consist (car 3001) appears to suddenly collide with a track obstruction, lift off the tracks in a pitching motion (rear end of the car lifted significantly more than the front end) and halt to a complete stop. The first three cars of the consist separated from car 3001 and continued traveling southbound. In the footage, the trailing truck of car 3001 can also be seen coming off the running rails. Shortly after, the train onboard computer detected an abnormality (due to the separation of car 3001) and the first three cars of the consist also stopped, about 50 metres south of car 3001 (see images on Figure 16). Other than the lost connection with Car 3001 after the accident, the onboard computer fault log did not record any abnormalities/faults with any of the cars' major operational systems prior to the event.

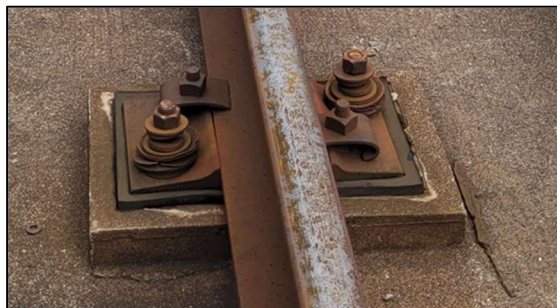
Figure 19 - Typical Track Fastener Assembly at Accident Site

3. The running rail track fasteners at the derailment location were found to be in good condition. Compression clips fasten the running to the tie plates at the derailment site. The compression clips are mechanically fastened to the tie plates. The tie plates are mechanically fastened to the concrete invert by two anchor bolts per tie plate. The tie plates sit on top of a resilient rubber pad. Only superficial damaged was observed to the running rail fasteners due to the derailment of the SRT train consist. Figure 19 below shows a typical running rail tie plate fastener assembly at the derailment site.

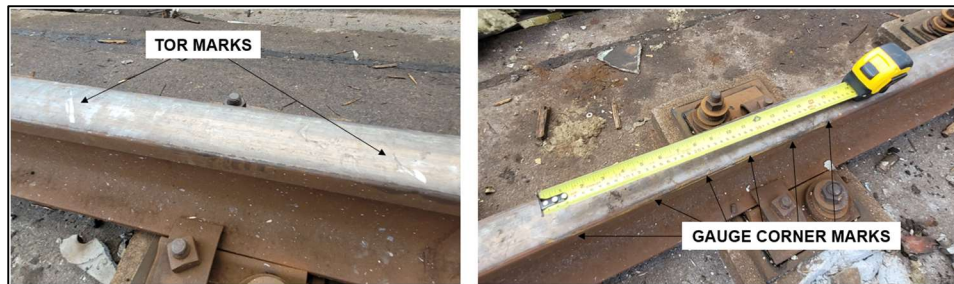
Figure 20 - Rail Markings

5. Superficial markings were found on the top/gauge corner of the west side running rail at the location where accident occurred. Some of these markings were apart by approximately 1,700 mm, which corresponds to the vehicle's truck wheelbase. However, it is worth noting that the site inspection occurred after car 3001 was already removed from the site. TTC has indicated the recovery crews on site faced difficulties when removing the trailing truck from the carbody, due to the extensive damage of the truck-to-carbody connections, and "bouncing" of the car had occurred a few times, which may have caused some of the markings. In addition, the surveillance footage of the accident shows the trailing truck of car 3001 being completely lifted from the rails as a result of the primary collision. Hence, the markings found on the rails are not indications of a conventional "derailment", but rather consequences of the truck lifting.

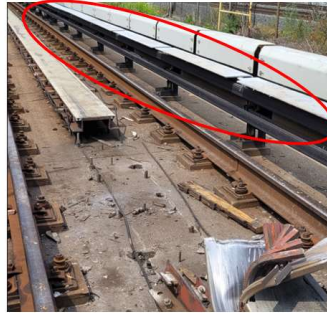
Figure 21 - 600V Contact Rail Assembly at Accident Site

7. The 600V contact rail assembly consists of two contact rails (a positive and negative rail), a contact rail support, non-conductive contact rail chair, and a non-conductive protective cover board that spans adjacent supports. The 600V contact rail assembly was found to be in good condition at the train accident site with only minor contact damage to the corner of one protective cover board. Figure 21 below shows the 600V contact rail directly adjacent to the derailment location.

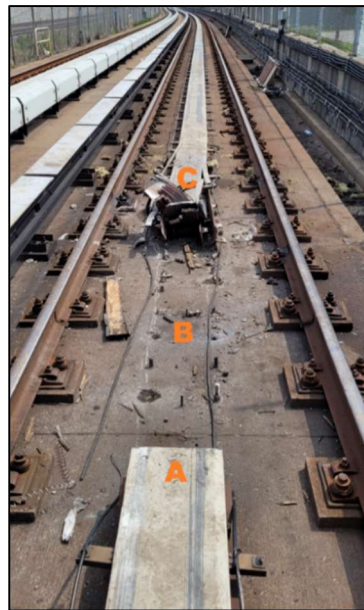
Figure 22 - Reaction Rail at the Accident Site

- a) Figure 22 depicts the SRT southbound track, approximately 60 metres south of Ellesmere Station, looking south as it was observed during site investigation. Section A corresponds to the reaction rail section immediately before the accident location, while Section B represents the reaction rail at the accident location (unseated) and Section C is the damaged section of reaction rail immediately after the accident location. Section B appears to have been struck by the incident train. This collision unseated the reaction rail section from its anchored location pushing it under subsequent reaction rail Section C.

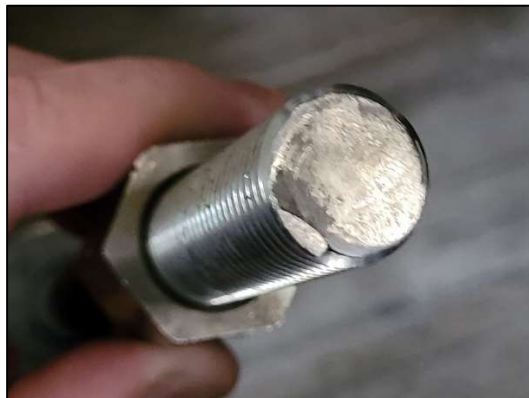
Figure 24 - Anchor Bolts #1 and #3

- g) Blue circles in Figure 23 identify anchor bolts that were observed to have been saw cut and abandoned prior to the incident.
- h) The flat failure face of the lower portion of anchor bolts #1 and #3 were observed to be polished, and the edge of the failure face was hammered flat by cyclical contact with the upper portion of the bolt, as shown in Figure 24. The top portion of anchor bolts #1 and #3 were observed to be still fastened to the unseated reaction rail.

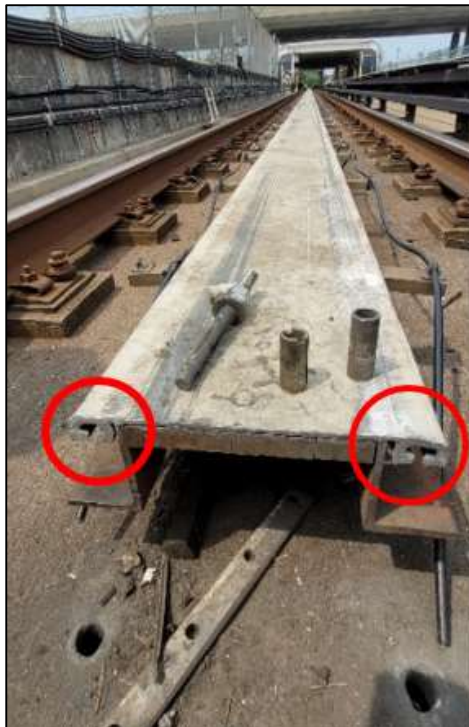
Figure 26 - Aluminum Top Cap of Reaction Rail Section A

- j) The aluminum top cap of reaction rail Section A was observed to have damage to the trailing edge of the T-bolt channel on both edges of the top cap as identified by the red circles in Figure 26. Close up of damaged T-bolt channel on top cap section of reaction rail Section A is shown in Figure 27. Corresponding damage to top cap T-bolt channel on reaction rail Section B is depicted in Figure 28.

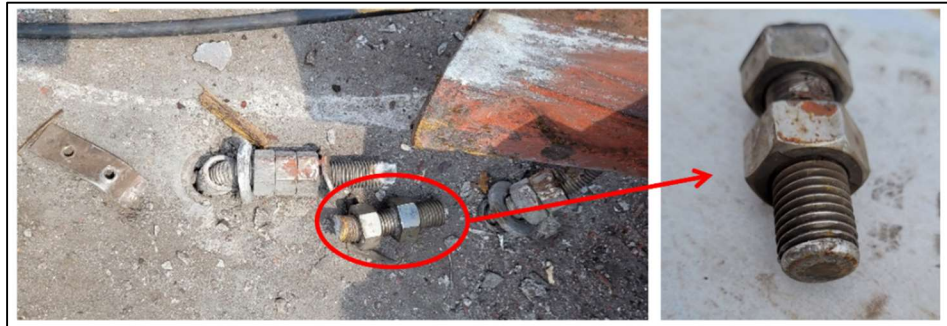
Figure 29 - Anchor Bolt #8

- k) Bent anchor bolt #8 with corresponding top section of bolt lying directly beside is shown in Figure 29. Evidence of ductile overload was observed resulting in the failure of bolt. The top portion of anchor bolt #8 with rounded bolt end is also shown.

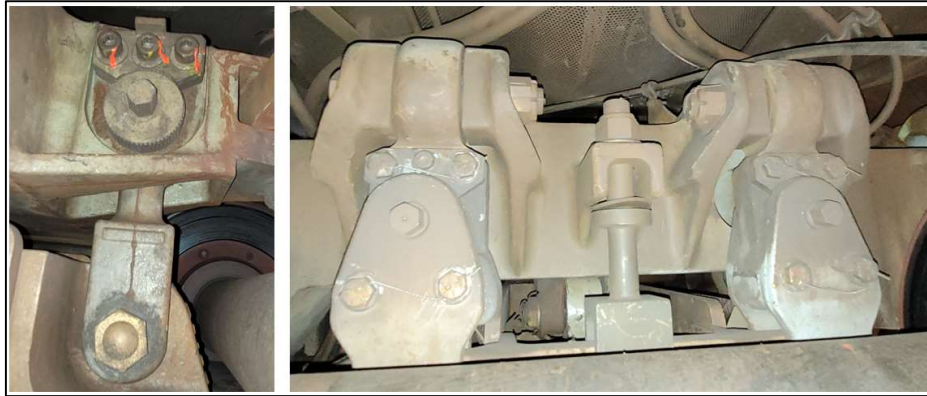
Figure 33 - Vertical Connection Links on Truck S/N 034

The vertical links attaching the LIM to the yoke assemblies and their connections were also physically inspected and found to be properly secured, as shown in Figure 33.

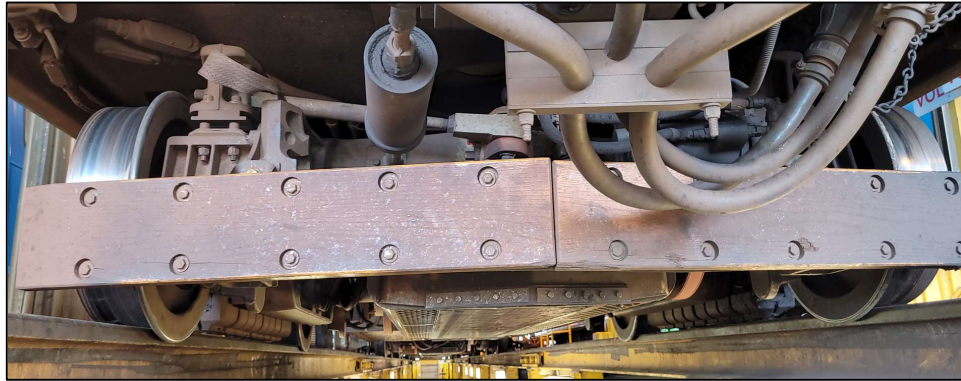
Figure 35 - Safety Fender on Truck S/N 034

No major damages were found on the safety fender, as shown in Figure 35.

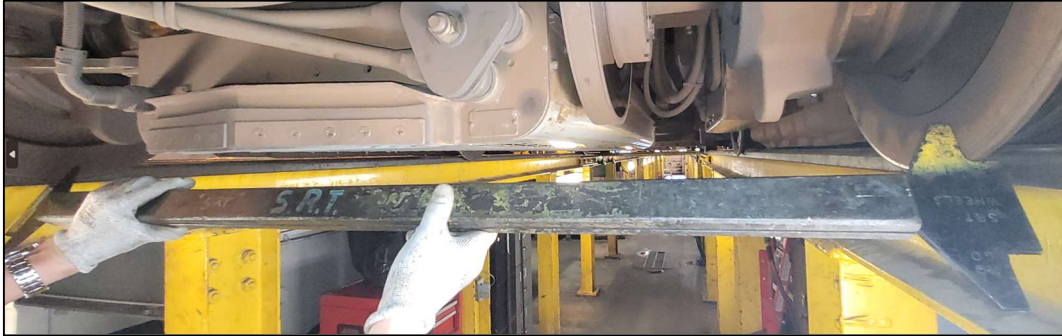
Figure 37 - Wheelset Back-to-Back Check

To rule out any abnormalities/non-conformities associated with wheel/rail interaction, the wheelset back-to-back dimensions were checked with the GO/NO-GO gauge illustrated in Figure 37 [10]. Both wheelsets on the truck were found to be compliant with the tolerances (back-to-back dimensions between 54.35" and 54.47").

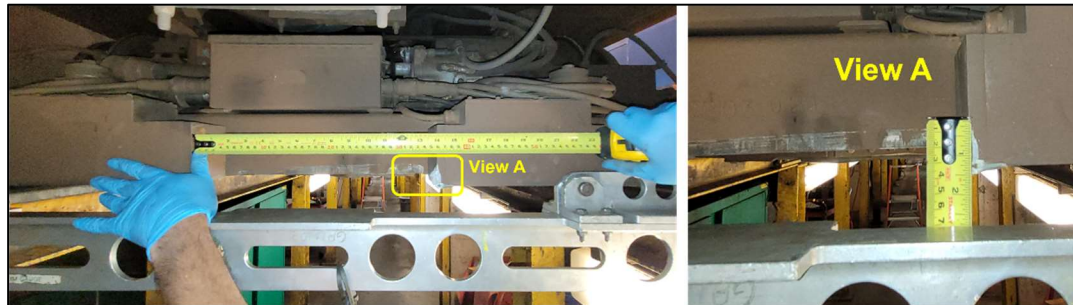
Figure 47 - ATC Antennas Damage Dimensions on Truck S/N 048

The highest damage mark was observed approximately 70 mm above the top of the running rails, and was on the left side antenna, corresponding to the east side of the southbound track, based on the traveling direction at the time of the collision. The antennas are approximately 355 mm apart (14 inches), as shown in Figure 47. Since the marks were not wider than 14 inches, it is believed that the obstruction hitting the truck had a width of approximately 14 inches, which corresponds to the width of the reaction rail (13.75 inches, as measured on site).

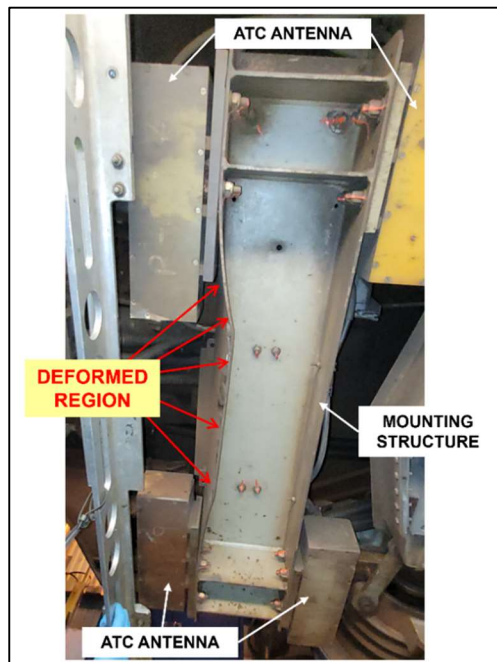
Figure 48 - ATC Antennas Mounting Structure Damage on Truck S/N 048

The aluminum structure where the ATC antennas are mounted, commonly known as ATC bridge, was also significantly damaged. It was found to be deformed inwards towards the LIM, as shown in Figure 48.

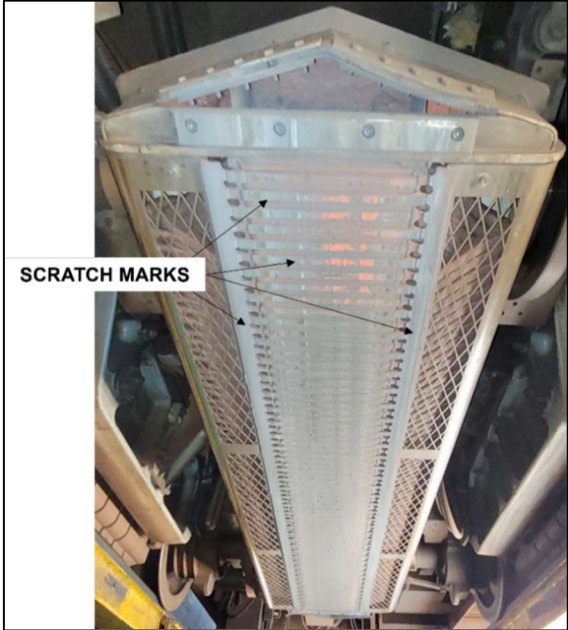
Figure 52 - Scratch Marks on Bottom of the LIM

Uniform scratch marks were found along the entire length of the LIM bottom, as shown in Figure 52, suggesting rubbing against the reaction rail top aluminum cap at various locations in the system. These marks appeared to be aged due to their discoloration and dirt build-up presence.

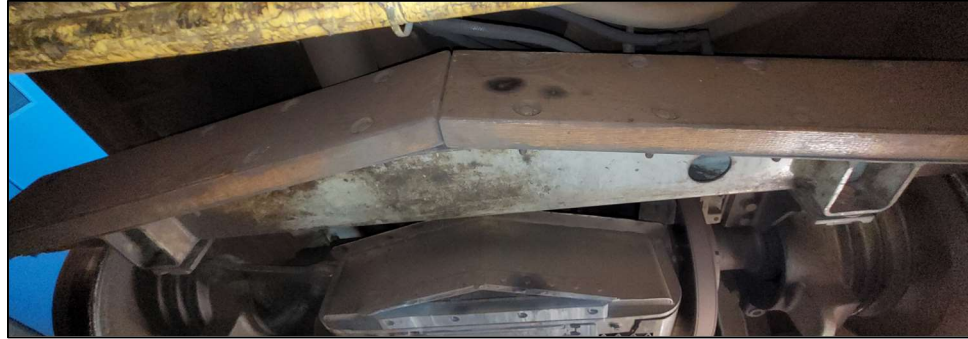
Figure 58 - Safety Fender on Truck S/N 028

No major damages were found on the safety fender, as shown in Figure 58.

A lack of contact damage on this truck compared to the leading truck (ATC antenna damage) suggests the obstruction somehow cleared momentarily as the vehicle passed chainage 135+10.

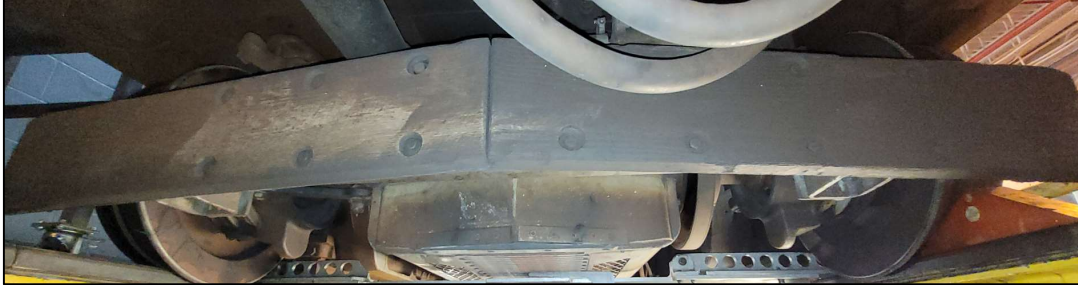
Figure 64 - Safety Fender on Truck S/N 005

No major damages were found on the safety fender, as shown in Figure 64.

A lack of contact damage on this truck compared to the ATC antenna damage on the leading truck of the previous car (3009) suggests the obstruction somehow cleared momentarily as car 3000 passed chainage 135+10.

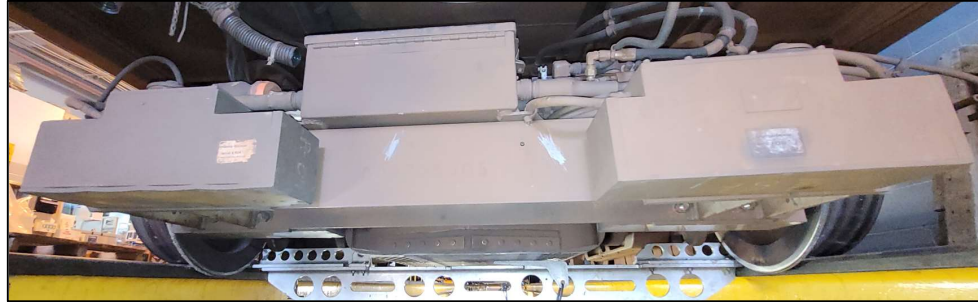
Figure 70 - ATC Antennas on Truck S/N 019

No major damages were found on the ATC antennas, as shown in Figure 70.

A lack of contact damage on this truck compared to the ATC antenna damage on the leading truck of the previous car (3009) suggests the obstruction somehow cleared momentarily as car 3000 passed chainage 135+10.

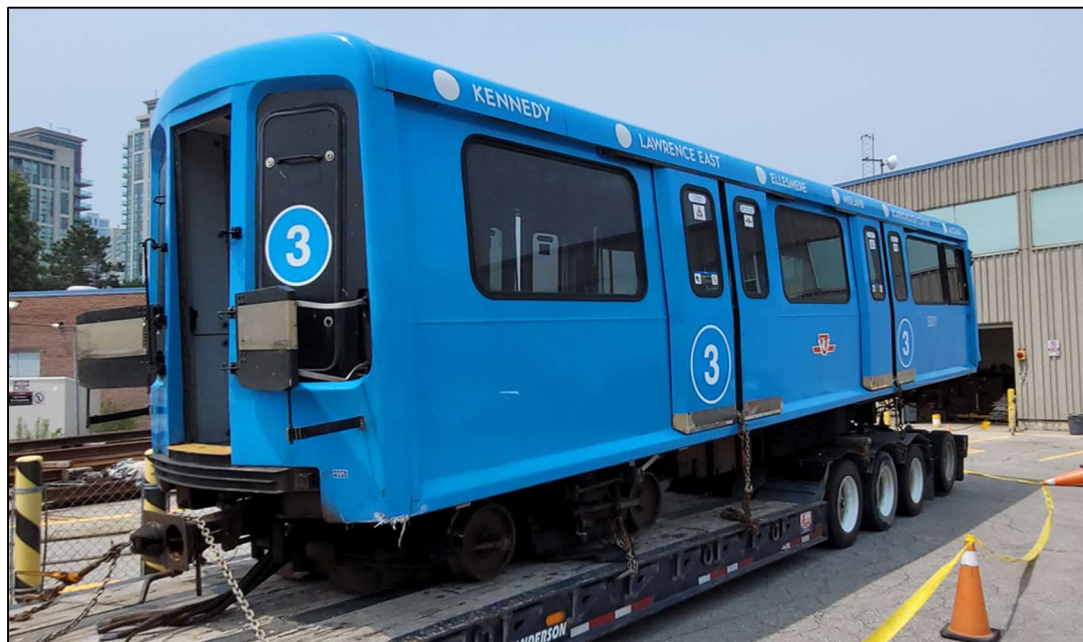
Figure 73 - Car 3001 at McCowan Carhouse

After the accident, Car 3001 was taken to McCowan Carhouse with its leading truck (S/N 027) still attached (Figure 73). The trailing truck (S/N 020), which was detached from the carbody, was taken to Greenwood Carhouse. A preliminary inspection confirmed the collision damage to the ATC antennas, similar to Truck S/N 048 (Car 3009), as shown in Figure 74.

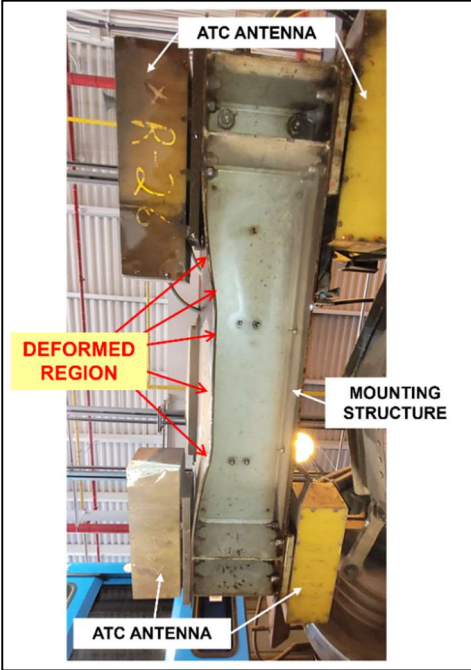
Figure 77 - ATC Antennas Mounting Structure Damage on Truck S/N 027

The aluminum structure where the ATC antennas are mounted (ATC bridge) was also significantly damaged. It was found to be deformed inwards towards the LIM, as shown in Figure 77. Once again, the damage was very similar to the one observed on Truck S/N 048 (see Figure 78). This similarity suggests both trucks have been struck by the same object violating the car clearance envelope.

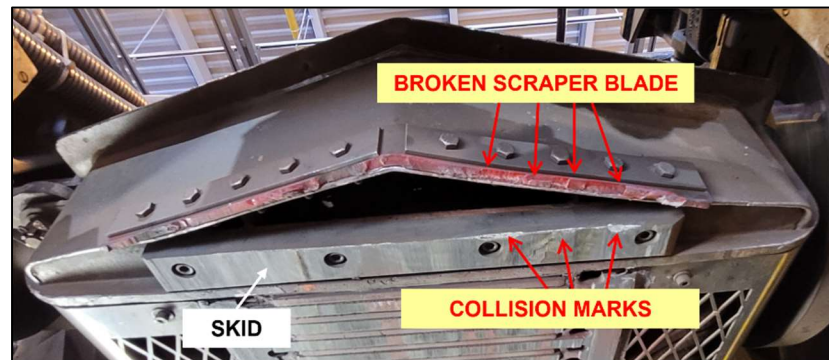
Figure 80 - Scraper Blades and Skid Damage on Truck S/N 027

Fractures were found on the LIM scraper blades, along with fresh scratch marks on the skid, as shown in Figure 80.

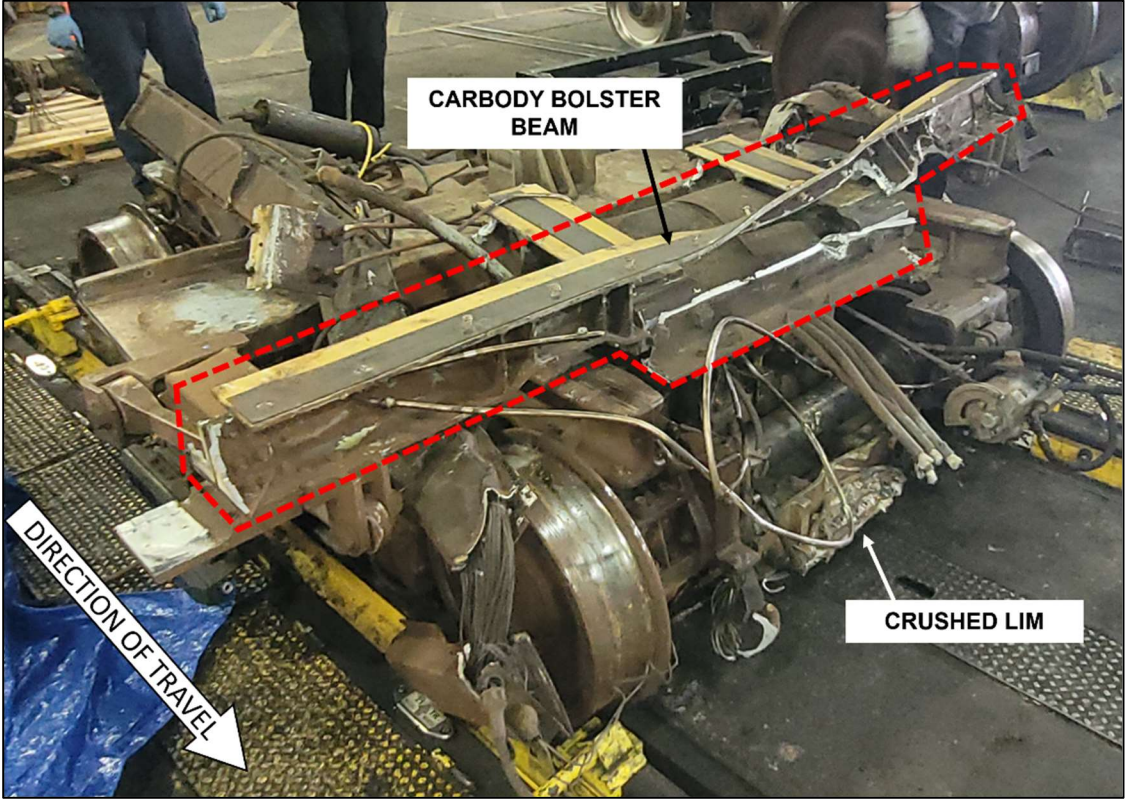
Figure 87 - Truck S/N 020 with Carbody Bolster Beam

As a result of the collision, the carbody bolster beam (where the traction rods are attached) fractured, completely separating the truck from the carbody (see Figure 87 and Figure 88). The traction rods did not break, although they were permanently deformed (buckled), and remained attached to the truck along with the carbody bolster beam (see Figure 89). All other mechanical truck-to-carbody connections (e.g., lifting chains, coupler rod, shock absorbers, etc.) were ruptured.

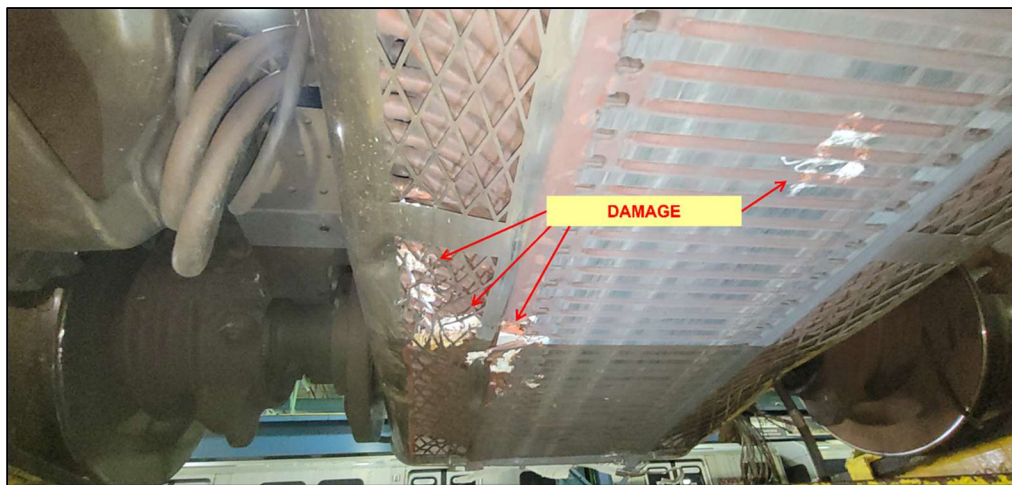
Figure 92 - LIM bottom damage

Substantial damage was also observed on the bottom of the LIM, although it is believed to be secondary (subsequent to the front collision). Some of the damage found is associated with the LIM landing on the rails after being lifted during the collision (Figure 92), while other areas were damaged when improper rigging was used to lift the truck during the vehicle's recovery (Figure 93).

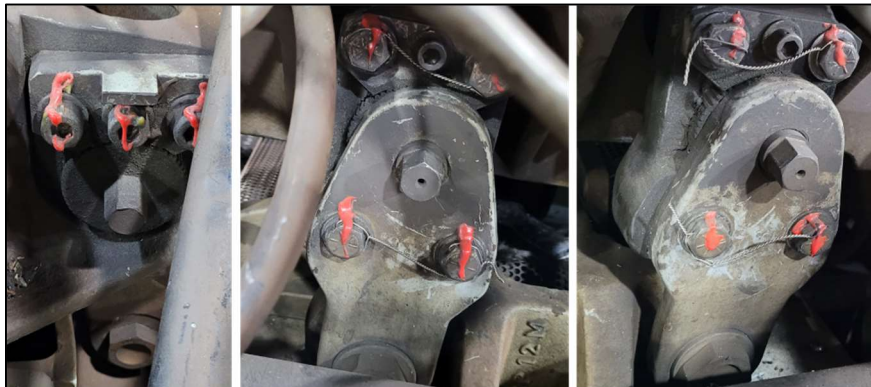
Figure 96 - Vertical Connection Links on Truck S/N 020

Despite the large collision impact load, the vertical links attaching the LIM to the yoke assemblies and their connections were undamaged and found to be properly secured, as shown in Figure 96. Since these connections are designed not to be subjected to horizontal loads (which are resisted by the lateral and thrust links), they remained mostly intact.

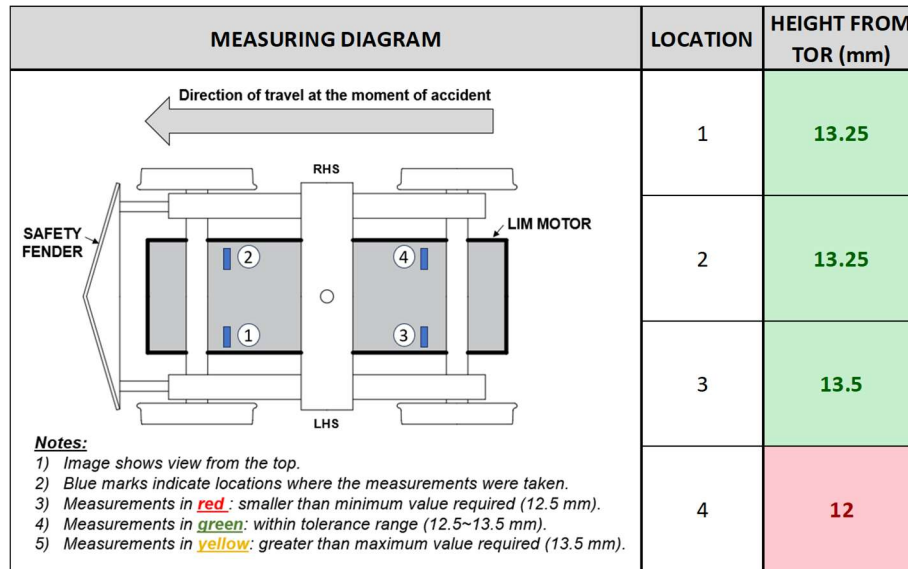
Figure 100 - LIM Height Measurement Results for Truck S/N 021

The LIM height with respect to the top of the running rails was measured using gauge number 127E-610-005 [9], depicted in Figure 10, and verified with a caliper. Results are given in Figure 100. One of the measurements was found to be outside of the specified range (0.5 mm smaller than the lower specification limit). The measurement directly opposite to it was 13.5 mm. Given how high the guideway obstruction collided with some of the trucks of the investigated cars (approximately 70 mm), the 0.5 mm LIM height tolerance violation is not believed to have been a contributing factor to the accident.

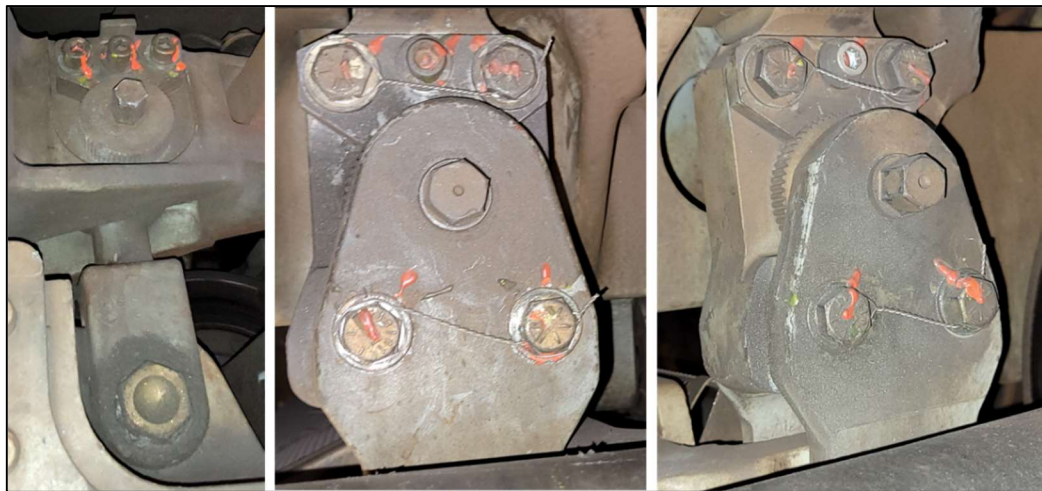
Figure 101 - Vertical Connection Links on Truck S/N 021

The vertical links attaching the LIM to the yoke assemblies and their connections were also physically inspected and found to be properly secured, as shown in Figure 101.

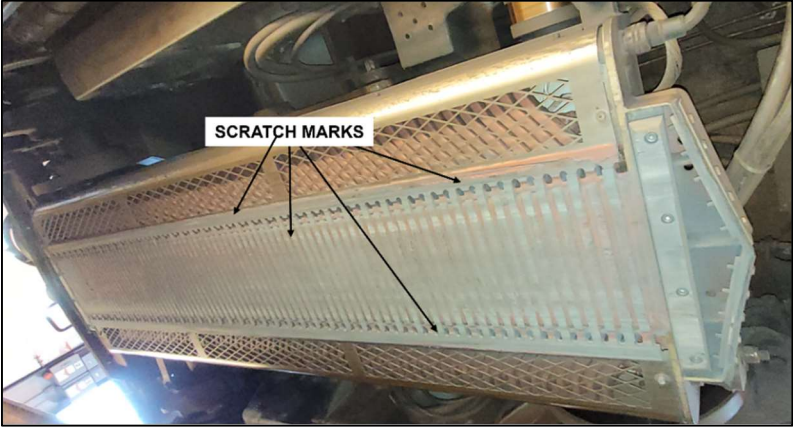
Figure 102 - Scratch Marks on Bottom of the LIM

Uniform scratch marks were found along the entire length of the LIM bottom, as shown in Figure 102, suggesting rubbing against the reaction rail top aluminum cap at various locations in the system. These marks appeared to be aged due to their discoloration and dirt build-up presence.

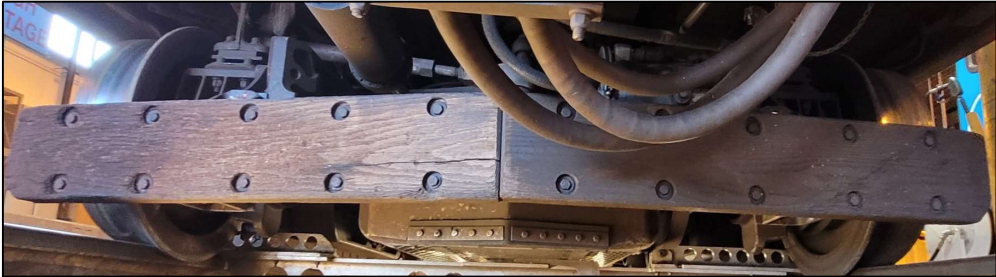
Figure 103 - Safety Fender on Truck S/N 021

No major damages were found on the safety fender, as shown in Figure 103.

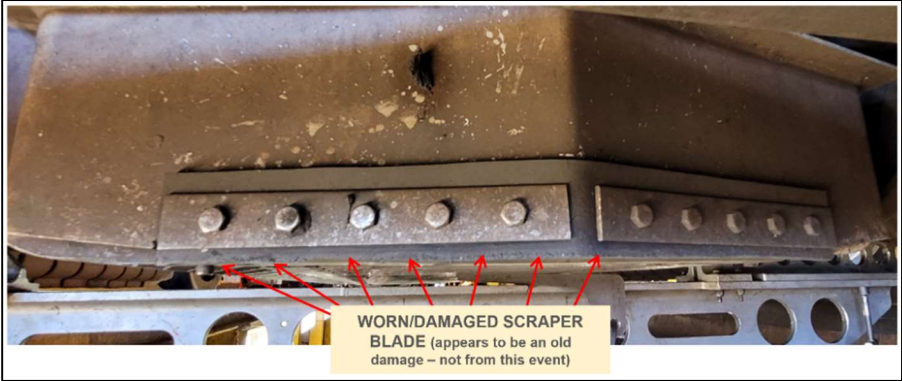
Figure 104 - Scraper Blades

Minor wearing/damage was found on the scraper blades, as shown in Figure 104. However, this is not believed to have been caused by the recent collision.

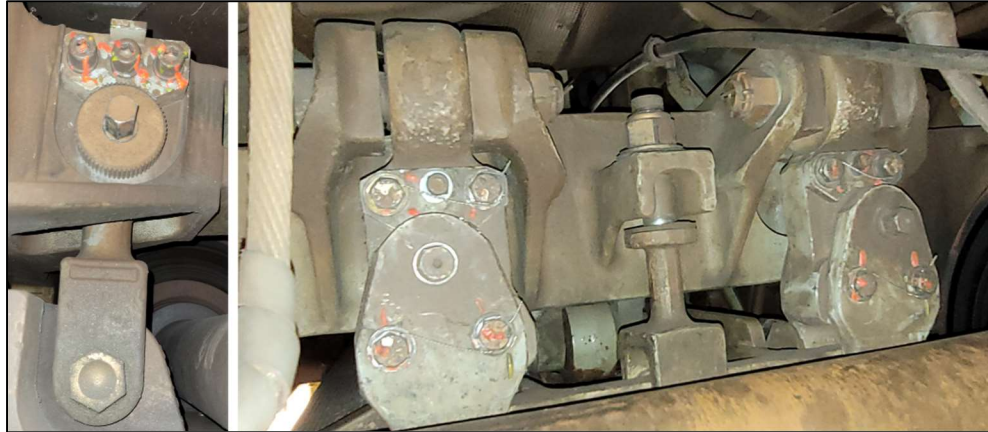
Figure 107 - Vertical Connection Links on Truck S/N 049

The vertical links attaching the LIM to the yoke assemblies and their connections were also physically inspected and found to be properly secured, as shown in Figure 107.

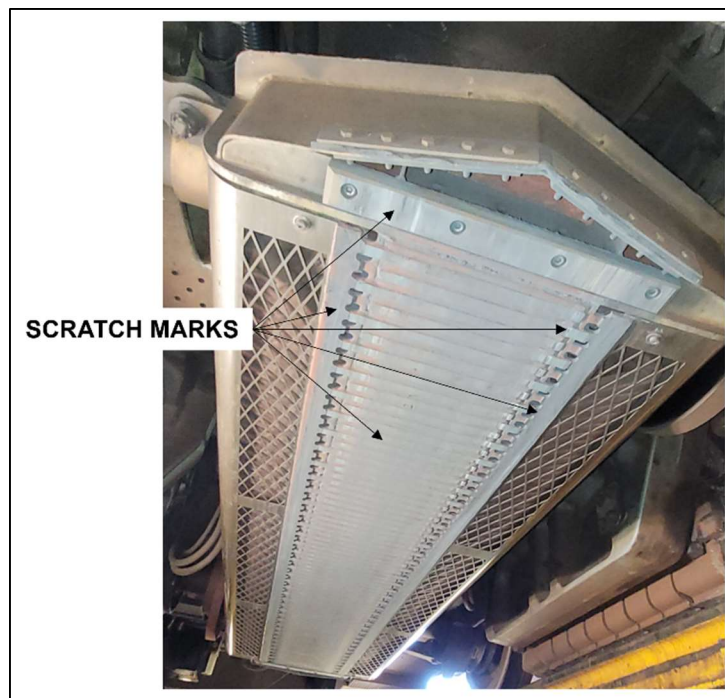
Figure 108 - Scratch Marks on Bottom of the LIM

Uniform scratch marks were found along the entire length of the LIM bottom, as shown in Figure 108, suggesting rubbing against the reaction rail top aluminum cap at various locations in the system. These marks appeared to be aged due to their discoloration and dirt build-up presence.

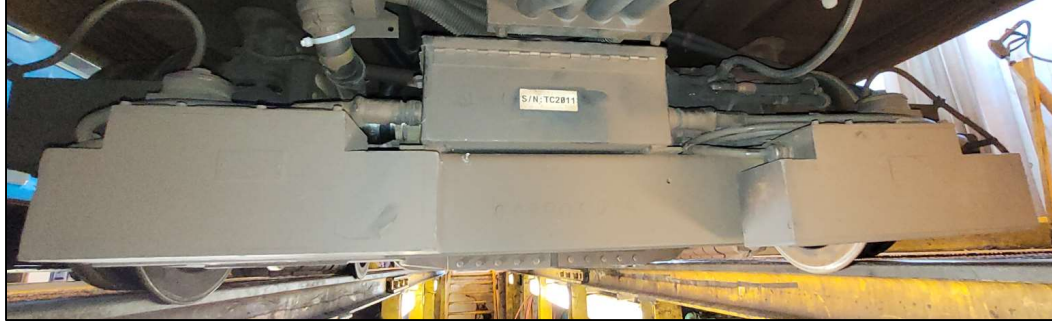
Figure 109 - ATC Antennas on Truck S/N 049

No major damages were found on the ATC antennas, as shown in Figure 109.

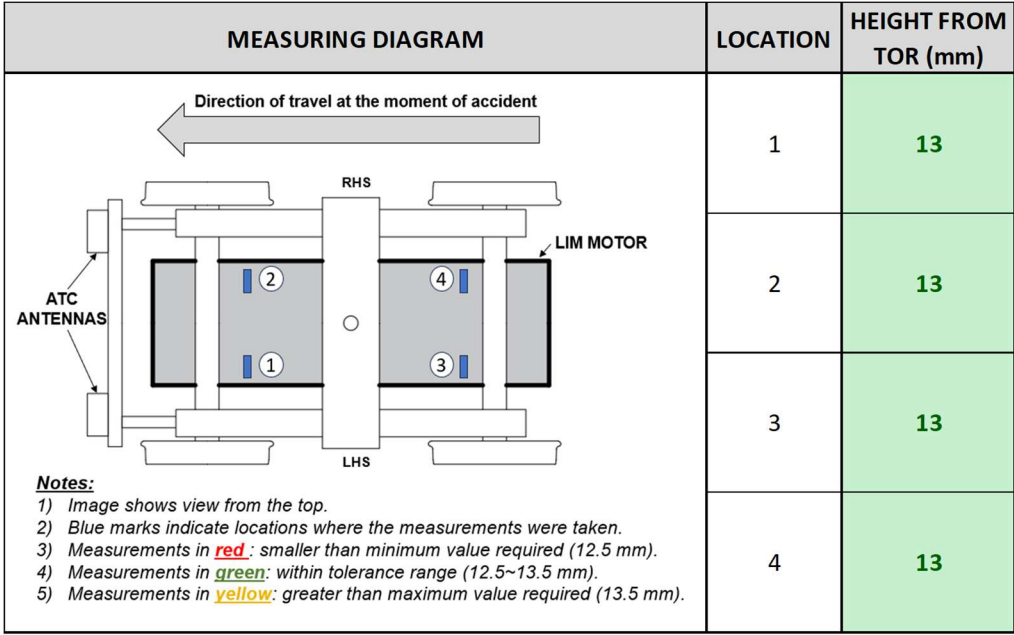
Figure 111 - LIM Height Measurement Results for Truck S/N 023

The LIM height with respect to the top of the running rails was measured using gauge number 127E-610-005 [9], depicted in Figure 10, and verified with a caliper. Results are given in Figure 111. All results were found to be within the acceptable limits.

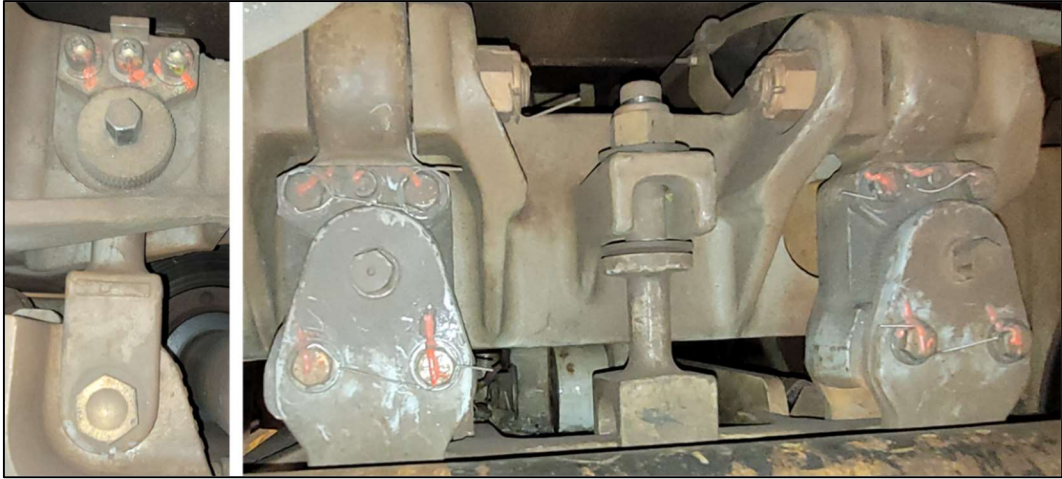
Figure 112 - Vertical Connection Links on Truck S/N 023

The vertical links attaching the LIM to the yoke assemblies and their connections were also physically inspected and found to be properly secured, as shown in Figure 112.

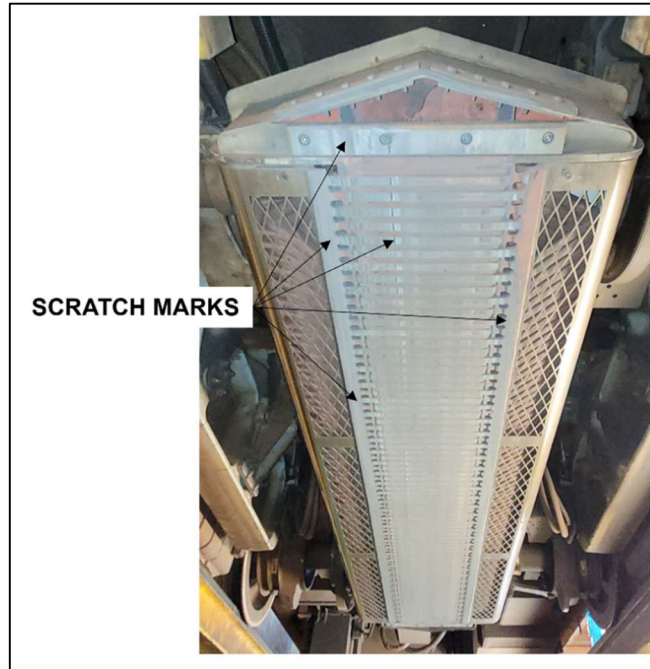
Figure 113 - Scratch Marks on Bottom of the LIM

Uniform scratch marks were also found along the entire length of the LIM as shown in Figure 113, suggesting rubbing against the reaction rail top aluminum cap at various locations in the system. These marks appeared to be aged due to their discoloration and dirt build-up presence.

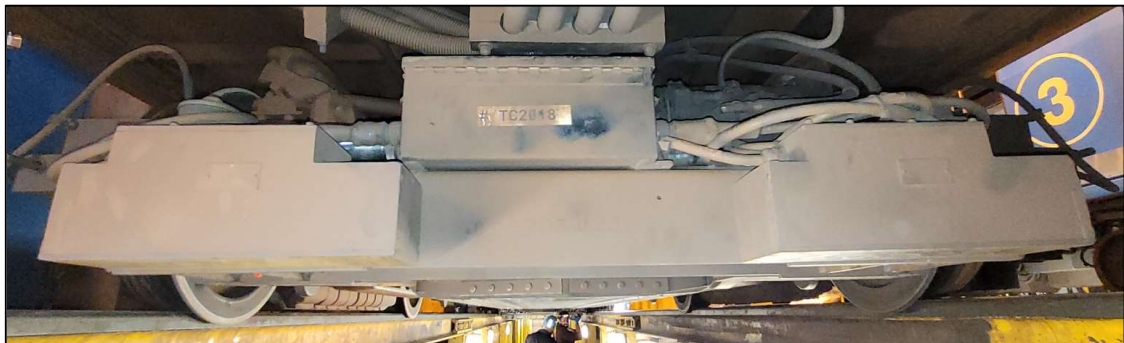
Figure 114 - ATC Antennas on Truck S/N 023

No major damages were found on the ATC antennas, as shown in Figure 114.

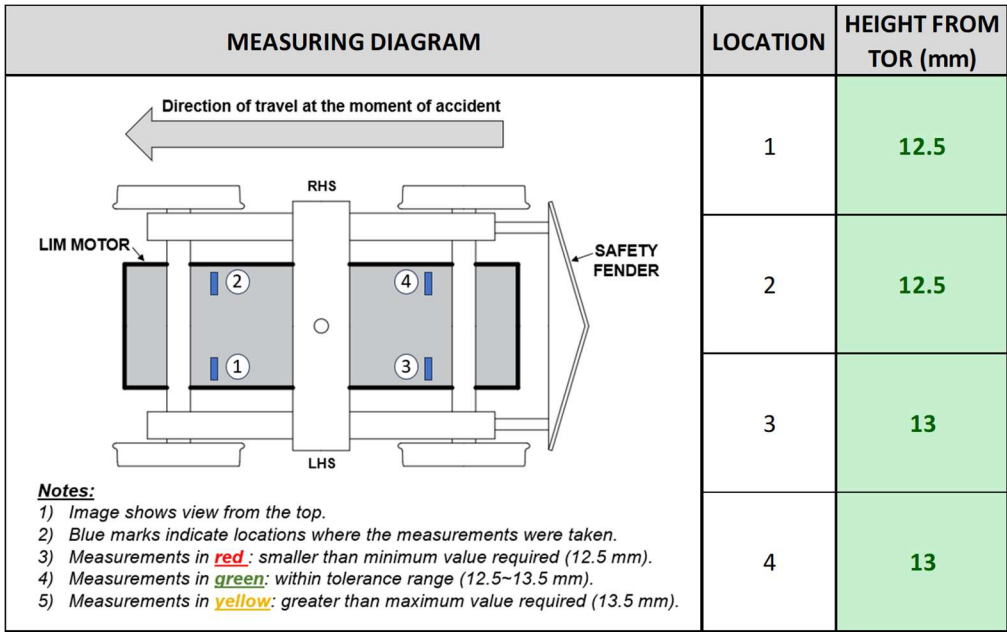
Figure 116 - LIM Height Measurement Results for Truck S/N 009

The LIM height with respect to the top of the running rails was measured using gauge number 127E-610-005 [9], depicted in Figure 10, and verified with a caliper. Results are given in Figure 116. All results were found to be within the acceptable limits.

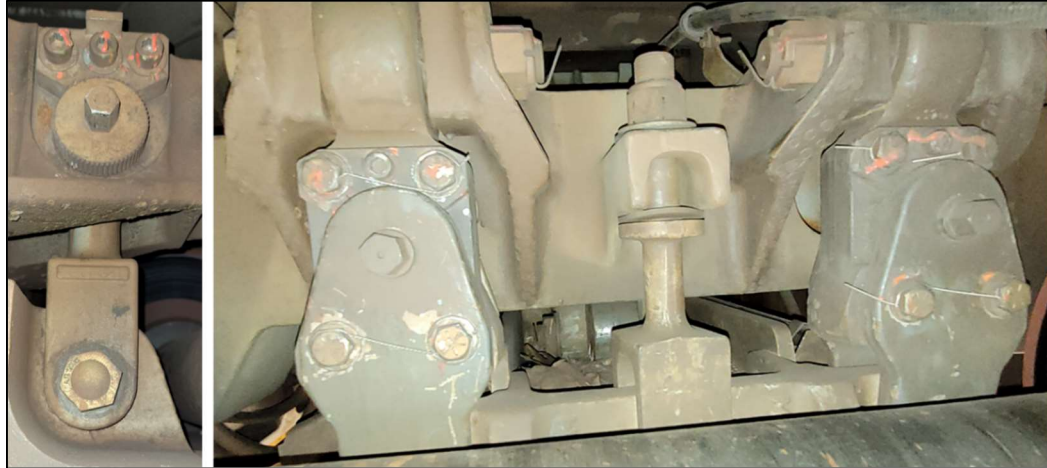
Figure 117 - Vertical Connection Links on Truck S/N 009

The vertical links attaching the LIM to the yoke assemblies and their connections were also physically inspected and found to be properly secured, as shown in Figure 117.

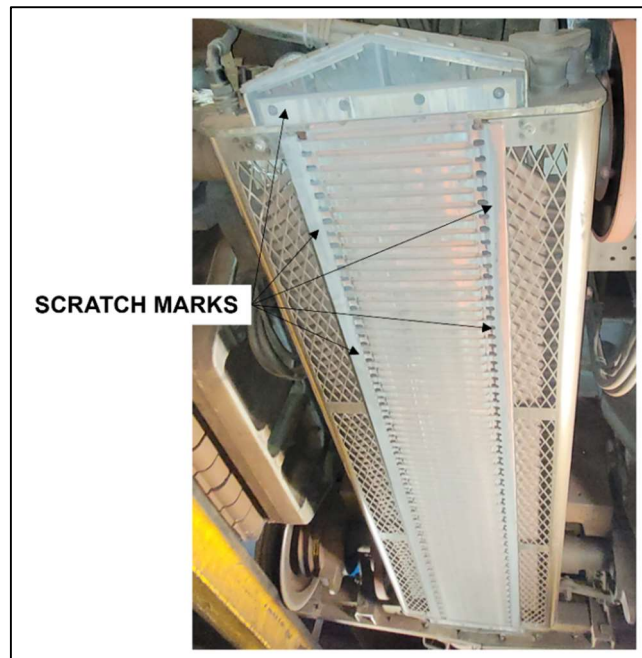
Figure 118 - Scratch Marks on Bottom of the LIM

Uniform scratch marks were found along the entire length of the LIM bottom, as shown in Figure 118, suggesting rubbing against the reaction rail top aluminum cap at various locations in the system. These marks appeared to be aged due to their discoloration and dirt build-up presence.

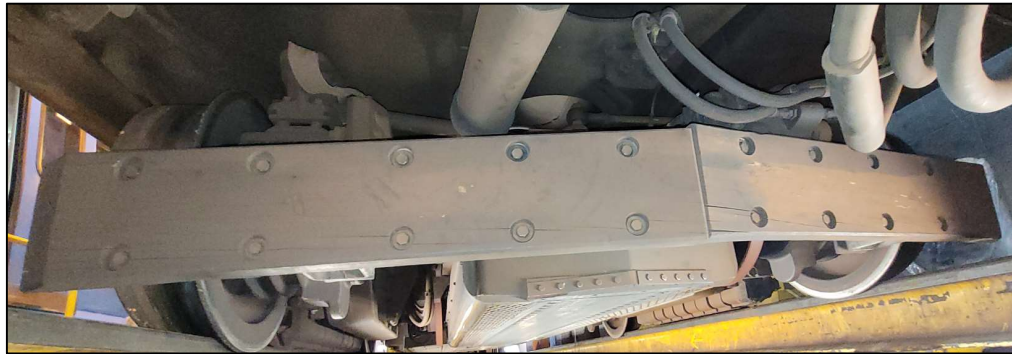
Figure 119 - Safety Fender on Truck S/N 009

No major damages were found on the safety fender, as shown in Figure 119.

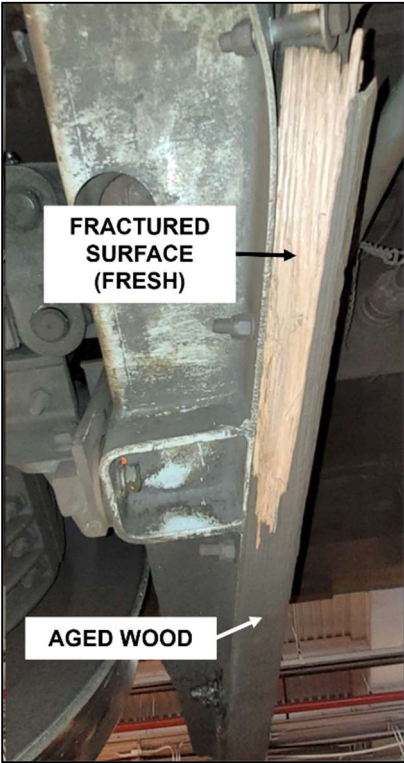
Figure 122 - Broken Wooden Safety Fender on Truck S/N 001

The fractured surfaces of the wooden fender appeared to have been broken recently (fresh fracture), with a non-aged appearance when compared with the other surfaces (see Figure 122).

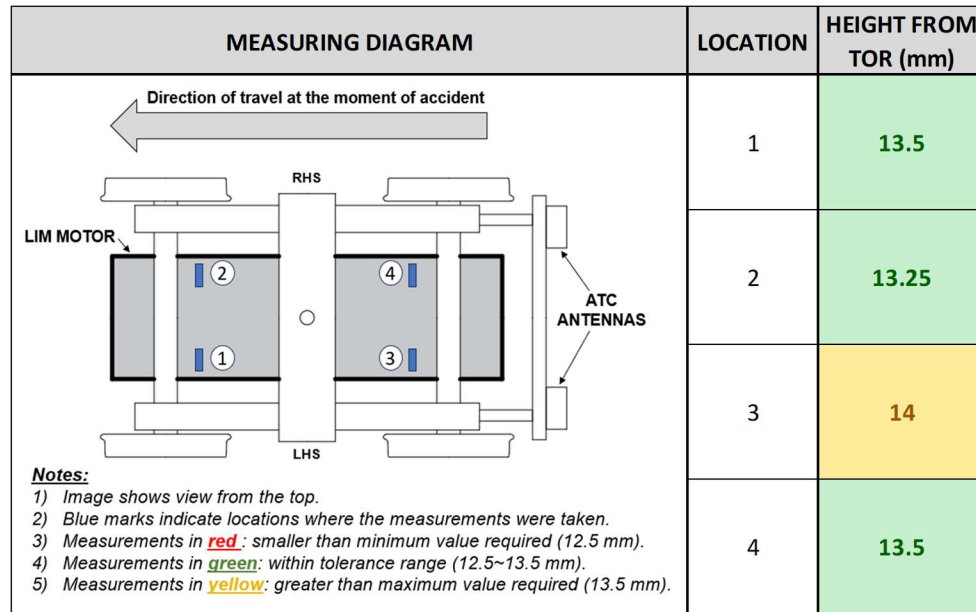
Figure 124 - LIM Height Measurement Results for Truck S/N 314

The LIM height with respect to the top of the running rails was measured using gauge number 127E-610-005 [9], depicted in Figure 10, and verified with a caliper. Results are given in Figure 124. One of the measurements was found to be outside of the specified range. However, it was greater than the maximum allowed, hence increasing the air gap with the reaction rail.

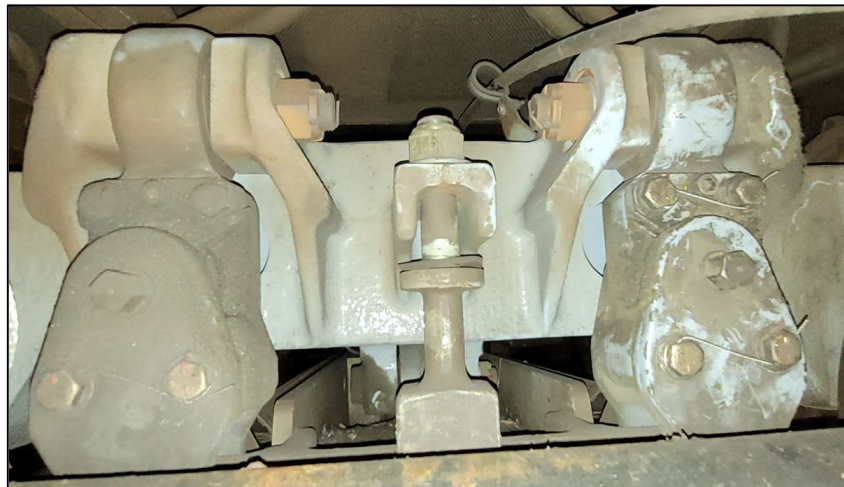
Figure 125 - Vertical Connection Links on Truck S/N 314

The vertical links attaching the LIM to the yoke assemblies and their connections were also physically inspected and found to be properly secured, as shown in Figure 125.
