Toronto Transit Commission

Scarborough Rapid Transit (SRT) Vehicle Accident Investigation Report

2023-09-28	A	Released	Marcel Silva, P.Eng. Glen Johnstone, P.Eng.	Nicholas Zeolla, P.E.	Sulaiman Janjua	Jarek Skonieczny, P.Eng.
Date	Rev.	Status	Prepared By	Checked By	Approved By	Approved By
HATCH

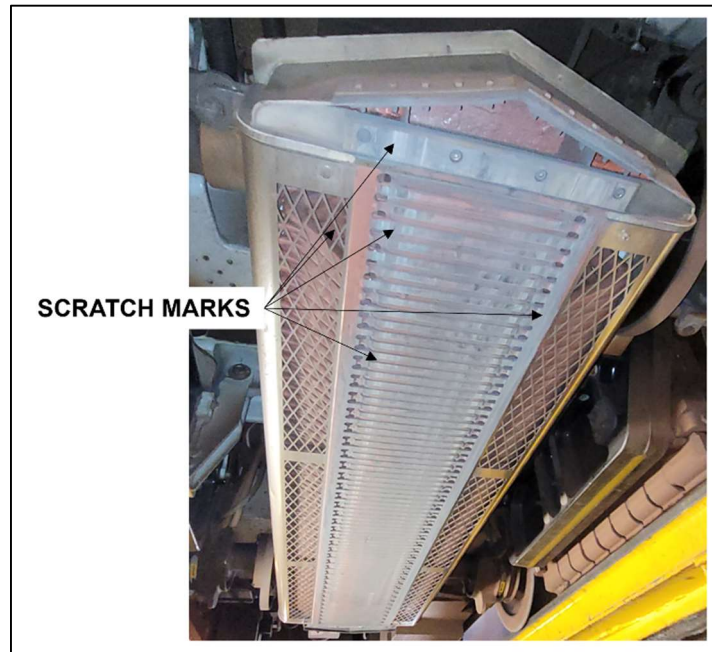
Figure 126 - Scratch Marks on Bottom of the LIM

Uniform scratch marks were found along the entire length of the LIM bottom, as shown in Figure 126, suggesting rubbing against the reaction rail top aluminum cap at various locations in the system. These marks appeared to be aged due to their discoloration and dirt build-up presence.

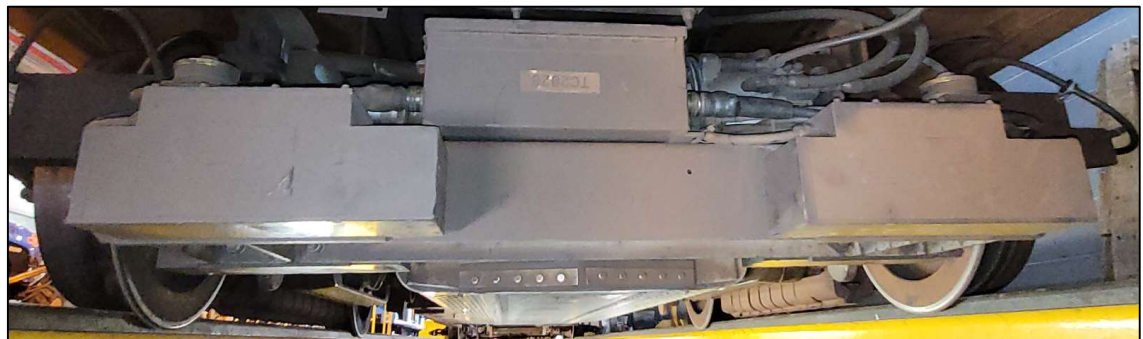
Figure 127 - ATC Antennas on Truck S/N 314

No major damages were found on the ATC antennas, as shown in Figure 127.

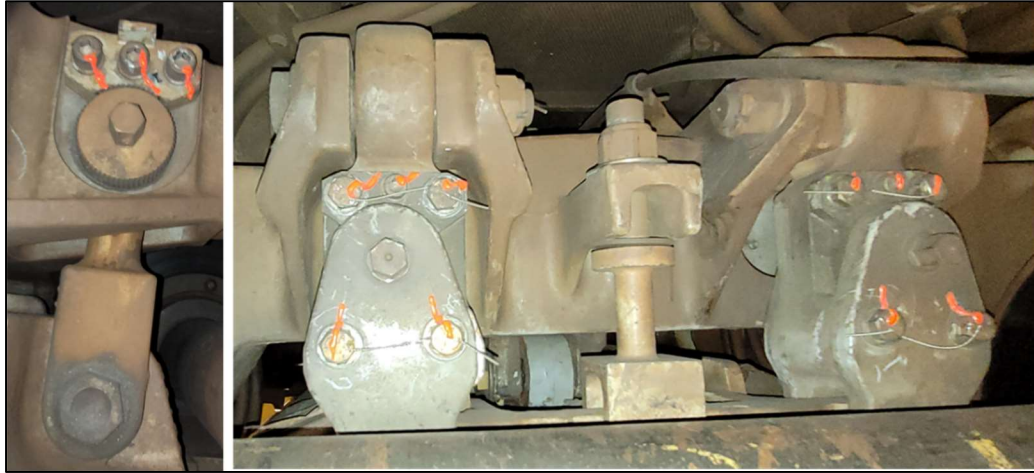
Figure 130 - Vertical Connection Links on Truck S/N 043

The vertical links attaching the LIM to the yoke assemblies and their connections were also physically inspected and found to be properly secured, as shown in Figure 130.

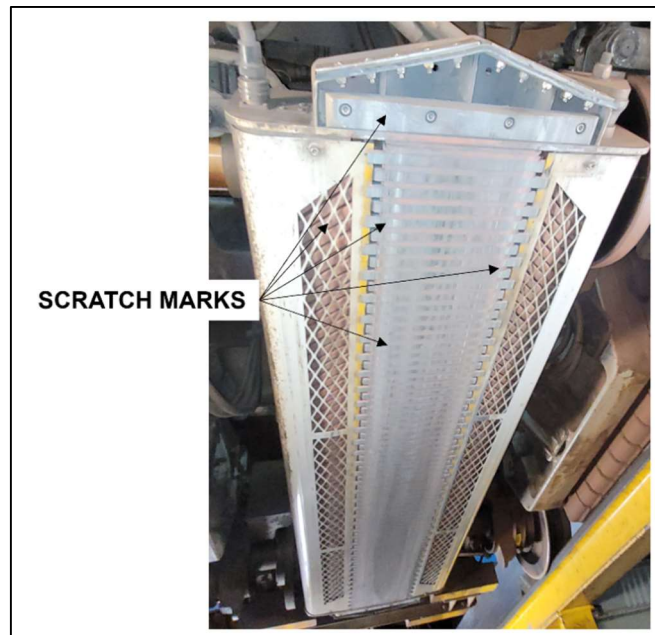
Figure 131 - Scratch Marks on Bottom of the LIM

Uniform scratch marks were found along the entire length of the LIM bottom, as shown in Figure 131, suggesting rubbing against the reaction rail top aluminum cap at various locations in the system. These marks appeared to be aged due to their discoloration and dirt build-up presence.

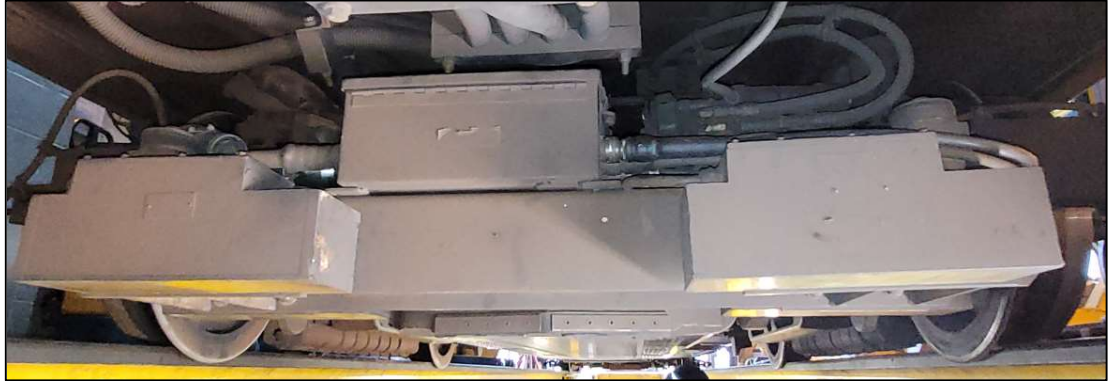
Figure 132 - ATC Antennas on Truck S/N 043

No major damages were found on the ATC antennas, as shown in Figure 132.

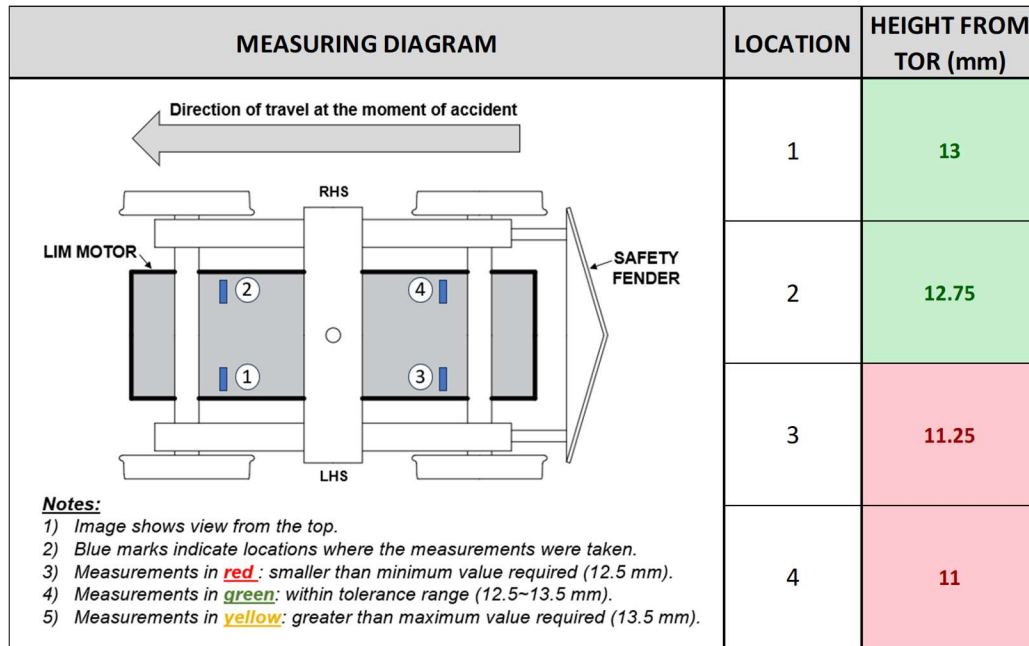
Figure 134 - LIM Height Measurement Results for Truck S/N 311

The LIM height with respect to the top of the running rails was measured using gauge number 127E-610-005 [9], depicted in Figure 10, and verified with a caliper. Results are given in Figure 134. Some of the measurements were found to be outside of the specified range (smaller than the lower specification limit). Given how high the guideway obstruction collided with some of the trucks of the investigated cars (approximately 70 mm), these small LIM height tolerance violations are not believed to have been contributing factors to the accident.

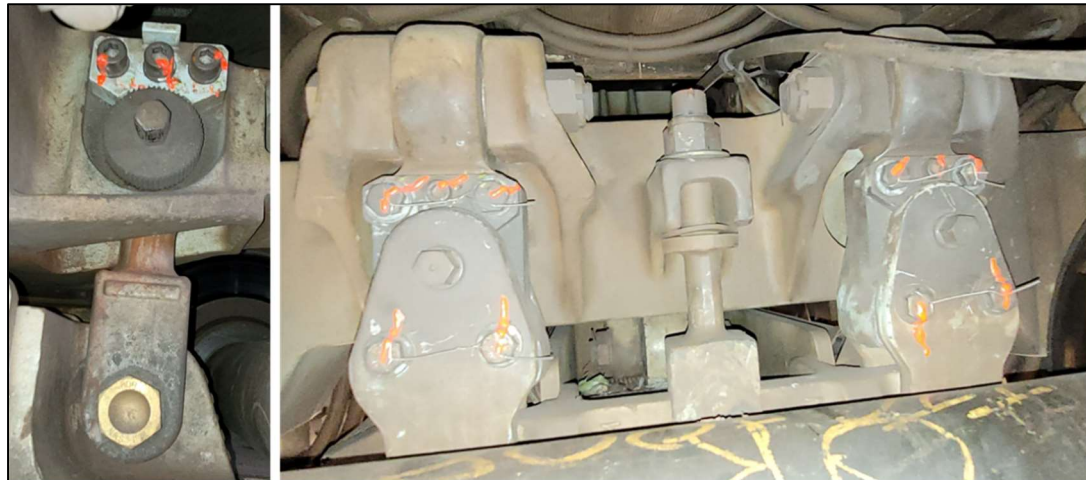
Figure 135 - Vertical Connection Links on Truck S/N 311

The vertical links attaching the LIM to the yoke assemblies and their connections were also physically inspected and found to be properly secured, as shown in Figure 135.

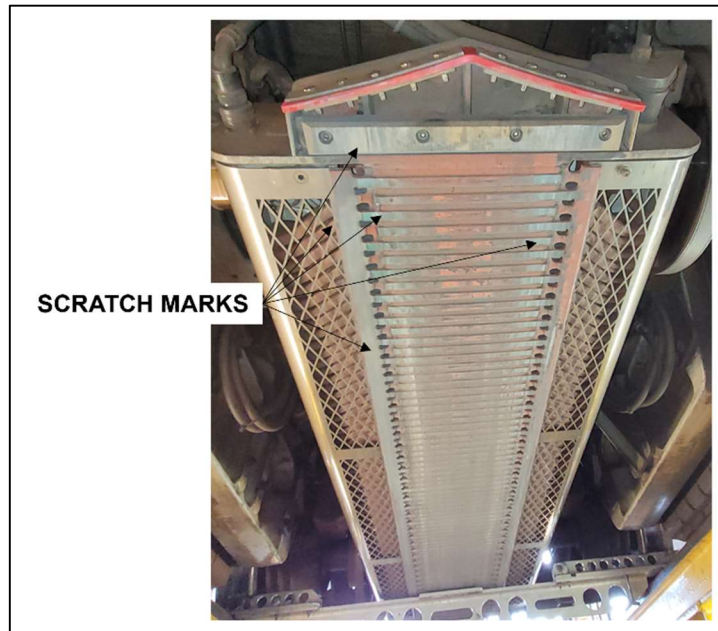
Figure 136 - Scratch Marks on Bottom of the LIM

Uniform scratch marks were found along the entire length of the LIM bottom, as shown in Figure 136, suggesting rubbing against the reaction rail top aluminum cap. These marks appeared to be aged due to their discoloration and dirt build-up presence.

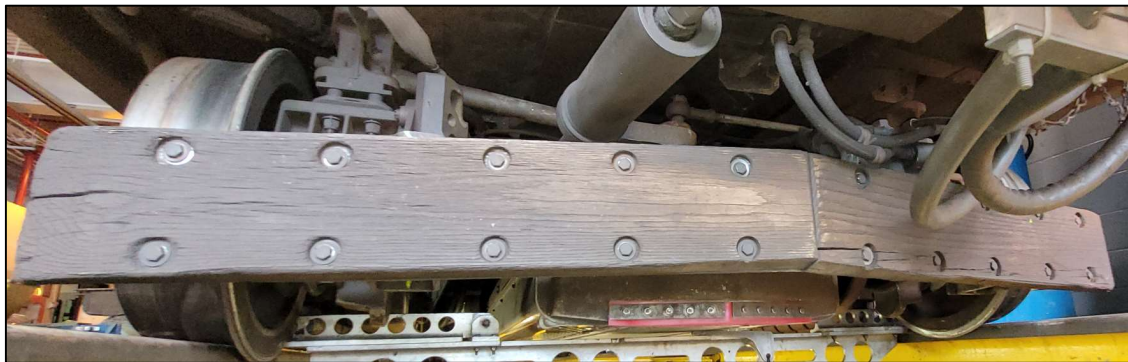
Figure 137 - Safety Fender on Truck S/N 311

No major damages were found on the safety fender, as shown in Figure 137.

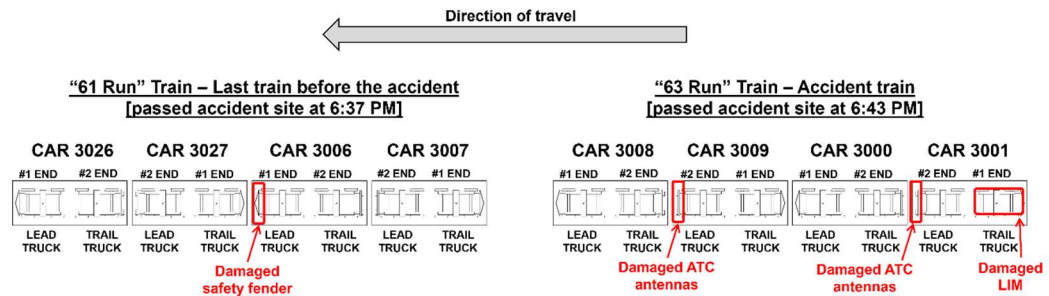
Figure 138 - Location of Damaged Trucks

2. Hatch found evidence of collision with a guideway obstruction on four trucks of the inspected cars (“63 Run” and “61 Run” trains), as shown Figure 138. The damage caused by the collision on all four trucks were very similar, indicating they were all struck by the same object. Since damage was also found on car 3006, the track obstruction was already present when “61 Run” train, ahead of train “63 Run”, passed over the accident site.
