TORONTO TRANSIT COMMISSION REPORT NO.

SUBJECT: YORKDALE FATALITY OF SEPTEMBER 14, 2012 -
FINAL INVESTIGATION REPORT

YORKDALE FATALITY INVESTIGATION REPORT

Spadina Line, Southbound Track at
277+54
Toronto Transit Commission

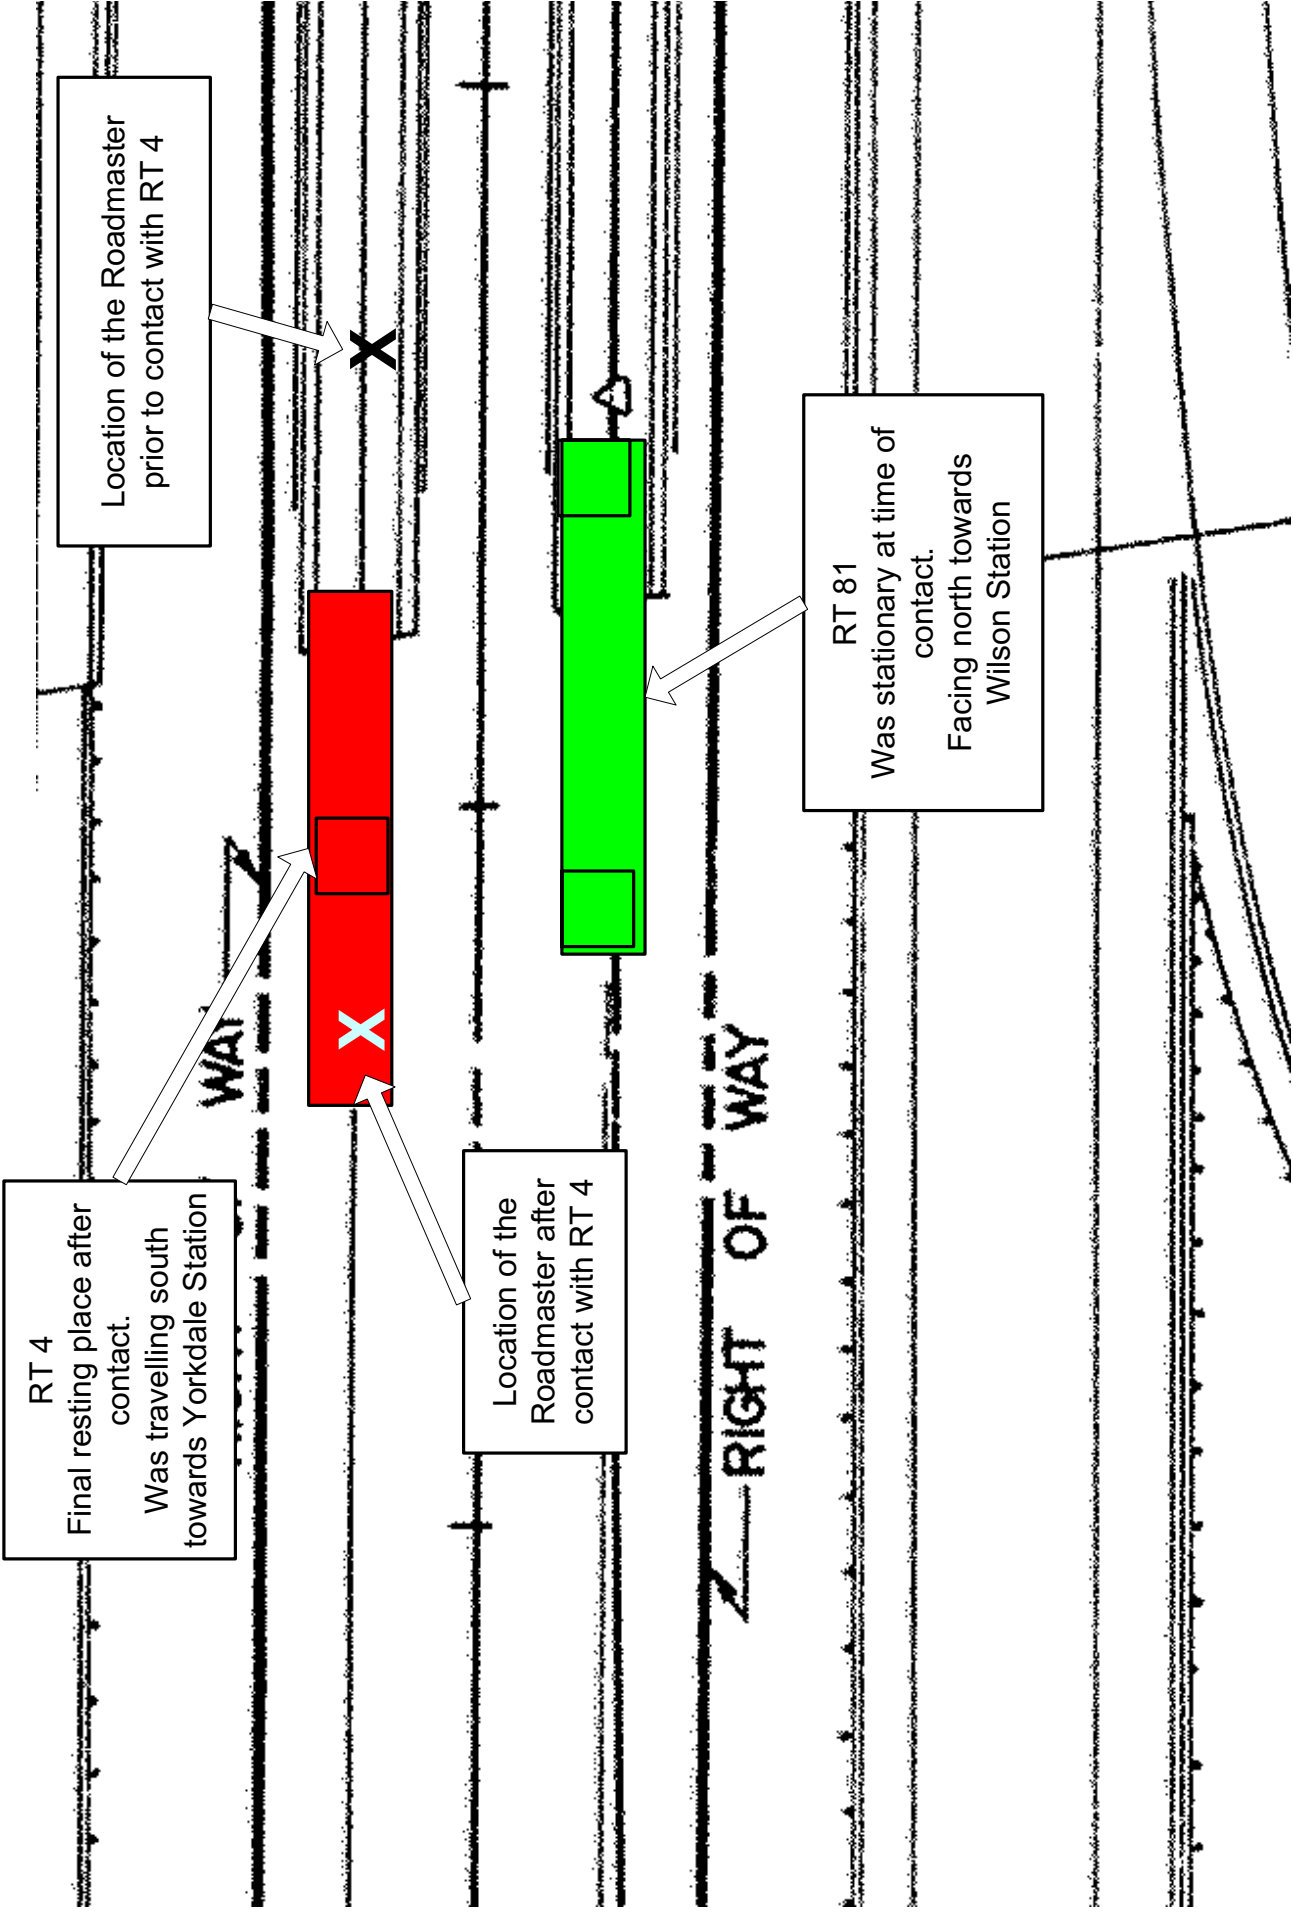
Map of Area
Yorkdale to Wilson Stations
Figure 2

The Team has collected a large number of records, documents and photos related to the work performed that night. A plan of the accident scene was prepared to show the positions of the work cars and point of contact with the work crew (Figure 2). Other records include details of the training of various employees and maintenance of work car RT-4. These records have been systematically organized in a unique filing system.
