SRT DERAILMENT-ELLESMERE STATION

FORENSIC ASSESSMENT REPORT

Rail Infrastructure Consultation
Toronto Transit Commission
Toronto, Ontario
2023-10-12

FIRM PROJECT NO.: 067065

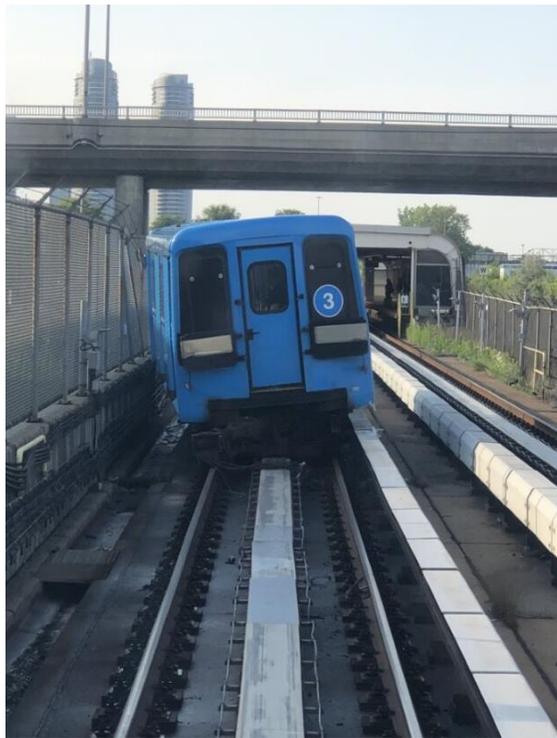
On Monday, July 24th at approximately 6:43 pm, an SRT Line 3 revenue train was travelling southbound from Ellesmere station at 40kph when it derailed at chainage 135+10. The trainset was carrying approximately 44 passengers. The rearmost car uncoupled from the trainset upon impact with a track obstruction and derailed. Preliminary investigations have focused on the track obstruction which resulted in the reaction rail lifting above the acceptable tolerance and contacting the underside of the trainset.

Figure 1: Derailed consist south of Ellesmere Station taken the evening of July 24th, 2023

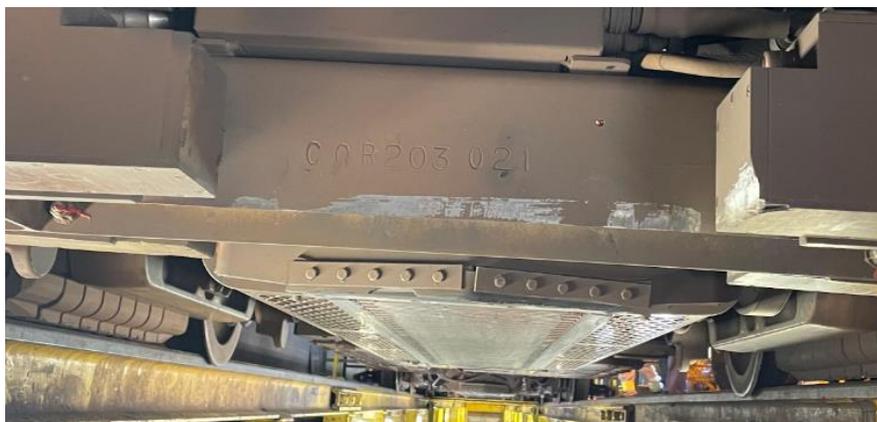
It was observed that the leading edge of Truck 2 of car 3009 also experienced minor damage to its antenna bridge, as shown below in Figure 6.

Figure 6: Leading Edge Damage to Antenna Bridge on car 3009

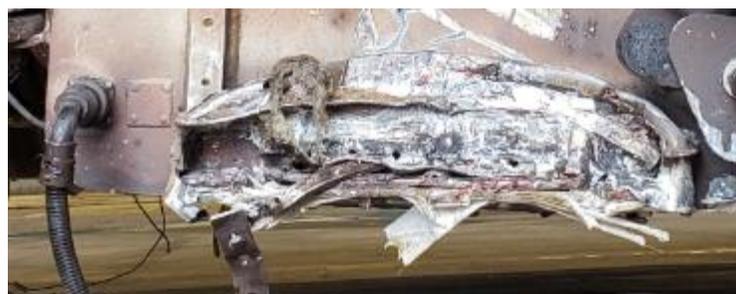
As expected, the most severe damage occurred on the leading edge of Truck 1 on car 3001 of the incident train. Figure 7 below depicts the damage sustained by the Linear Induction Motor mounted on the underside, which struck the reaction rail, causing the derailment.

Figure 7: Leading Edge Damage to LIM on car 3001

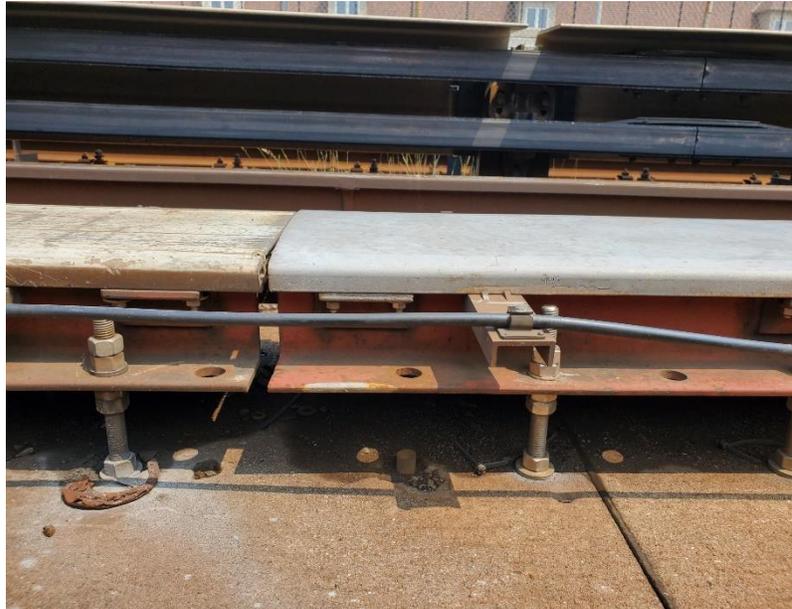
At the derailment site, as noted in the previous section, it was observed that mounting bolts had been replaced. This replacement occurred at a jointed section of the reaction rail despite the typical TTC requirement at these locations being that the top cap be continuous and overlap the reaction rail joint. However, it was noted that the reaction rail was cut at the joint to install the anchor bolts, leaving a gap and a non-continuous surface at this location. The conditions here would mirror Figure 10 taken 70m south of the point of derailment.

As seen in Figure 10, the gap and non-level surface have the potential to create a scenario where the linear induction motor could make severe contact with the top cap. As discussed with TTC personnel, typical

practice is for the top cap to be continuous at the reaction rail joints, with top cap joints staggered as opposed to coinciding.

Figure 10: Maintenance activity at similar jointed reaction rail location south of derailment site

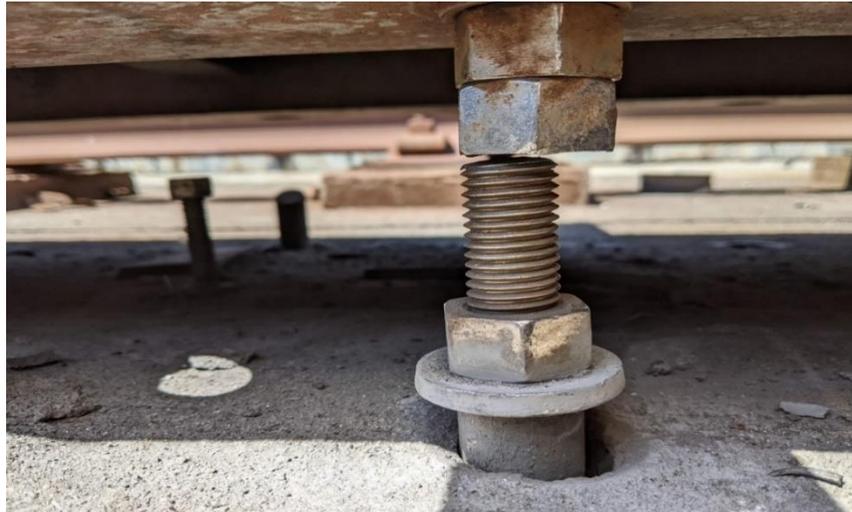
It was noted within the derailment site that numerous newer stainless steel anchor bolts secured the reaction rail frame to the invert slab, and some of the stainless steel bolts showed signs of fracture prior to the derailment. Figure 15 shows a similar fractured and misaligned anchor bolt found approximately 70 m south of the derailment site.

Figure 15: Fractured anchor bolt located approximately 70m south of the derailment site

This proposed scenario finds additional reinforcement in similar observations, as Figure 15 shows another instance of premature bolt failure 70 m south of the derailment site. With bolt assemblies 0, 1, 3, 5 and 7 failing prematurely, the remaining bolts would have borne heightened loads, particularly at the leading edge of the reaction rail with a higher moment arm.

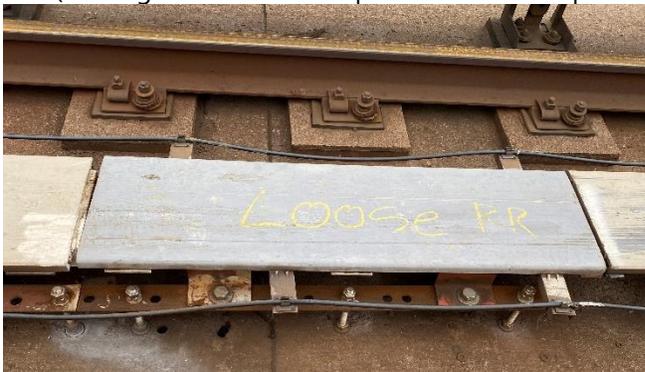
The aluminum cap plate on top of the reaction rail exhibits scars, likely from contact with train components, along the entire section of track. Many of these marks were tarnished with oxidation, suggesting that contact between the reaction rail and the trains had occurred for some time. Many T-bolts (holding the aluminum cap to the induction plate frame on the reaction rail) were loose or missing.

Figure 19: Retrofit south of the derailment site, short segment with coincident joints in aluminum cap and inductor

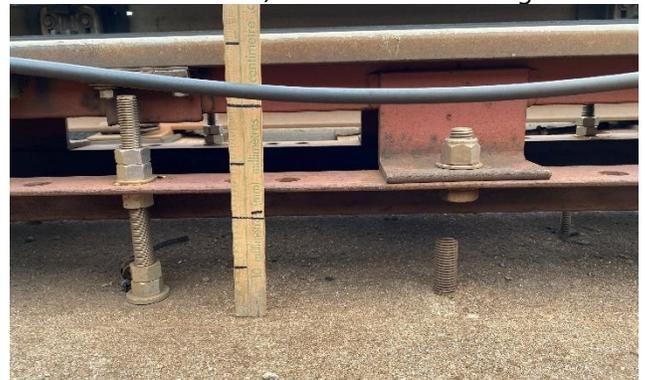
The impacted reaction rail assembly had been retrofitted, including modifications to the assembly and replacing the anchors using post-installed torque-controlled expansion anchors (Hilti HSL-GR stainless steel heavy-duty anchors, M20/30). Figure 20 shows an existing post-installed anchor found south of the derailment site. At the original sections of the reaction rail, the joints in the aluminum cap are offset from the joints in the lower frame, whereas at the retrofit sections, the joints in the aluminum cap and lower frame coincide at the same location (see Figure 19). The lapping of the aluminum cap over the lower frame joints found in the original sections mitigates the effect of any vertical variation in the reaction rail segments, making the original sections less likely to snag the train induction motor in the event of a loose or high reaction rail segment.

Figure 20: HSL-GR M20 anchors at retrofit south of the derailment site

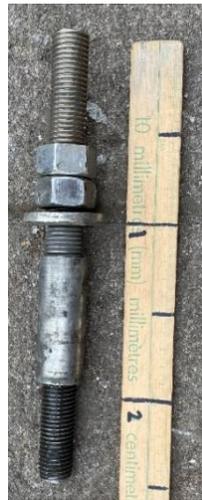
Figure 23: Partial Anchor Assembly Found at Derailment Site

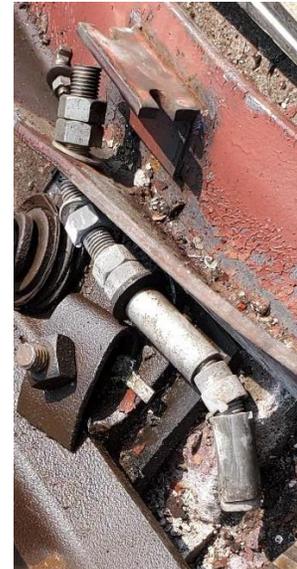
Figure 24: Anchor Assembly (pullout failure)

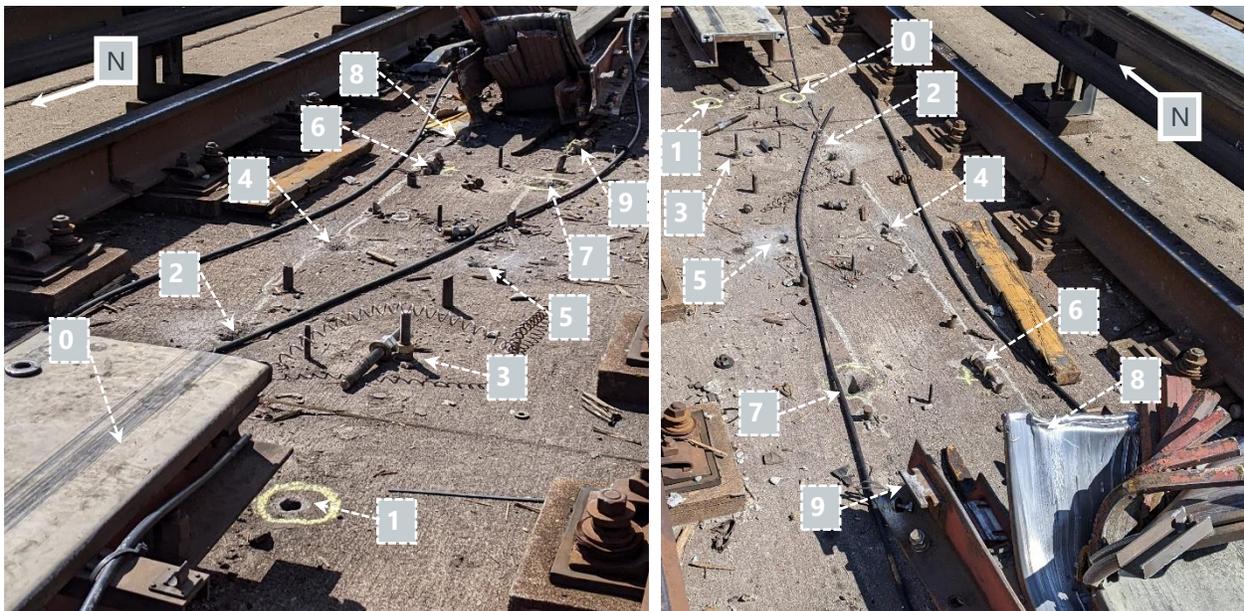
Figure 27: Anchor Layout Sketch

Figure 27 below outlines the numbering convention for the anchors at the segment of reaction rail impacted during the derailment, with views looking north and south at the concrete invert slab following the derailment. Additional photos are provided in **Appendix B**.

<p>Failure mode: The anchor pulled out of the concrete. Bending deformation of the rod occurred prior to and during the pull-out failure during the incident, with the spalling damage to the concrete appearing to have occurred during the pull-out.</p>
3	<p>Findings: Rod was fractured at the top, directly below the lower nut below the reaction rail frame. The remainder of the anchor was still intact and secured in the concrete. Slight bending deformation of the rod was noted (Appendix E, Section 2.1.vii). The top of the rod appeared to have a hammered texture (Appendix B, Figure 11). Core sample C5 was taken at this location.</p>
	<p>Failure mode: The fracture in the rod directly below the reaction rail frame, without any bending deformation, indicates that the rod was fractured at this location prior to the incident. The hammered texture at the location of the fracture in the rod may have been a result of repeated lifting and dropping of the loose reaction rail, prior to the incident.</p>

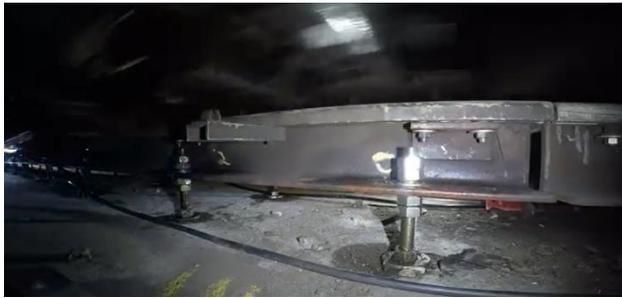
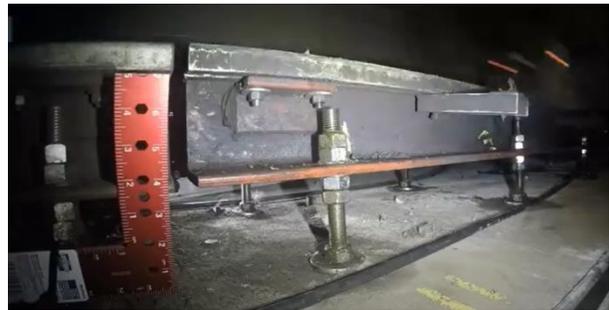
Figure 30: Go Pro View of Reaction Rail (Left Side)

Figure 31: Go Pro View of Reaction Rail (Right Side)

Upon careful review of the reenactment procedure's video footage, a discernible conclusion emerges: the elevation of the reaction rail beyond the maximum permissible tolerances necessitated the failure of a minimum of two rows of bolts. This alignment corresponds with the structural insights garnered from the fractured bolts and failed anchors. Analysis of the structural components reveals that bolt/anchors 0, 1, and 3 exhibited signs of breakage and potential loosening preceding the incident. Scenario 7 indicated that a minimum of two rows of anchor bolts were required for the reaction rail to begin to bend upward and behave like a hinge; however, with only two rows of bolts failing, the reaction rail would not rise beyond tolerances as demonstrated in the videos.

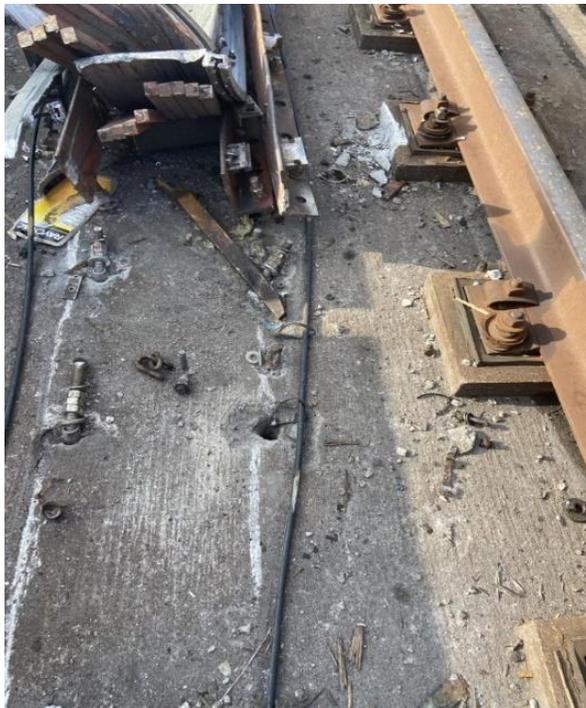
Figure 3: Damaged Reaction Rail and Bent Anchor Bolts

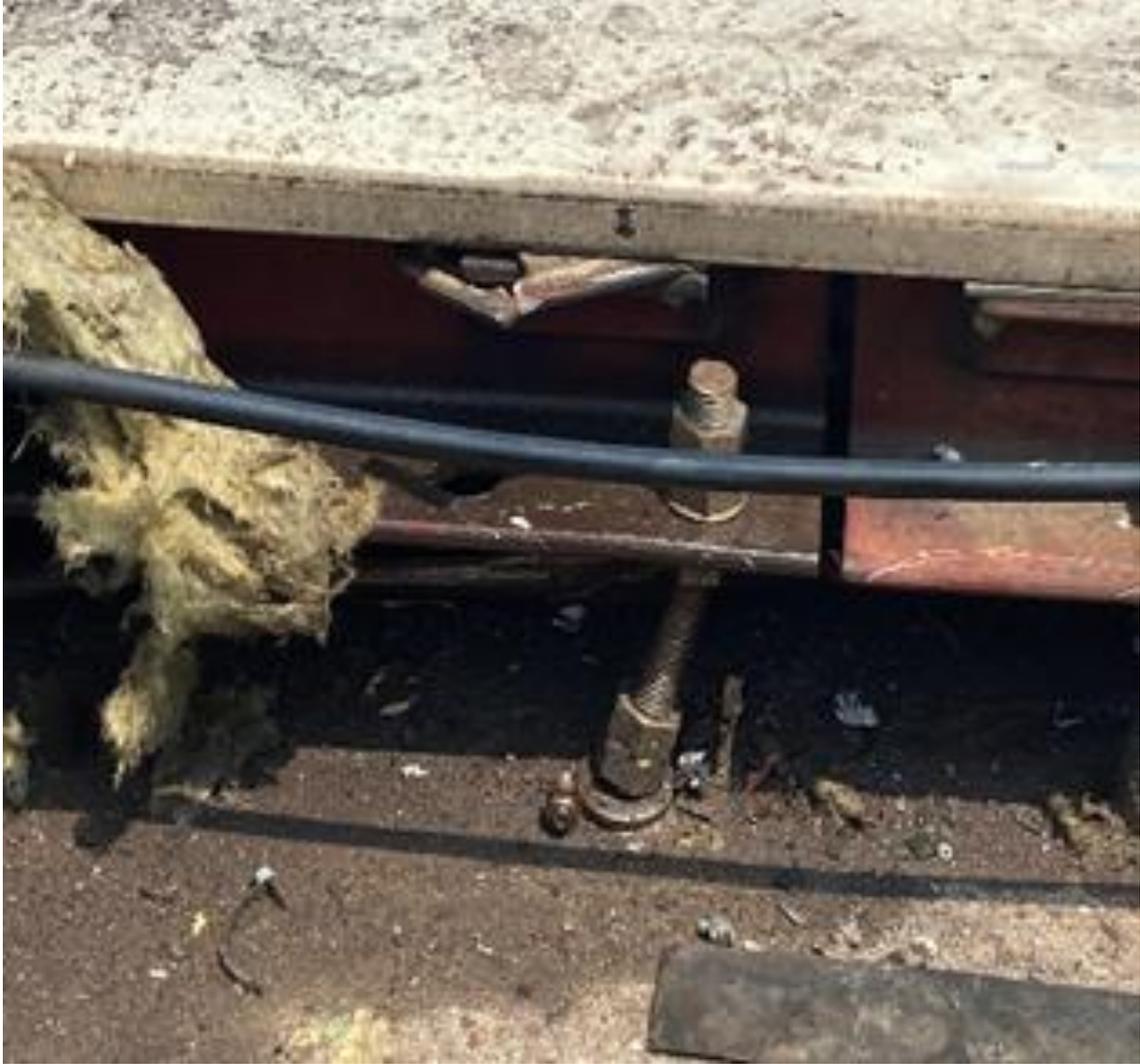
Figure 5: Bent Anchor Bolts immediately South of Derailment Site

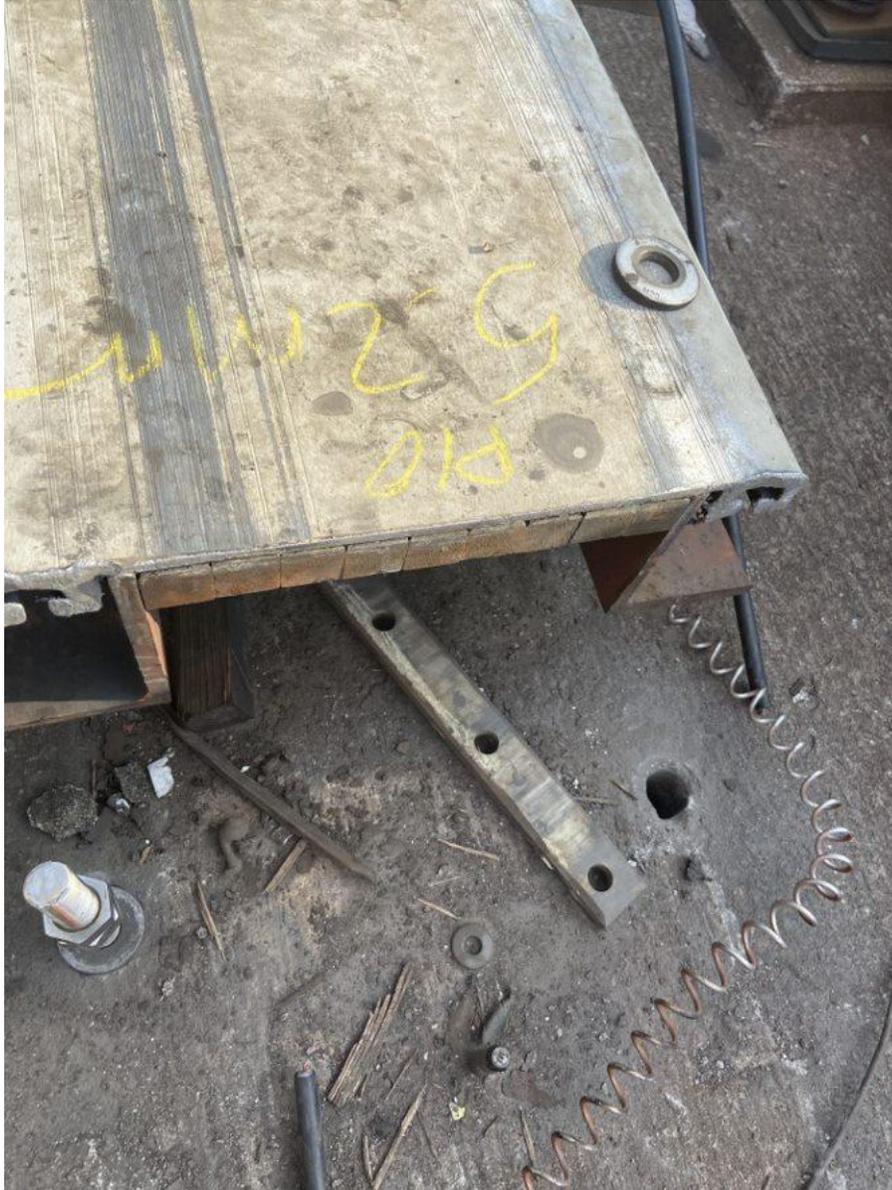
Figure 7: Anchor Bolts zero (0) and one (1) at point of impact. Top cap abrasion

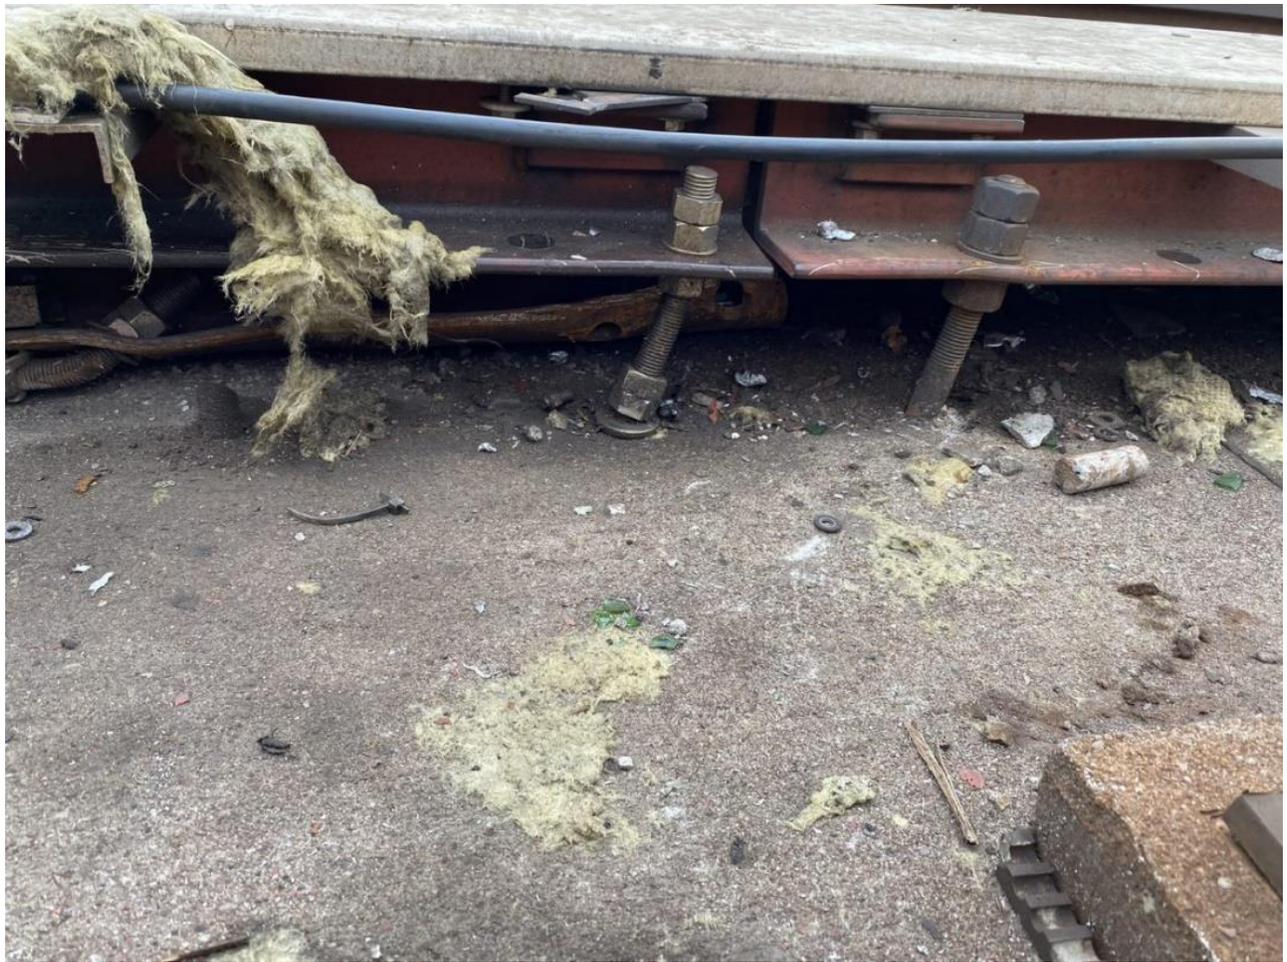
Figure 8: Bent Anchor Bolts South End of Derailment Site

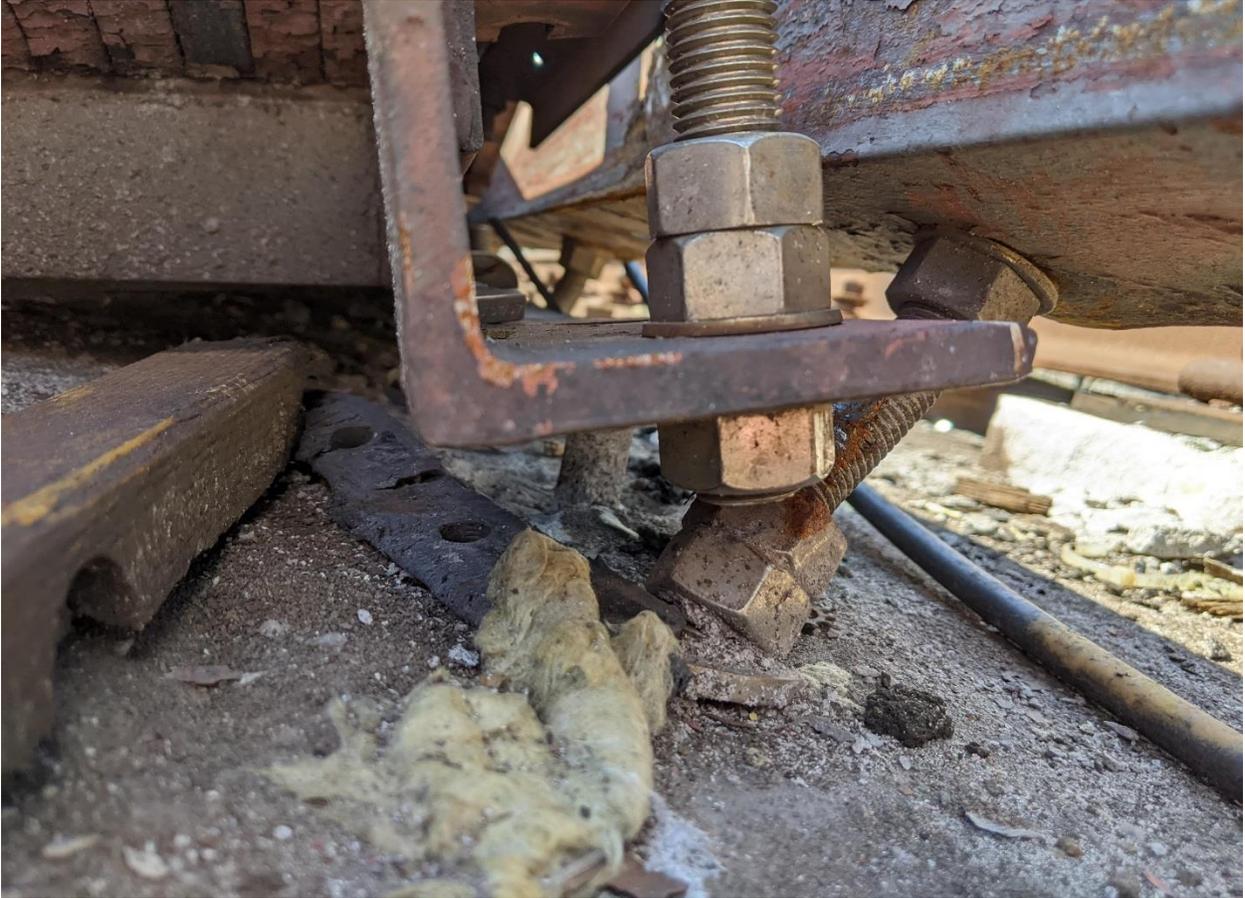
Figure 13: Upper Portion of Anchor Bolt Attached to Reaction Rail Frame (Anchor No. 1)

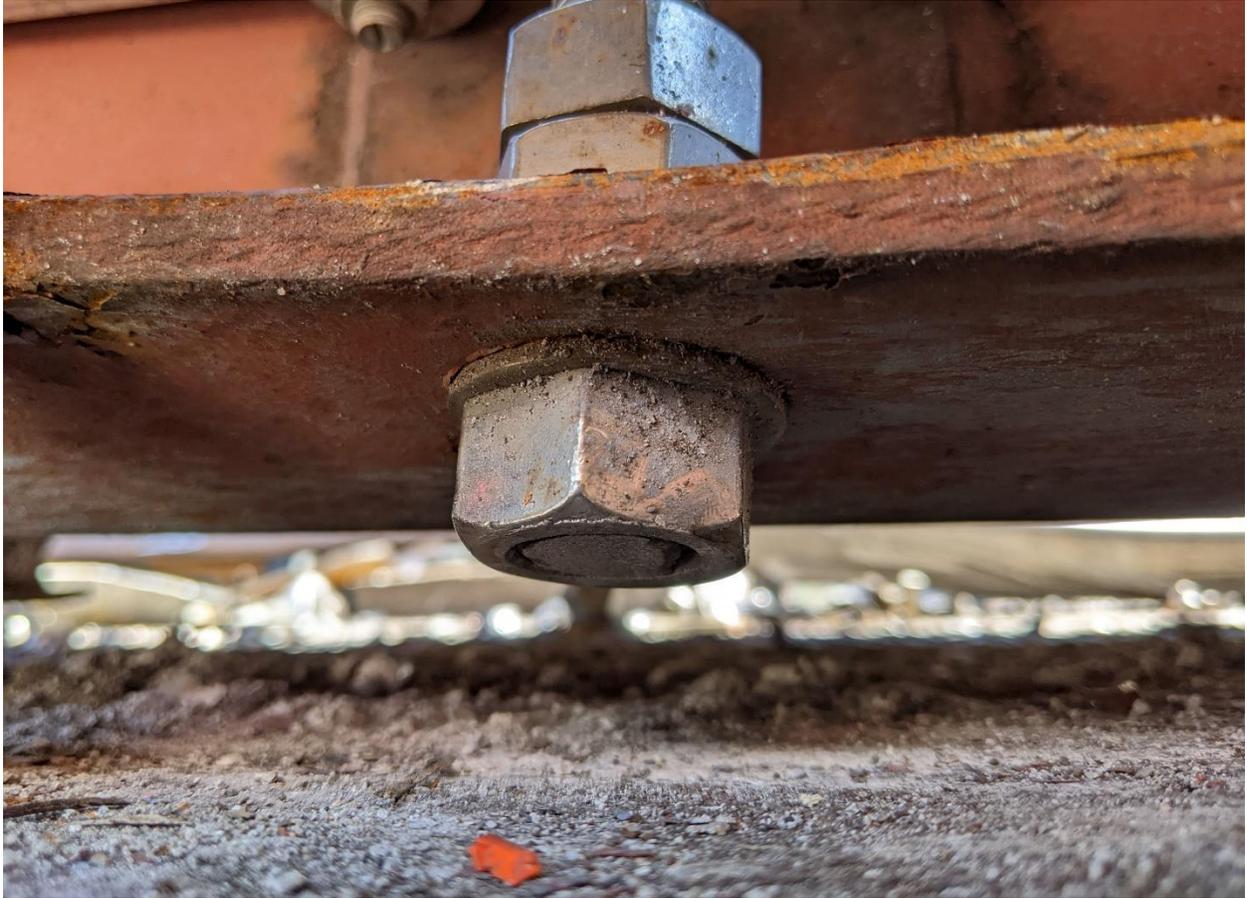
Figure 14: Upper Portion of Anchor Bolt Attached to Reaction Rail Frame (Anchor No. 3)

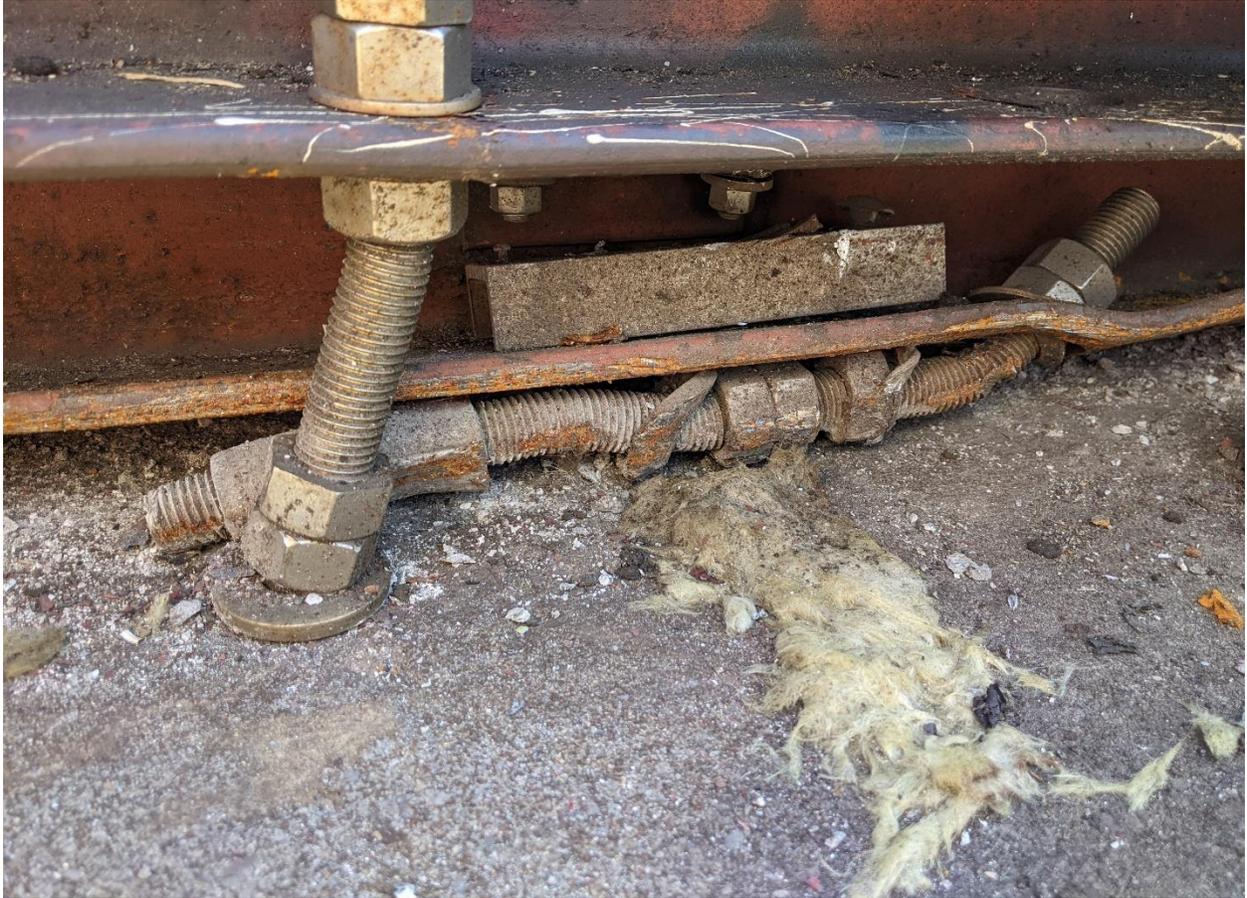
Figure 15: Upper Portion of Anchor Bolt Attached to Reaction Rail Frame (Anchor No. 7). Note that the spacer sleeve remains attached to rod, while cone and expansion sleeve remained within the concrete.

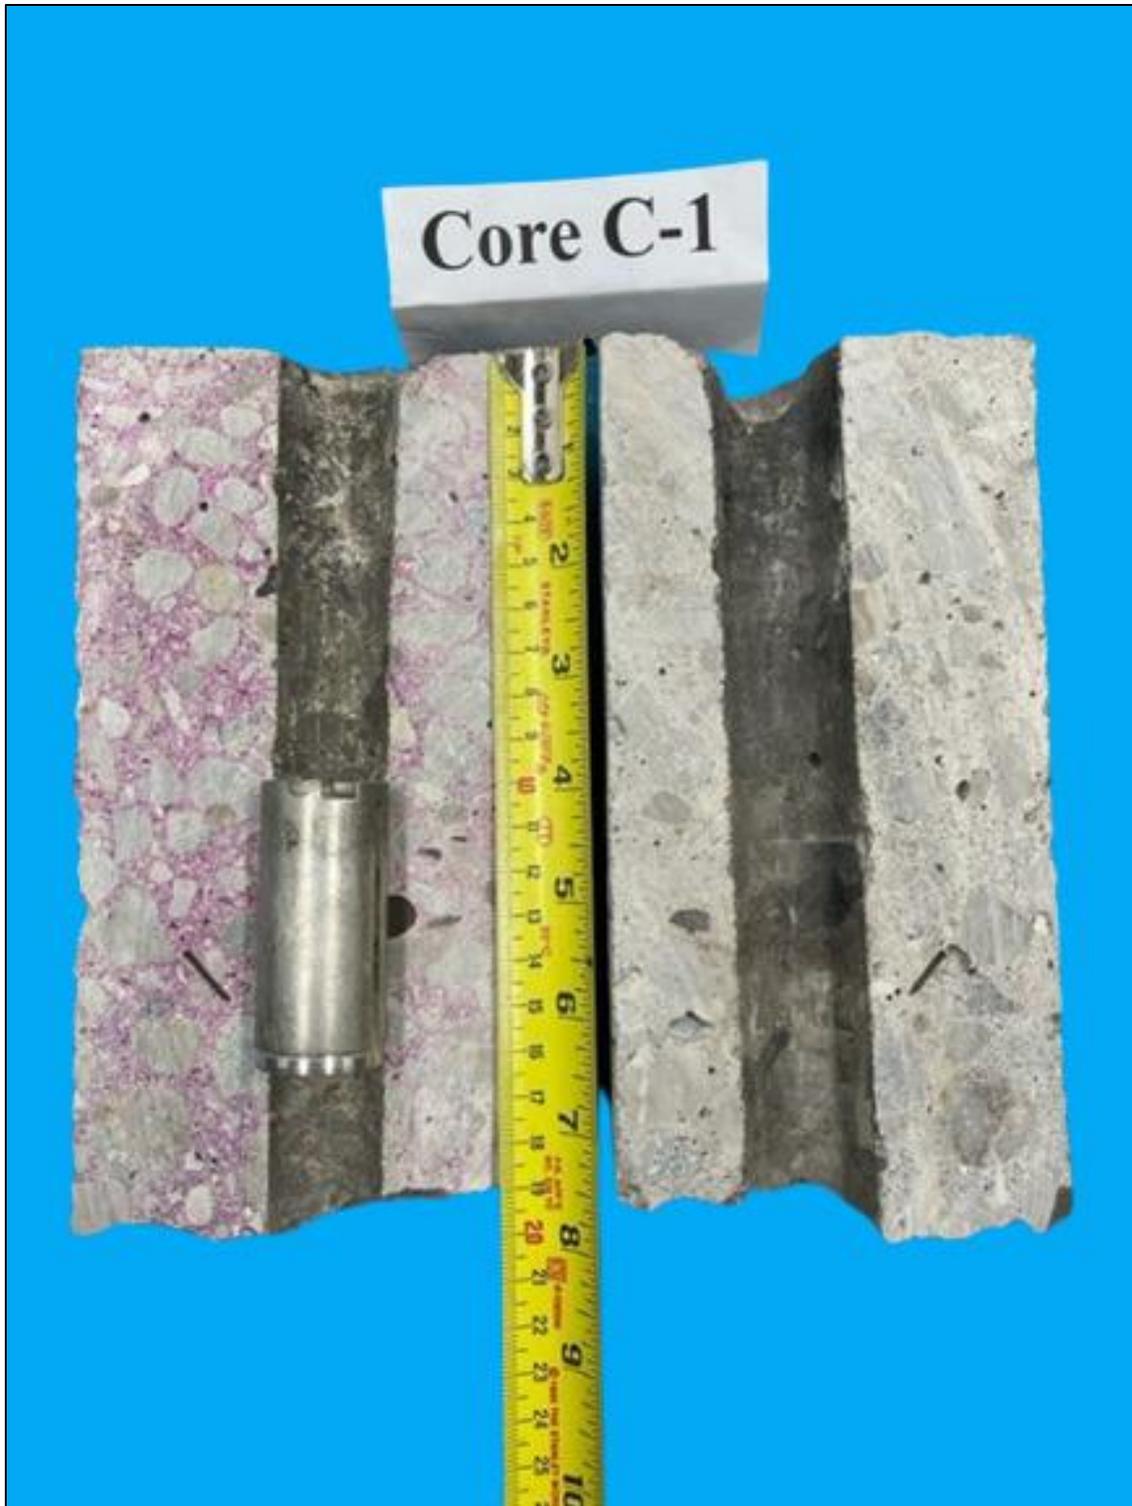
Photo P3 –Core C1 Sawn Sample Faces

(The expansion sleeve and cone placed in the imprinted anchor position on the interior of the core hole likely due to the expansion force applied during the installation and tightening of the bolts; left side core half was tested for depth of carbonation)

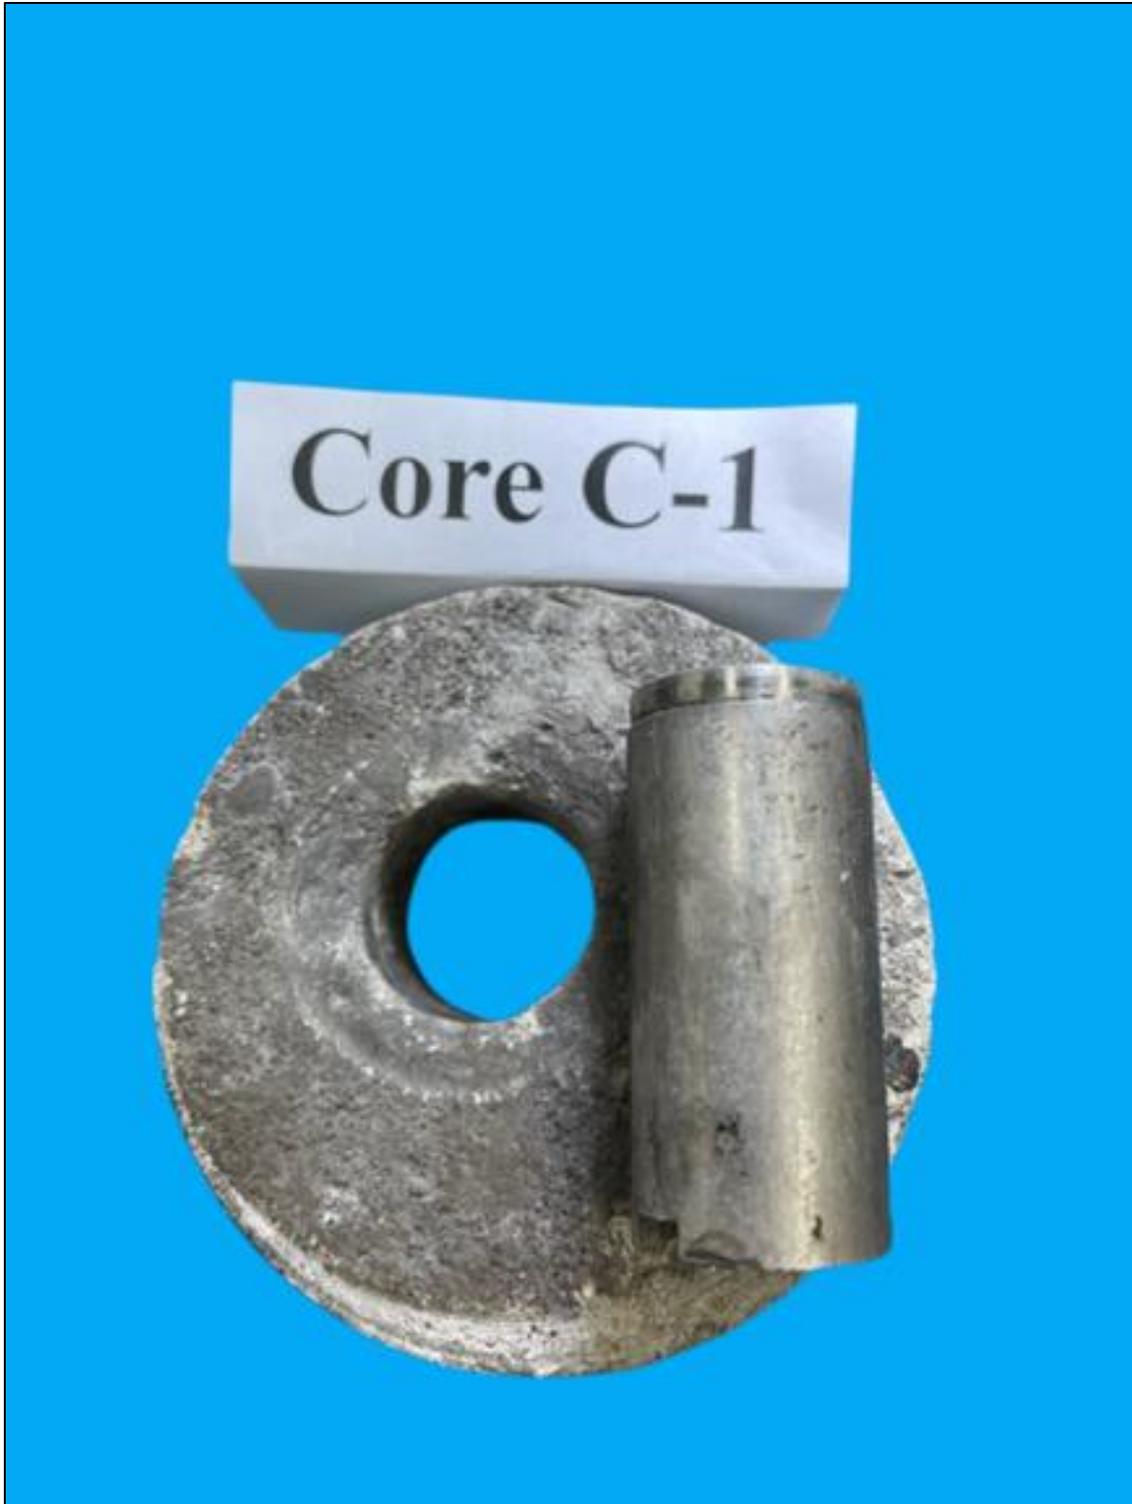
Photo P4 –Core C1 Top View

(The expansion sleeve and cone assembly fell out of core when handled)

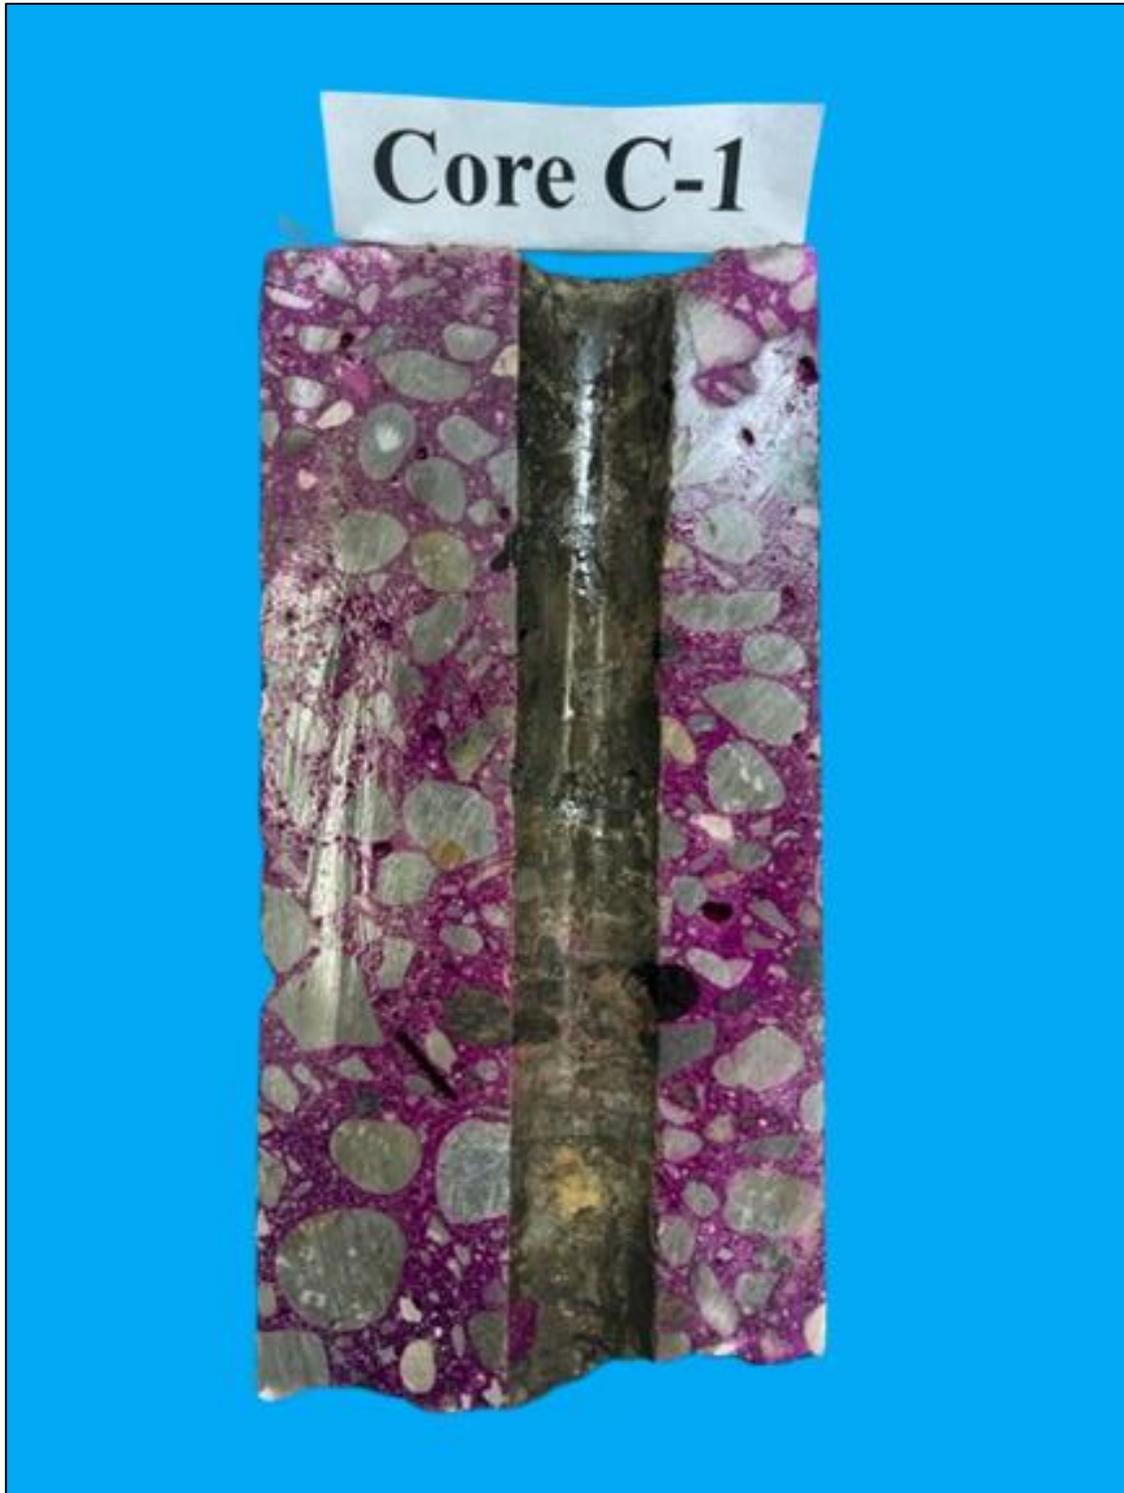
Photo P5 – Core C1

(Showing carbonation tested surface; Carbonation depth was determined to be less than 0.5mm)

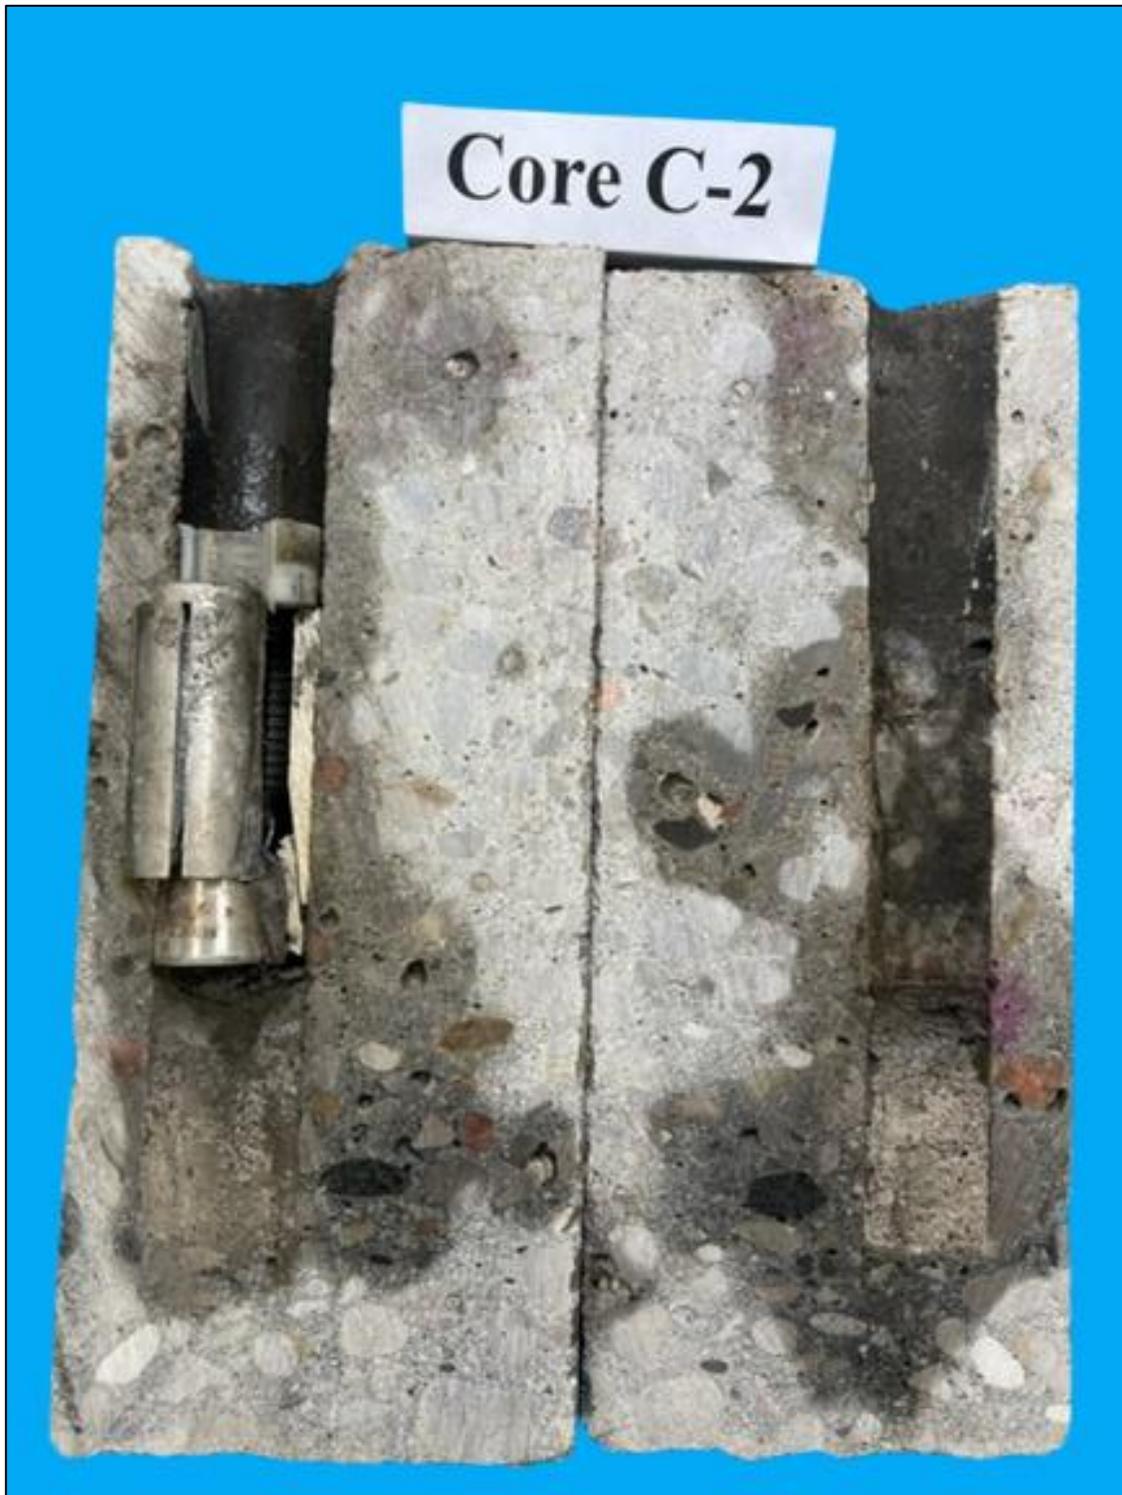
Photo P7 – Core C2 Sawn Sample Faces

(Note: the position of the expansion sleeve/cone and plastic spacers, and the drilling powder at the bottom of the drill hole)

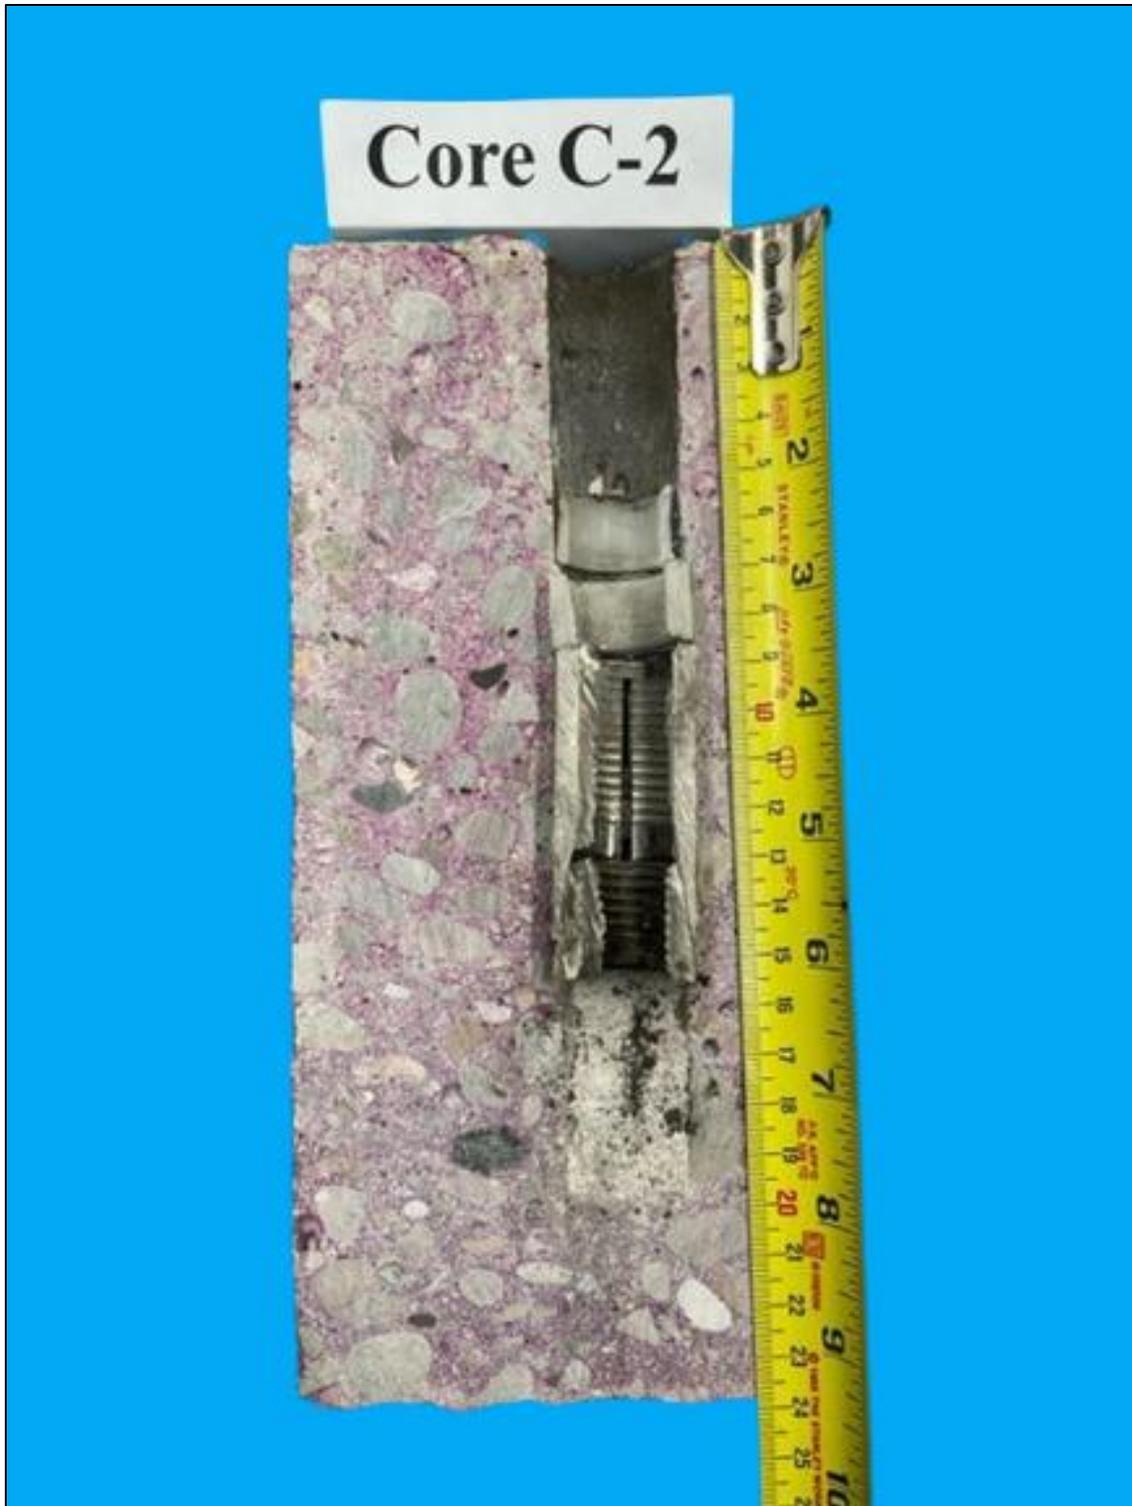
Photo P8 – Core C2 Sawn Sample Face

(Showing sawn expansion sleeve and cone, and plastic spacers; note the position of the expansion sleeve/cone and plastic spacers, and the drilling powder at the bottom of the drill hole.)
