SRT DERAILMENT-ELLESMERE STATION

FORENSIC ASSESSMENT REPORT

Rail Infrastructure Consultation
Toronto Transit Commission
Toronto, Ontario
2023-10-12

FIRM PROJECT NO.: 067065

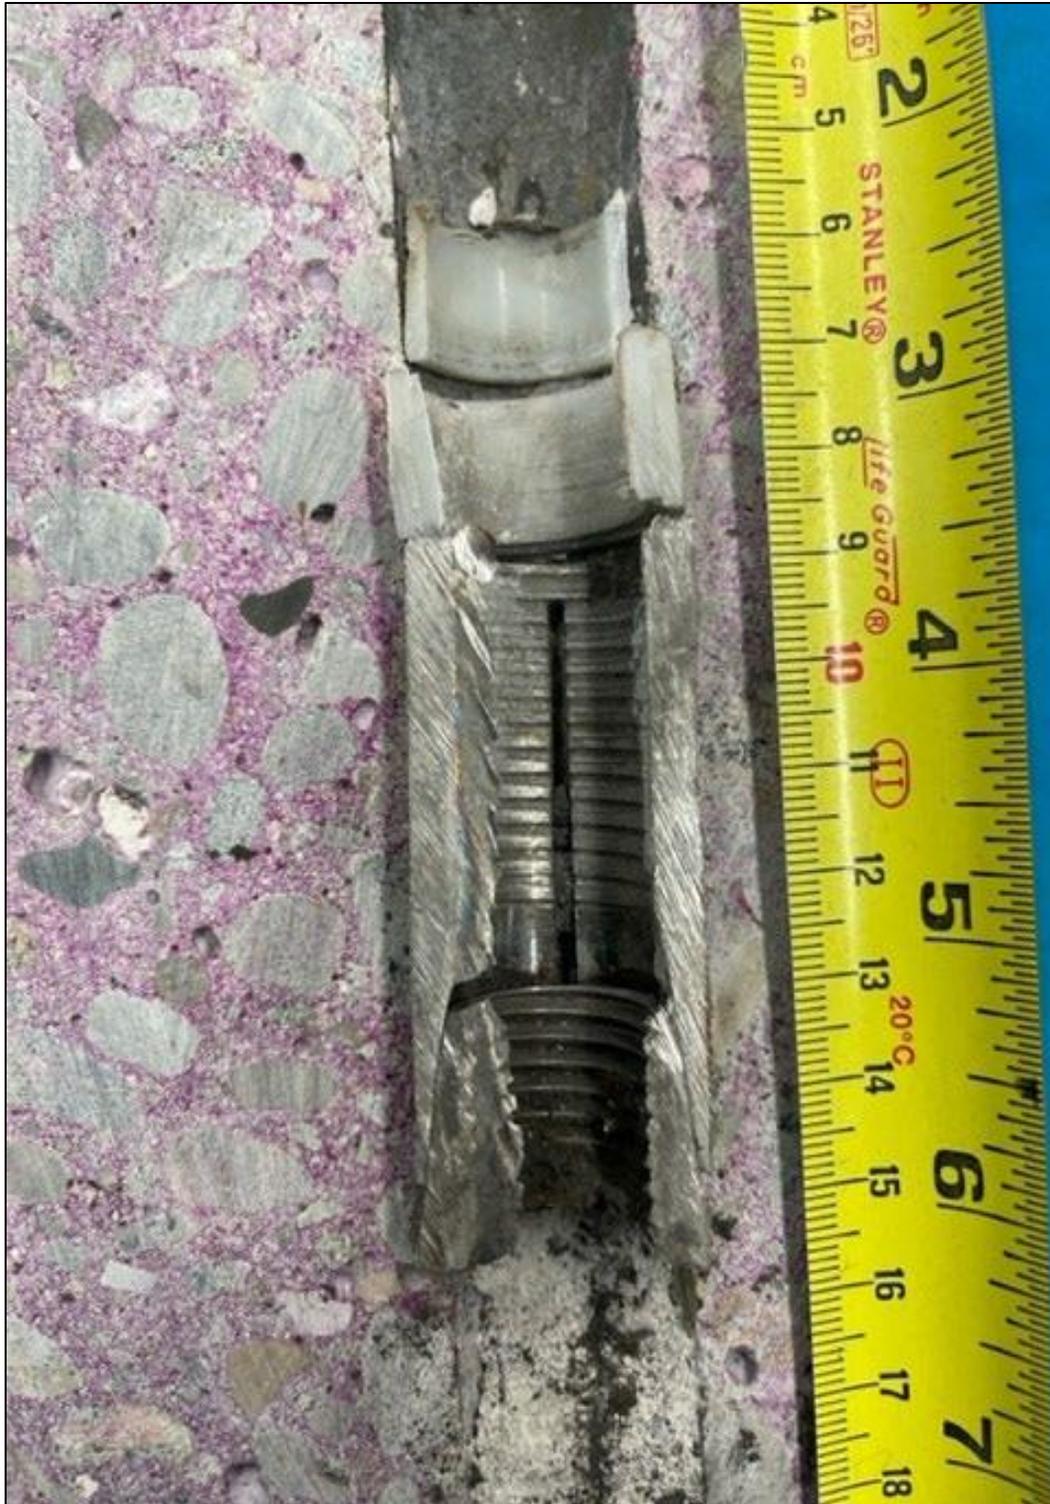
Photo P9 – Core C2 Sawn Sample Face

(Showing close-up view of sawn expansion sleeve and cone, and plastic spacers; note the visible threading seen in the cone, and sleeve, and the drilling powder at the bottom of the drill hole.)

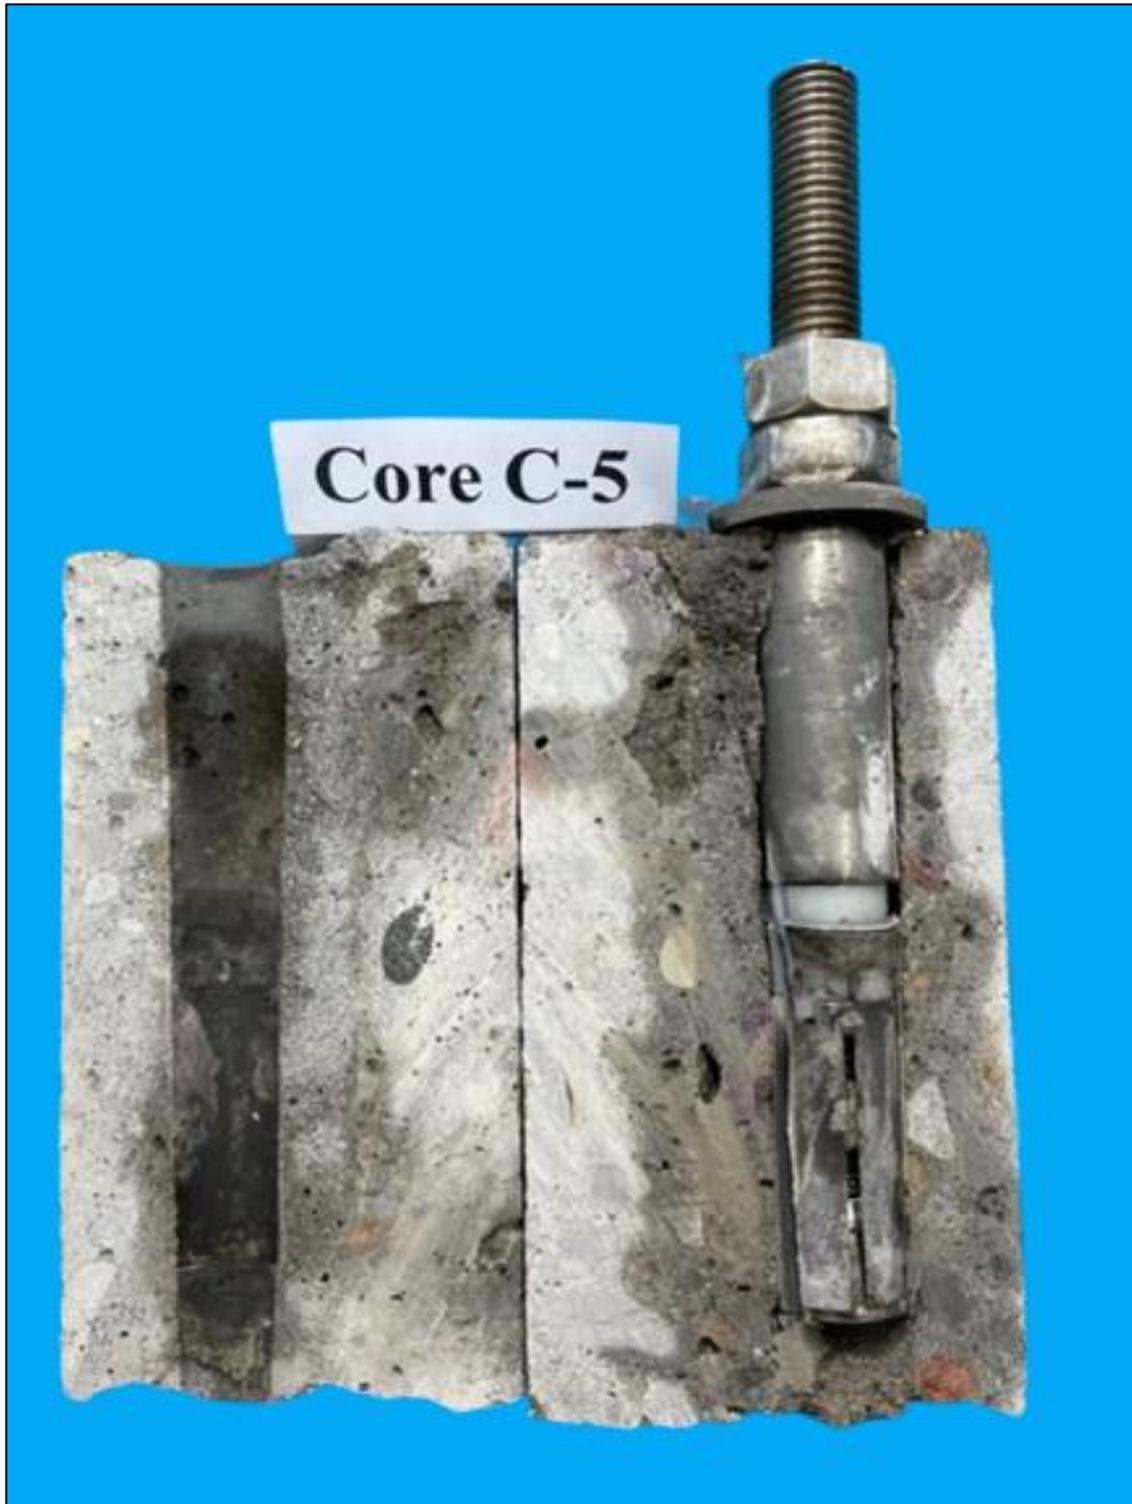
Photo P21 – Core C5 Sawn Sample Faces

(Note : the position of the spacer sleeve, plastic spacers, expansion sleeve and cone, and drilling powder at the bottom of the core hole)

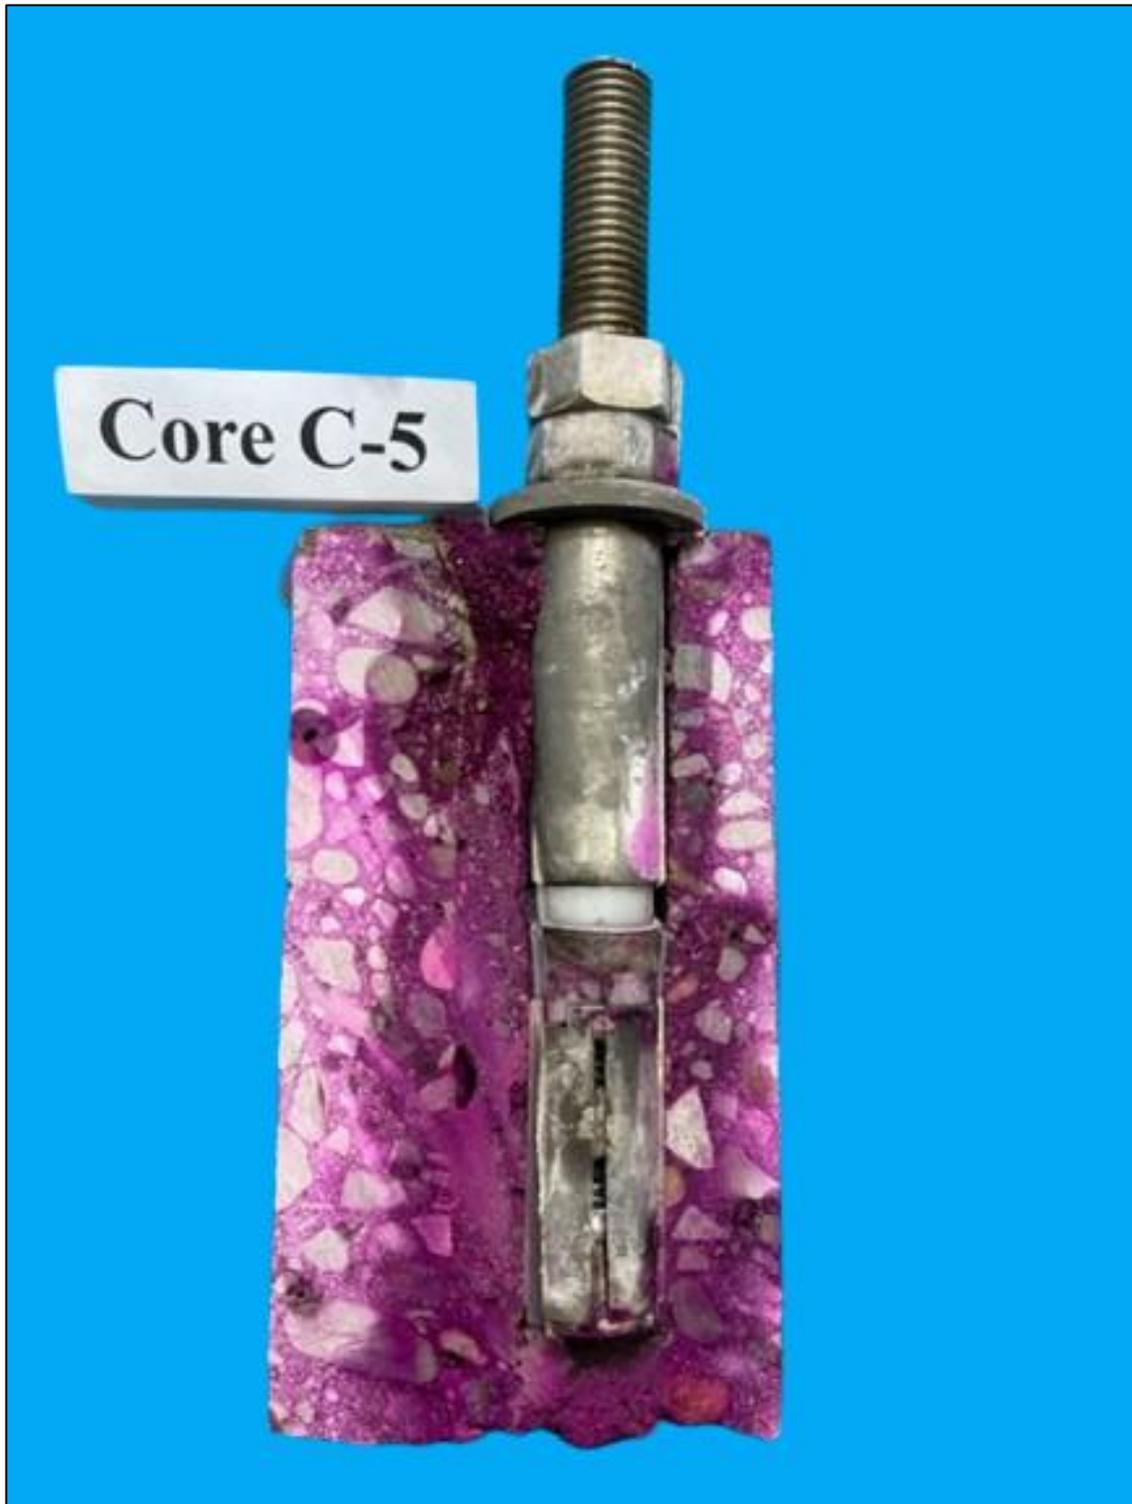
Photo P23 – Core C5

(Showing carbonation tested surface; carbonation depth was determined to be less than 0.5mm.)

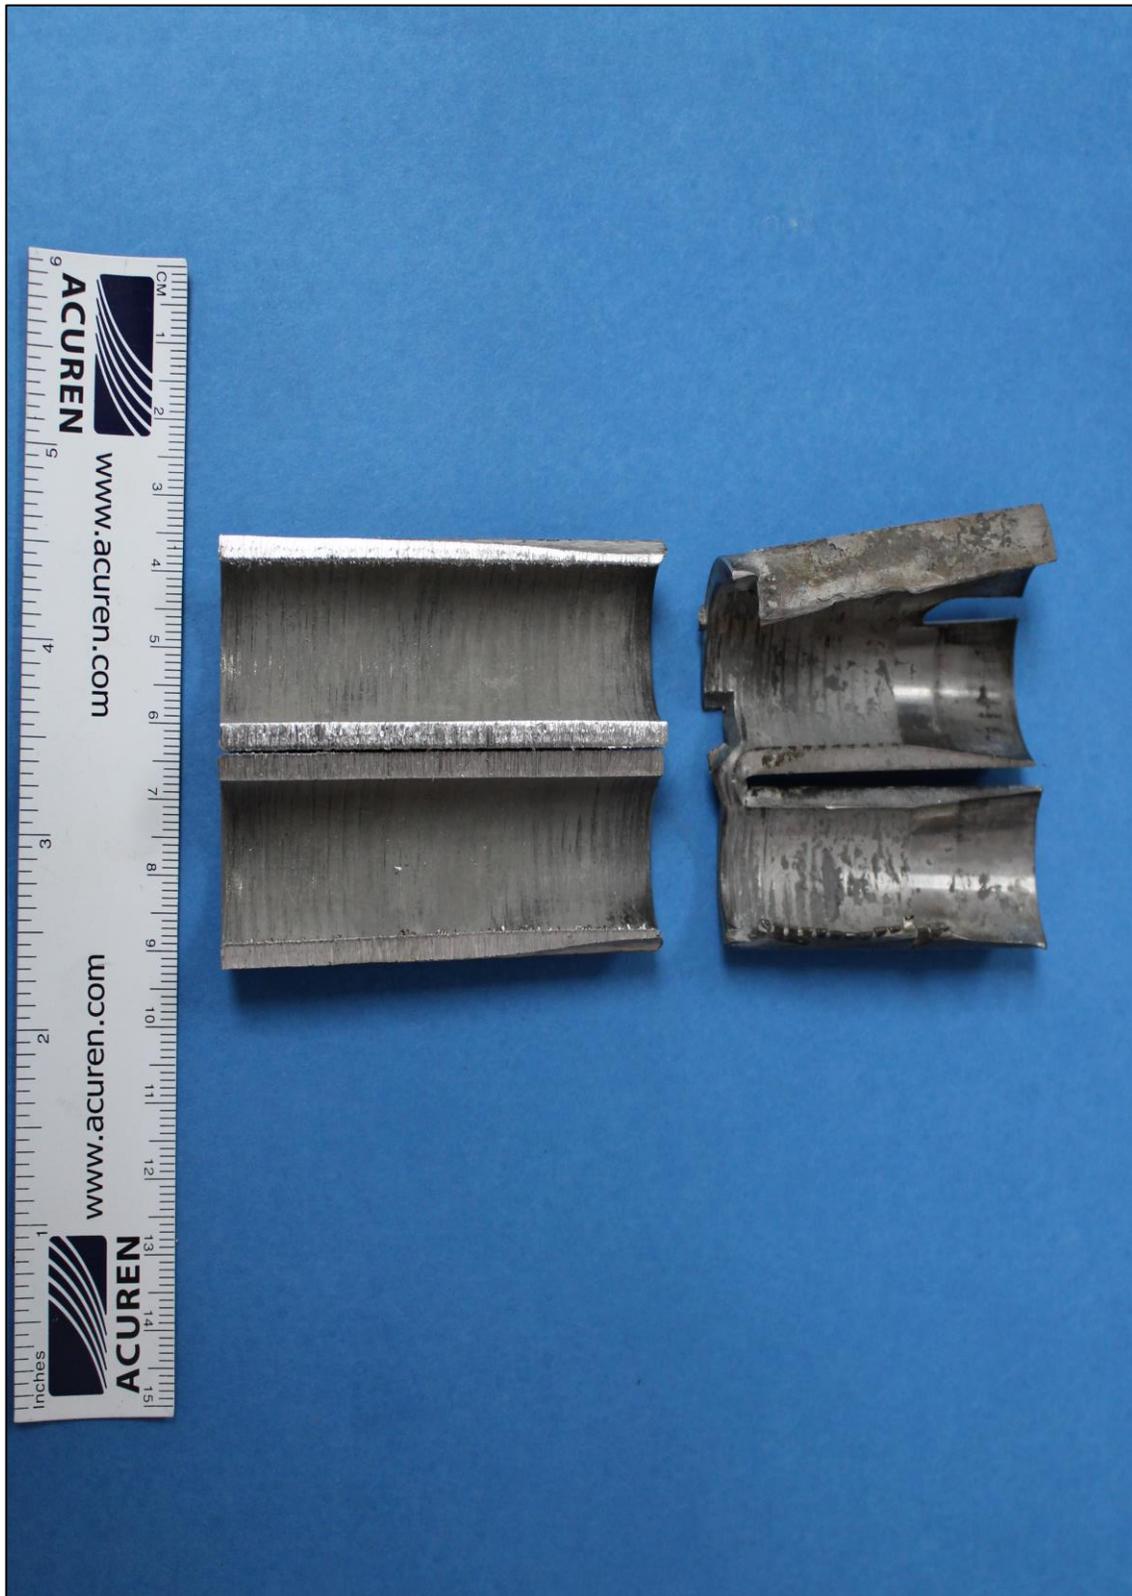
Photo P27 – Core C5

(It was noted that the sleeve of C5 has very minor indentations)

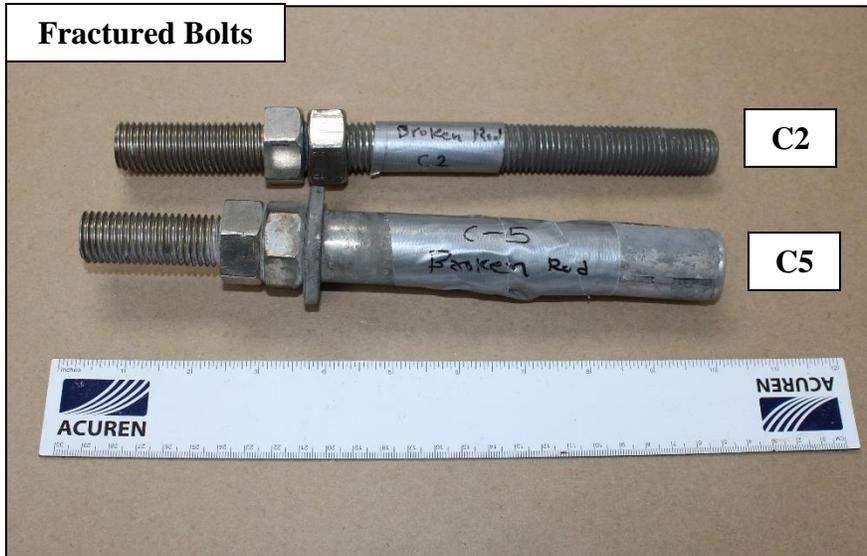
FIGURE 4. PHOTO OF SUBMITTED FRACTURED BOLTS.

- i) The submitted bolts can be seen in Figure 3. The fractured bolts can be seen in Figure 4. The fractured bolt C2 had two nuts attached to the bolt. One was fixed in place, the other was free to move up and down the threads of the bolt (Figure 5).

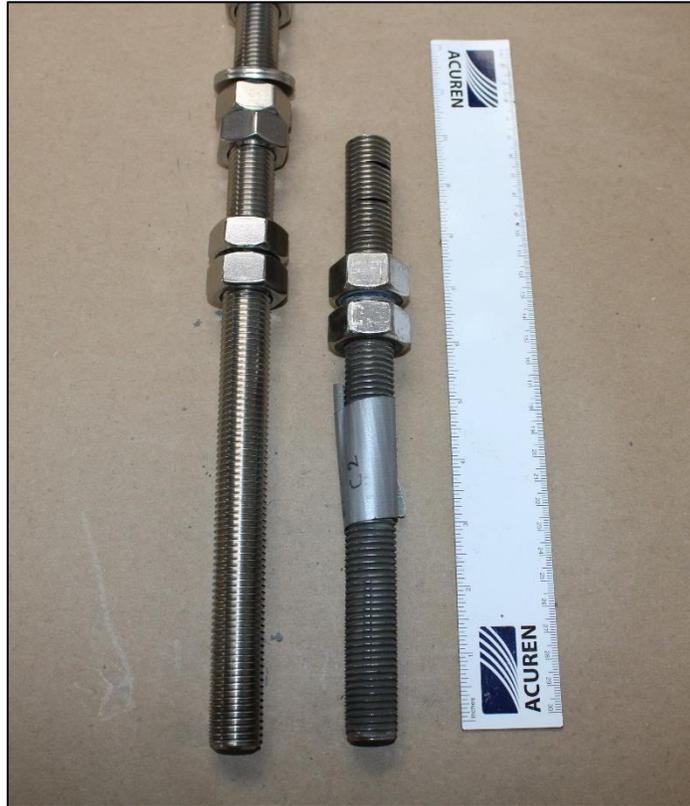
- iv) Further examination found bolt C2 to have a slight curve to it. When placed next to a ruler, it was not parallel along the entire length to the ruler (Figure 8).

FIGURE 8. PHOTO DISPLAYING A SLIGHT CURVE IN BOLT C2 UPON INITIAL EXAMINATION.

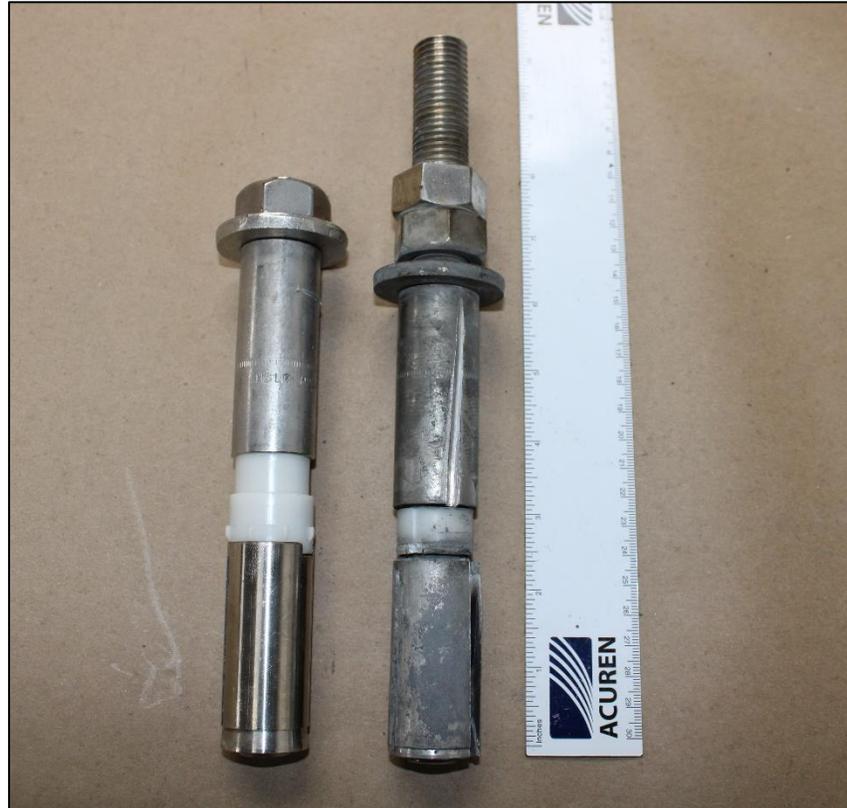
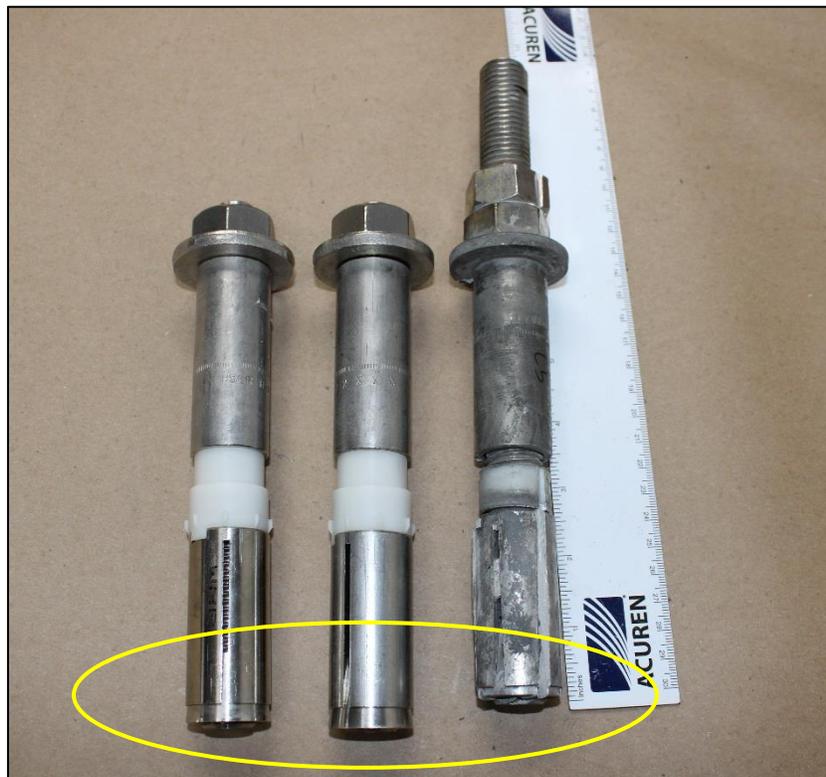
- vii) Further examination found bolt C5 to exhibit the same slight curvature along its length. When placed next to a ruler, it was not parallel along the entire length of the ruler (Figure 10).

FIGURE 10. PHOTOS DISPLAYING THE SLIGHT CURVE OBSERVED IN BOLT C5 COMPARED TO THE ORIGINAL BOLTS. THE INSERTS AT THE BOTTOM OF THE ANCHOR FIXTURING WAS DIFFERENT BETWEEN THE ORIGINAL BOLTS AND BOLT C5.

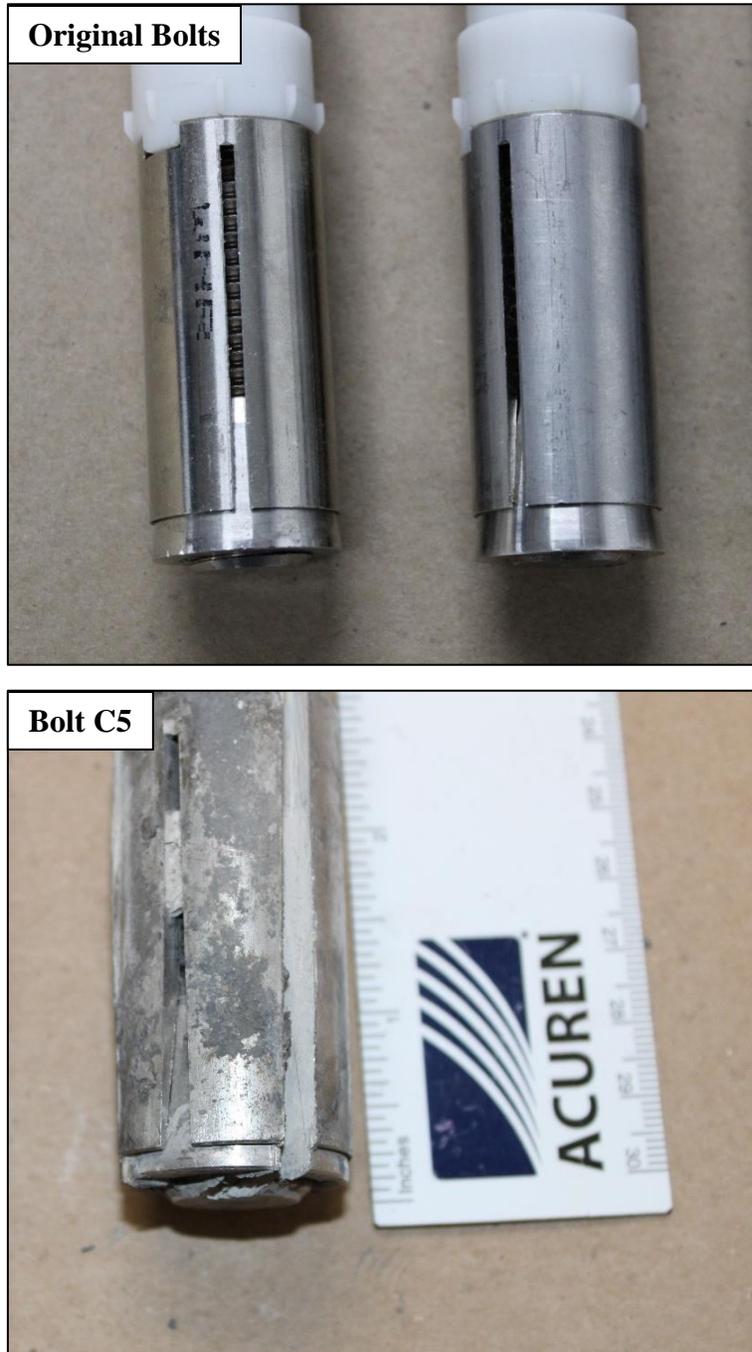
FIGURE 11. PHOTOS SHOWING THE BOTTOM OF THE ANCHOR FIXTURING ON THE ORIGINAL BOLTS AND BOLT C5.

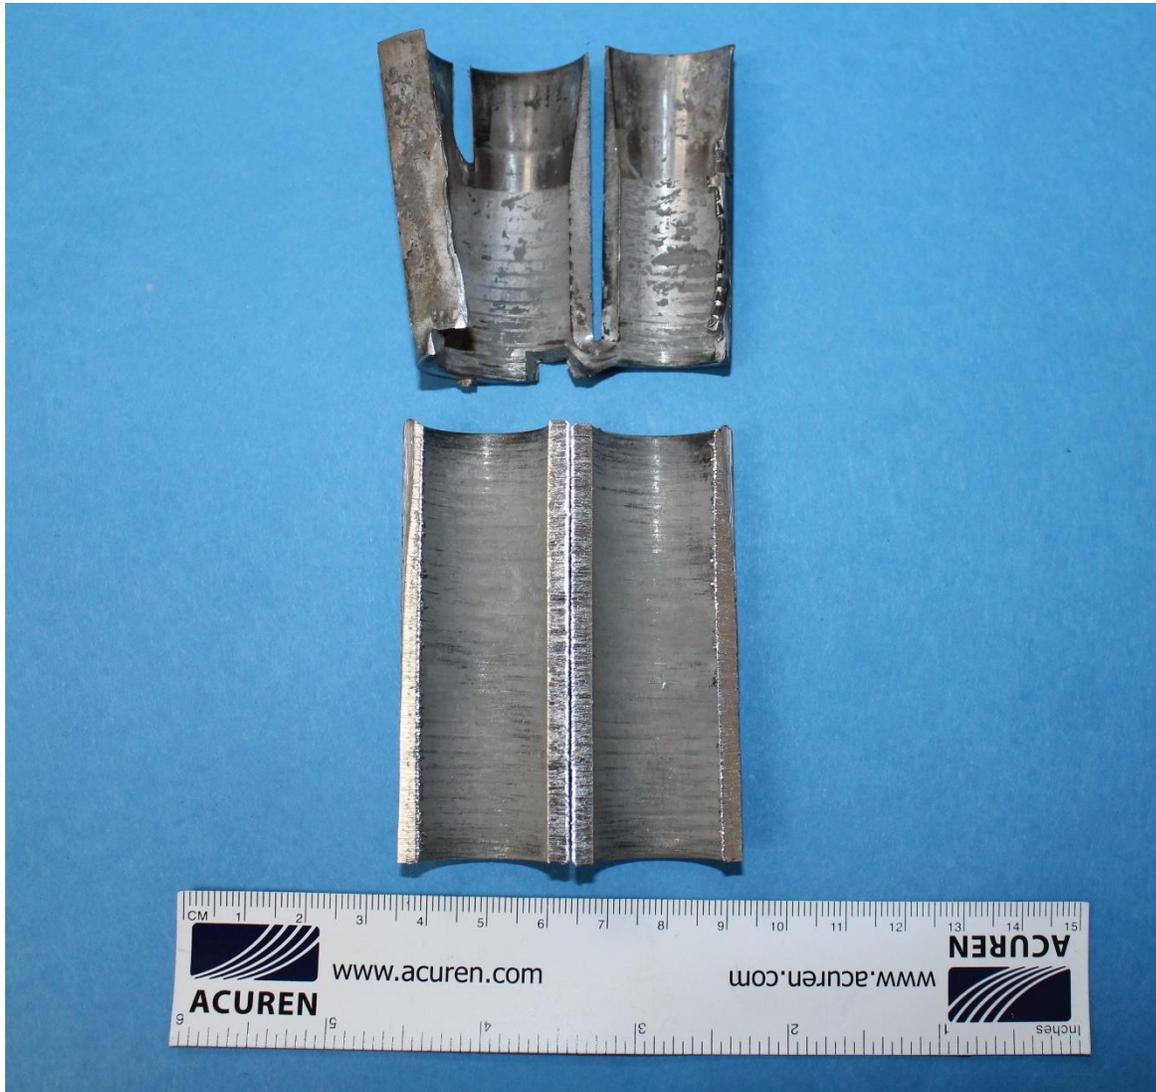
FIGURE 12. PHOTO OF THE INNER SURFACE OF THE SLEEVE AFTER REMOVING BOLT C5.

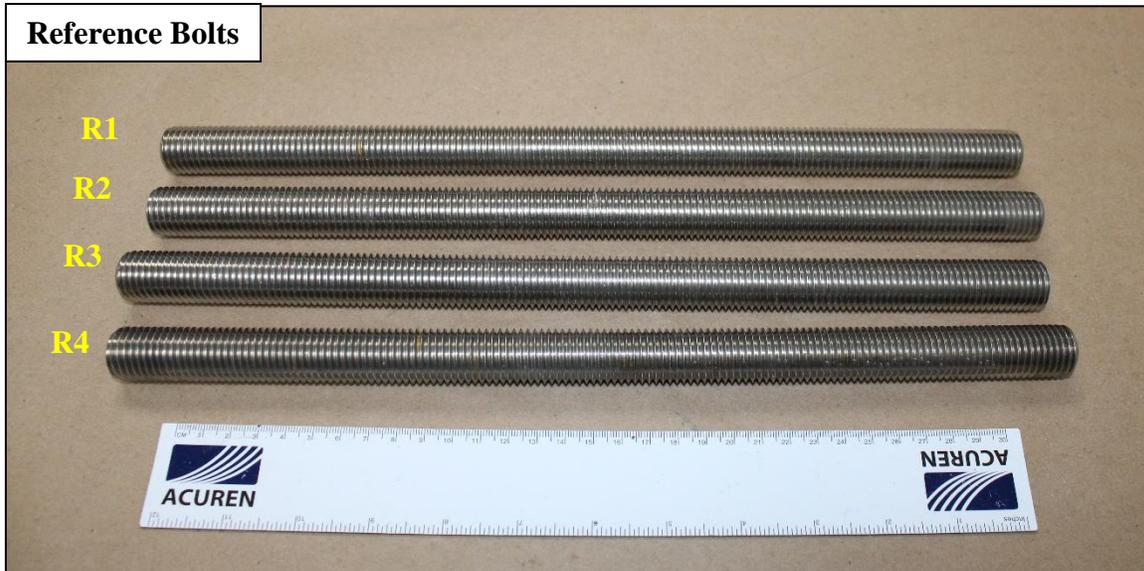
FIGURE 15. PHOTO OF THE REFERENCE BOLTS AFTER REMOVING HARDWARE.

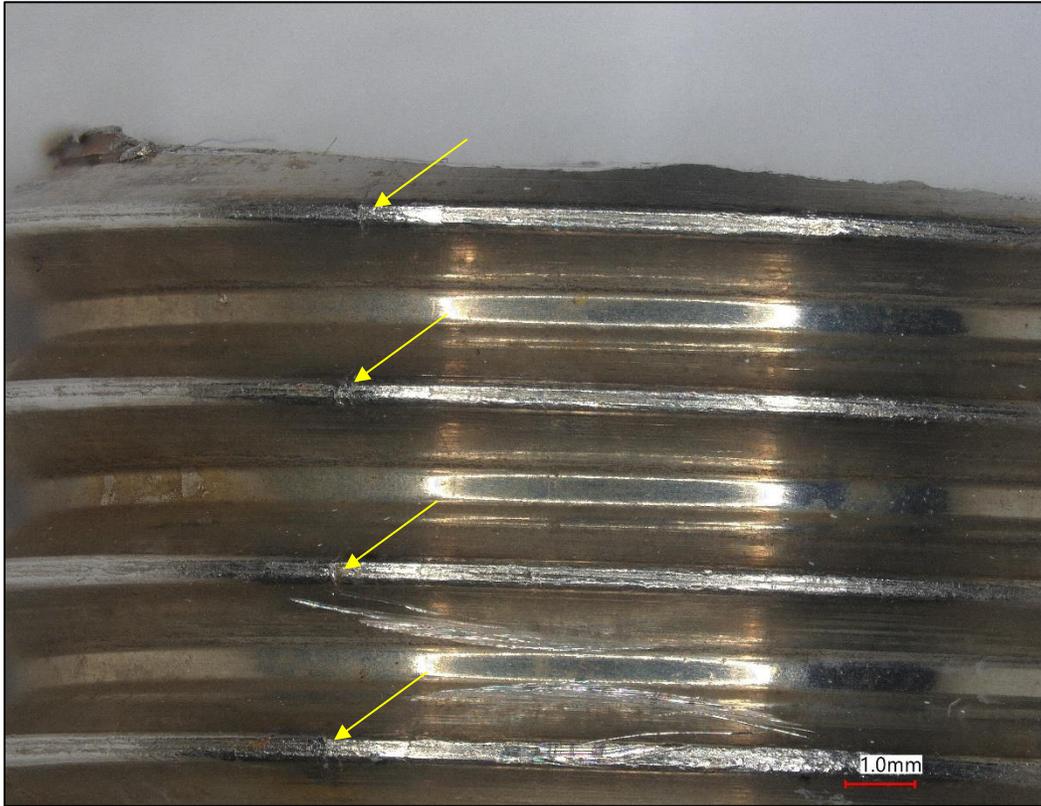
- x) A crack like indication, longitudinal in direction, was observed on the threads of the bolt, Figure 25. The indication was observed on the crests, flanks and the root of the thread.
- xi) No deformation (other than a small damage that formed after crack initiation and crack propagation) was observed in the vicinity of fracture area.
- xii) Figure 26 show the fracture surface of Bolt C5. The fracture surface was completely damaged, covered with scratch marks, removing all fracture features. Some pink foreign residues were also observed.
- xiii) We did not observe any secondary crack at the thread roots in the vicinity of the fracture. Figure 28 shows some of the threads in the vicinity of the fracture surface.
- xiv) Crack like longitudinal indications were observed on bolt C5 as well. Figure 29 shows on of those longitudinal indications.

FIGURE 29. CRACK LIKE LONGITUDINAL INDICATION ON THE THREADS, BOLT C5

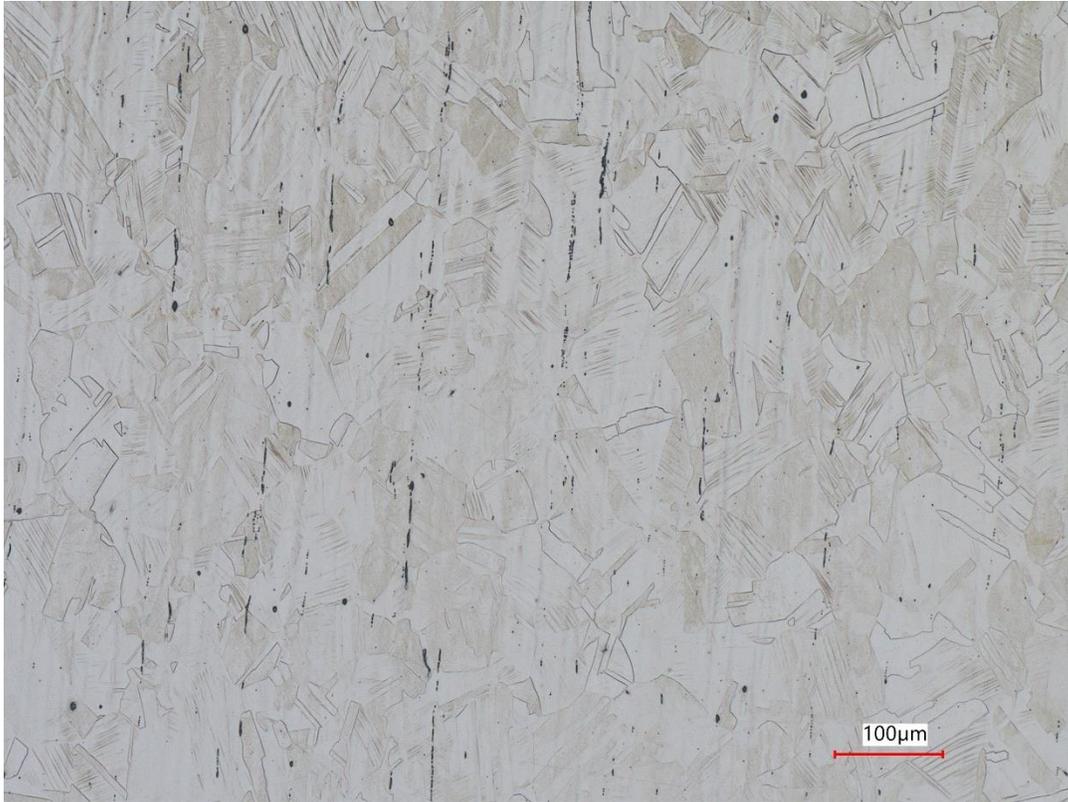
FIGURE 65. CORE MICROSTRUCTURE, BOLT O1

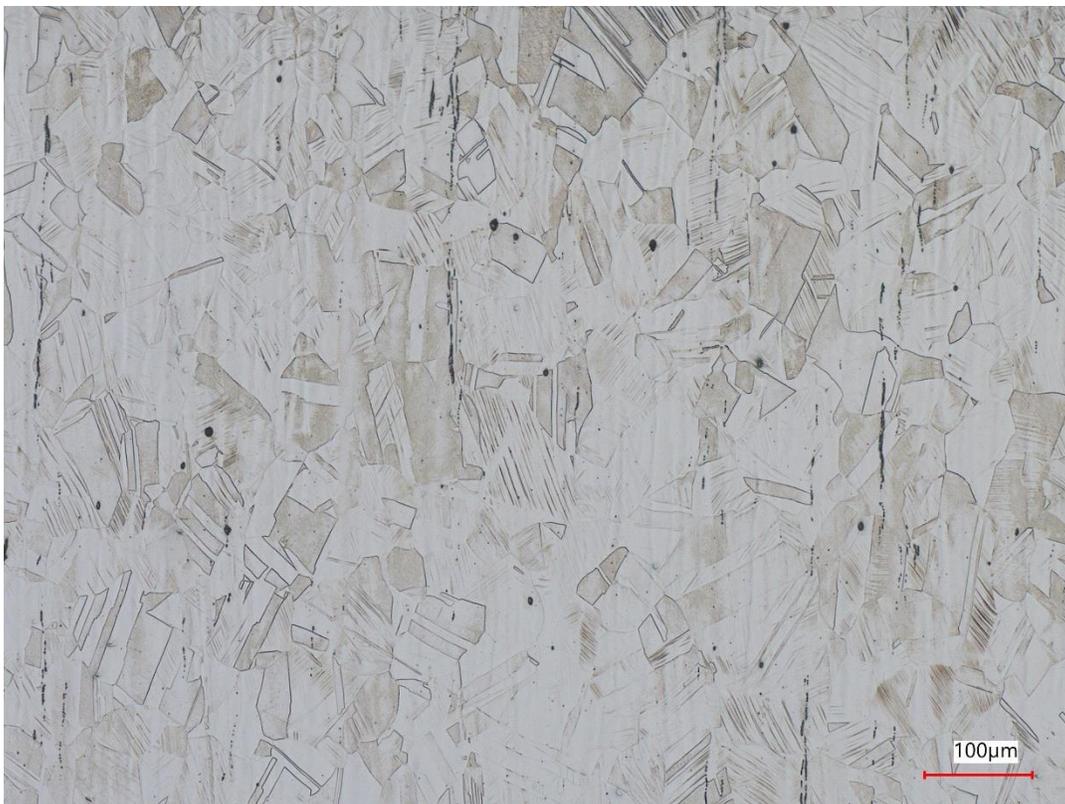
FIGURE 68. CORE MICROSTRUCTURE OF BOLT O2

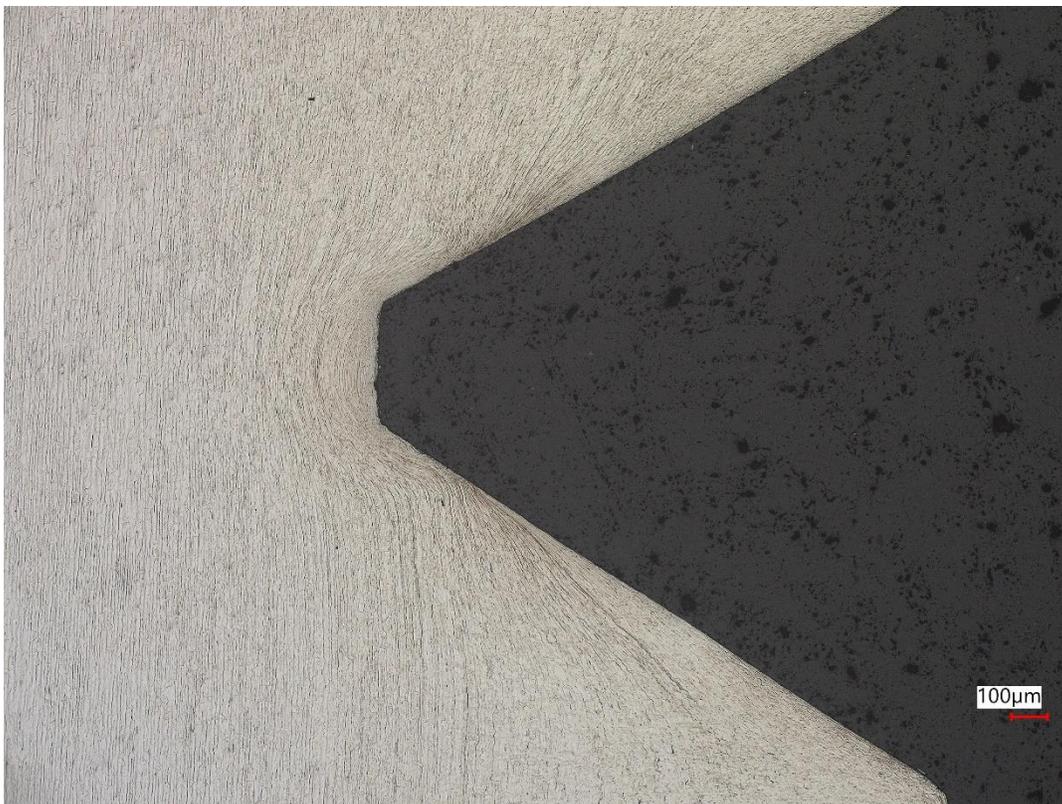
FIGURE 70. ROOT SHAPE OF THREADS IN BOLT R1, SHARP CORNER
